*Transportation Pooled Fund Project 5(165)*

**DEVELOPMENT OF DESIGN GUIDE FOR THIN AND ULTRA-THIN CONCRETE  
OVERLAYS OF EXISTING ASPHALT PAVEMENTS**

*TASK 1 REPORT:*

**COMPILATION AND REVIEW OF EXISTING  
PERFORMANCE DATA AND INFORMATION**

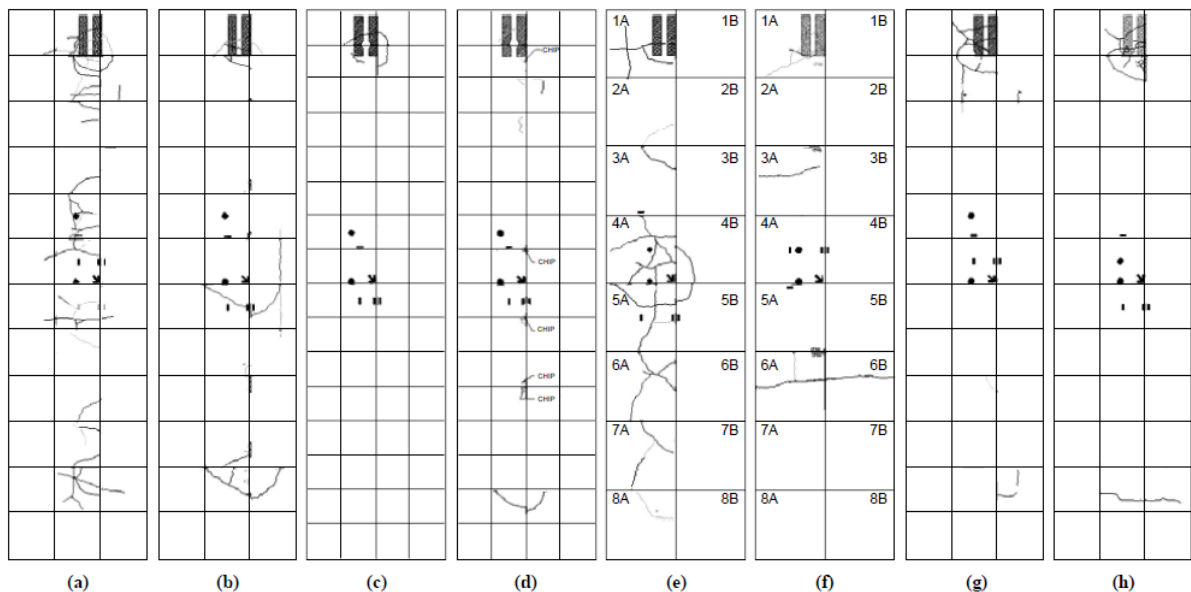
The numbers of load applications for each overlay ranged from 200,000 to more than 1 million. The test load was 12.3 kips on all lanes except for the first 310,000 load applications on Lanes 11 and 12 where a load of 10 kips was used. It may be noted that the temperature of the HMA layer was kept constant, at about 80 °F, when loaded. In order to maintain this uniform temperature, radiant heaters were cycled on and off when the ambient temperature was lower than 80 °F, which resulted in temperature gradients through the concrete. The exhibited distress was recorded as it developed through periodical visual observations. Typical distresses observed were mid-slab transverse cracking, mid-slab longitudinal cracking, corner cracking, joint faulting (longitudinal and transverse), and spalling. Figure 3 is a schematic of the distress observed at the end of loading.

Figure 3: Schematic of distress in the UTW lanes at the FHWA ALF (a) Lane 5; (b) Lane 6; (c) Lane 7; (d) Lane 8; (e) Lane 9; (f) Lane 10; (g) Lane 11 and (h) Lane 12.  
(Rasmussen et al., 2002)

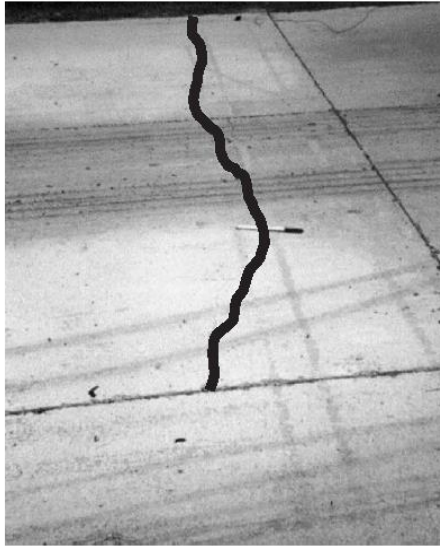
Figure 4 and Figure 5 show typical transverse and corner cracks observed in the ALF experimental study. The most significant faulting was observed along the longitudinal joint probably due to the channelized nature of the loading. Faulting was also observed in a few transverse joints but this was less severe compared to the longitudinal faulting. Figure 6 shows faulting that developed. Most of the observed spalling was of low severity.

Figure 4: Typical UTW transverse cracking at the FHWA ALF.  
(Rasmussen et al., 2002)

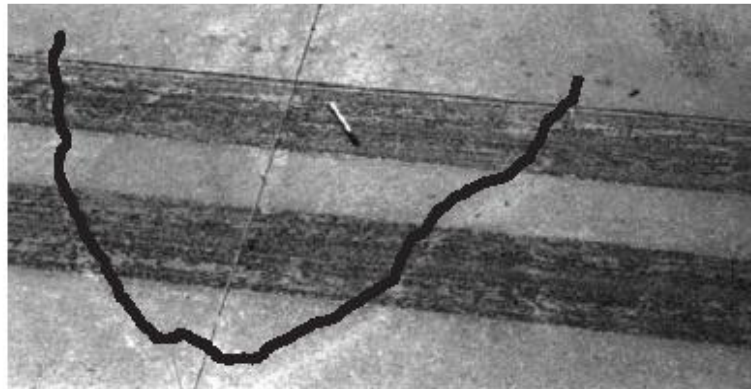
Figure 5: Typical UTW corner cracking at the FHWA ALF.  
(Rasmussen et al., 2002)

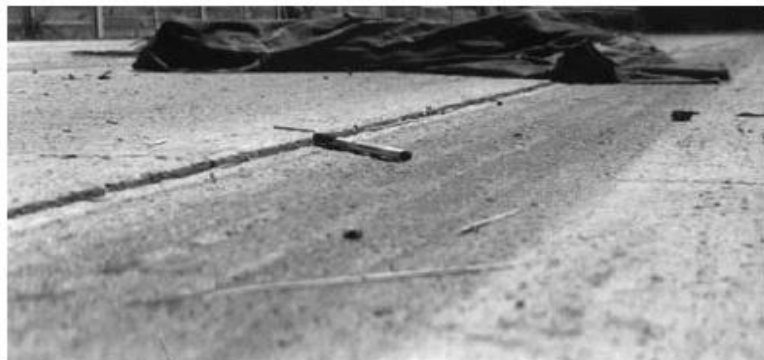
Figure 6: Typical UTW longitudinal faulting at the FHWA ALF.  
(Rasmussen et al., 2002)

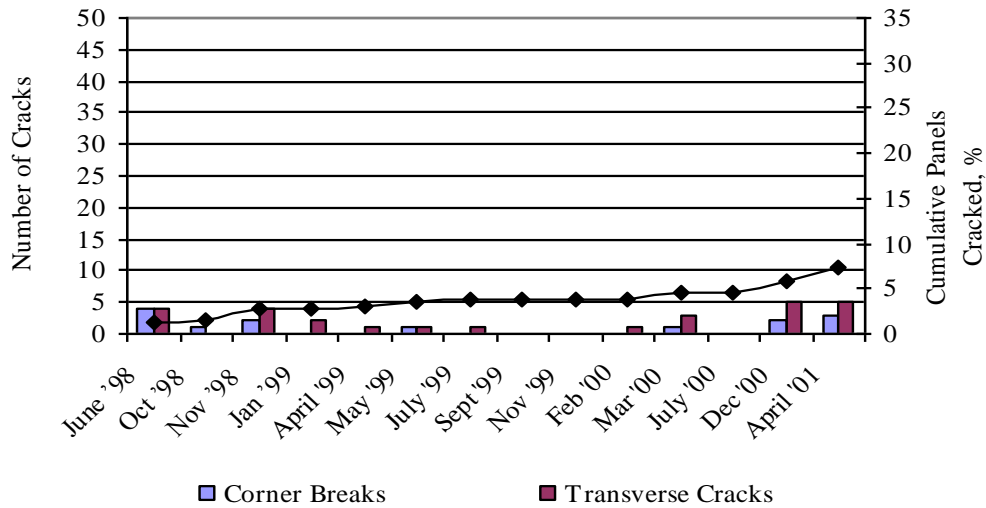
(a) Cell 93

The distress surveys conducted for the 1997 cells revealed that Cells 93, 94 and 95, which included overlays that ranged from 3- to 4-in thick, exhibited cracking by June 1998. Most of the cracks were corner cracks, and very little transverse (mid-slab) cracks developed until January 1999, when a couple of reflection cracks developed. It can be seen in Figure 16 that Cell 94 (3-in thick and 4-ft x 4-ft square panels) exhibited a significant increase in cracking near the end of 2000, which was not exhibited by the other Cells. Similar increases in cracking occurred in 2003 for Cells 93 and 95 (Burnham, 2005).

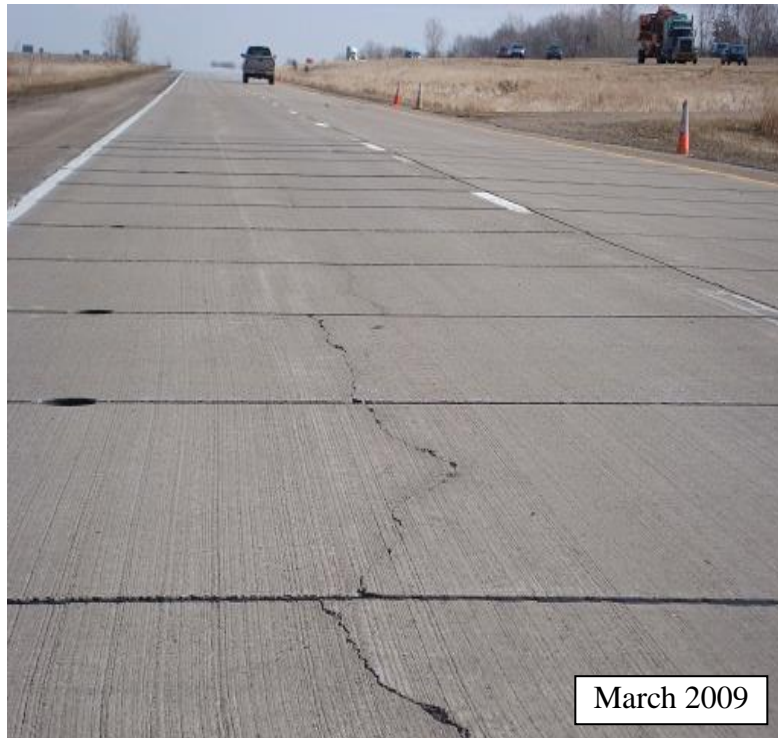
Figure 20: Longitudinal cracks in Cell 97.

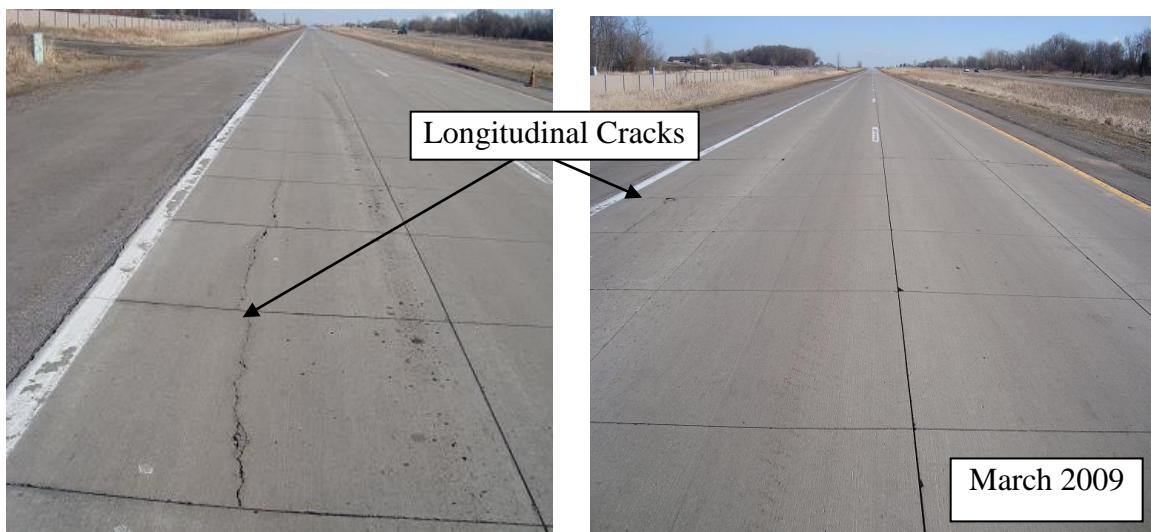
Cells 60 and 62, which were constructed in 2004 and have a 6-ft x 5-ft joint spacing and are 5- and 4-in thick, respectively, developed a relatively small amount of longitudinal cracks after 3.8 million ESALs. Both cells are undoweled and unsealed. It can be seen in Figure 21 that the longitudinal cracks in these cells also went through multiple panels similar to those in Cell 97. The severity of the cracks is still low; however, some spalling has occurred in Cell 60 (Figure 21). It is interesting to note that the longitudinal cracking that developed in Cells 61 and 63 are comparable, indicating that the longitudinal cracking is associated with the panel size for these TWT sections (Figure 22).

Figure 21: Longitudinal cracks in Cells 60 and 62.

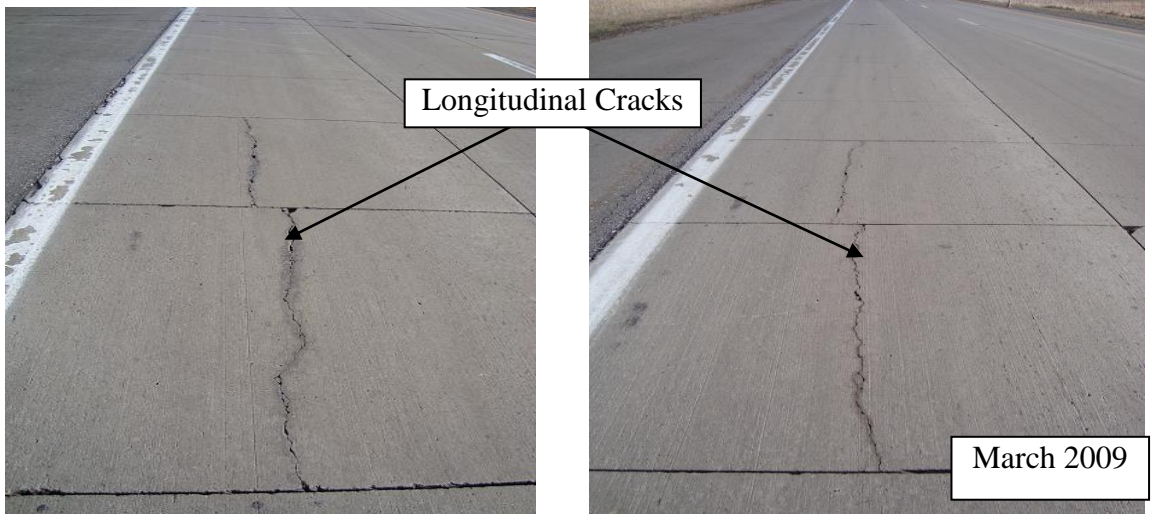
(a) Cell 61

Figure 22: Longitudinal cracks in Cells 61 and 63.

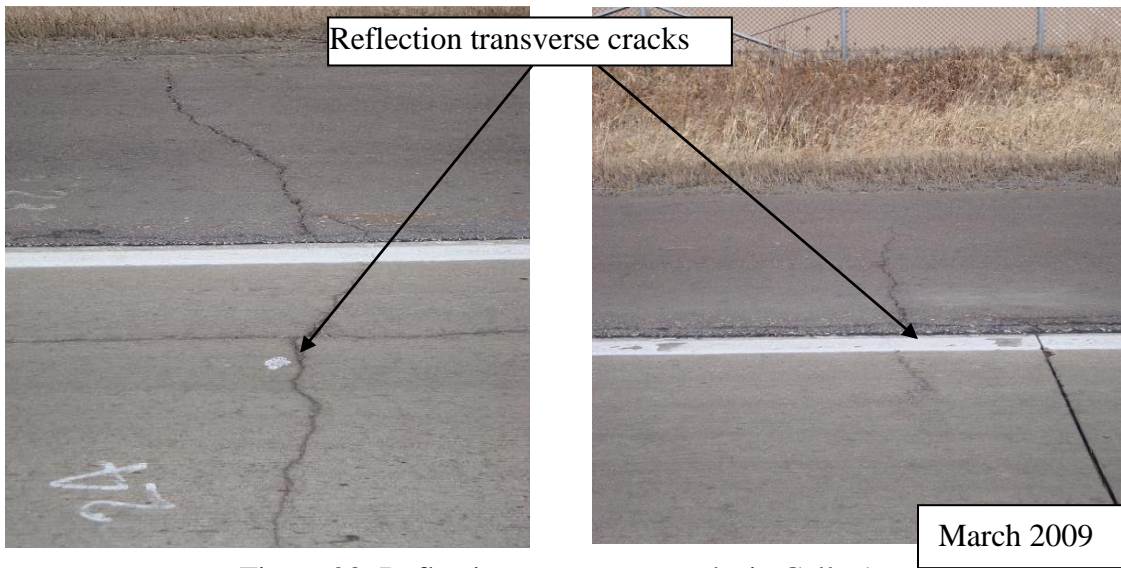
Figure 23: Reflection transverse cracks in Cell 61.

Cell 60 is performing reasonably well, while Cells 62 and 63 developed transverse cracks at an early age. Cell 61 developed its first transverse crack after 1.8 million ESALs. Until March 2009 (3.8 million ESALs), two out of 176 slabs (1.4 percent) in Cells 61 and 62 were cracked. Out of 176 slabs, six (3.4 percent) low to medium severity transverse cracks developed in Cell 63 after the same period of time. In Cell 61, both cracks were reflected from the underlying asphalt layer, while three out of six cracks in Cell 63 were reflected. This can be seen in Figure 23 and Figure 24. Cell 63 also experienced one corner break after 2.2 million ESALs (Figure 19).

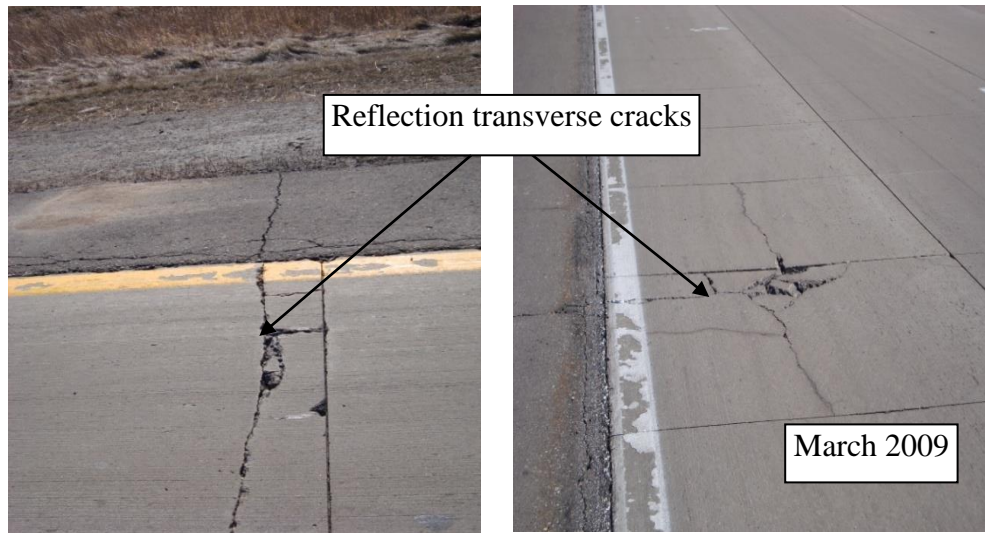
Figure 24: Reflection transverse cracks in Cell 63 at two locations.

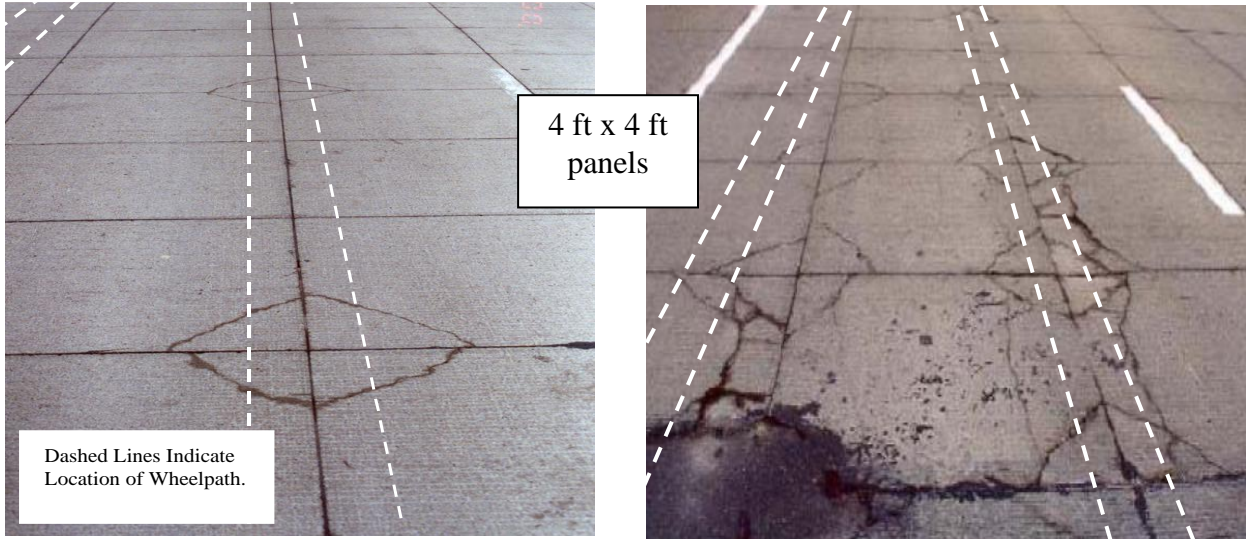
(a) Cell 94 during 2001

Figure 27: Corner cracks along the inside wheelpath on Cell 94.  
(Vandenbossche, 2001 and Burnham, 2005)

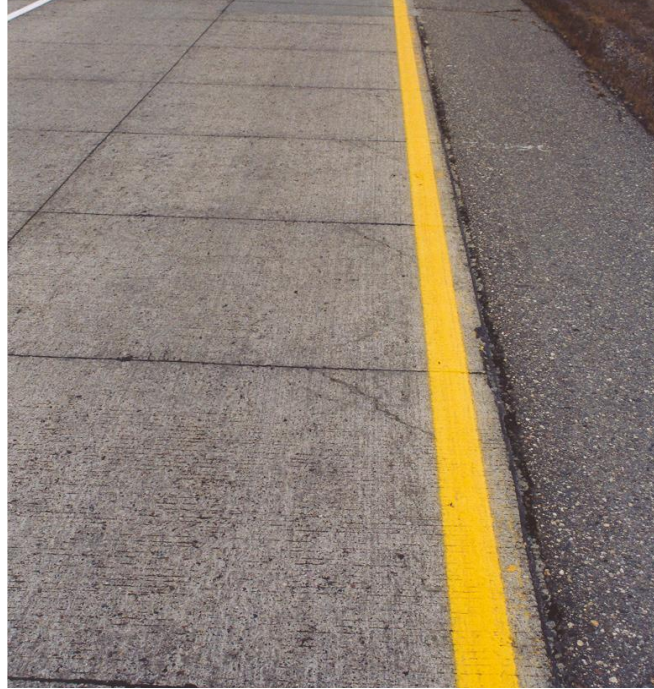
Figure 28: Distress is reduced with the 5-ft x 6-ft panels because the wheelpath is not located adjacent to the longitudinal joint (Burnham, 2005).

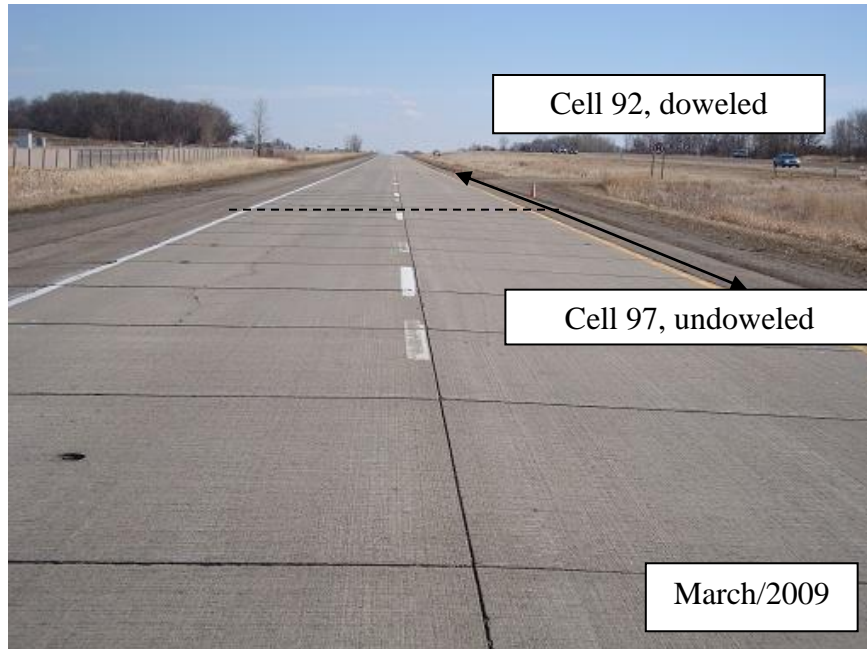
Among all of the MnROAD whitetopping sections, only Cell 92 has doweled joints. The faulting history of the cells, as mentioned in Section 4.1.2, shows that the presence of dowel bars helps to reduce the joint faulting in Cell 92. Cell 92 and Cell 97 have a similar configuration except that Cell 92 contains 1-in dowel bars. Figure 29 clearly shows the presence of faulting in Cell 97, whereas no faulting is visible in the adjacent Cell 92. Dowels are not typically used for TWT or UTW since these overlays are commonly constructed on lower volume roads. The results show that there is potential to extend the range of applications for these overlays since they have the potential to perform for extended periods of time (11.5 years), even on the interstate. This increase in performance was observed with only a 1-in diameter dowel bar. It is interesting to see that the performance of the joints in Cell 92 (doweled, 10 ft x 12 ft) and Cell 96 (undoweled, 5 ft x 6 ft) are comparable. Decreasing the joint spacing exhibited a similar improvement in joint performance as the addition of 1-in dowels.

Figure 29: Faulting of panels in Cell 97(undoweled) but no faulting in Cell 92 (1-in dowels).

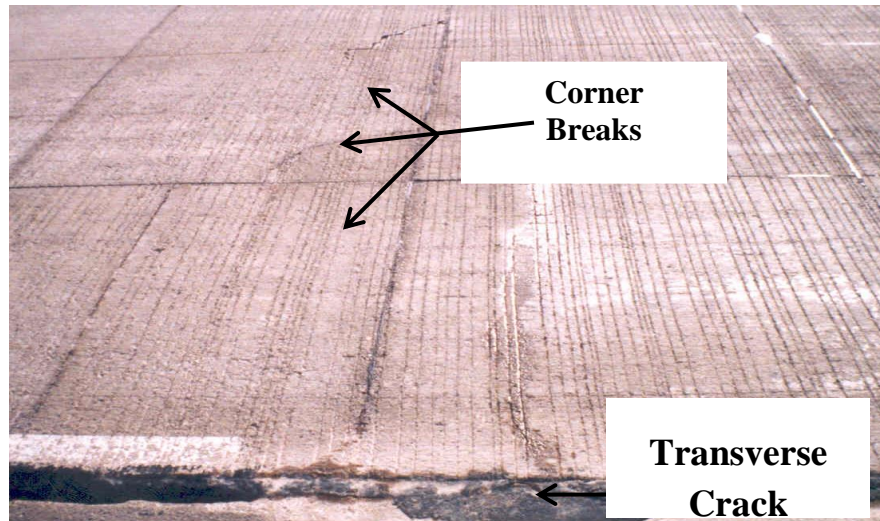
Cracks observed in the ultra-thin whitetopping test sections with a 4-ft x 4-ft joint pattern included corner breaks and transverse cracks. The corner breaks occurred primarily along the inside longitudinal joint and the lane/shoulder (L/S) longitudinal joint. Many of the corner breaks that developed along the inside longitudinal joint did not appear until 1999. The inside longitudinal joint lies directly in the inside wheelpath resulting in high edge and corner stresses. Transverse cracks developed in the panels adjacent to the shoulder. The transverse cracks typically developed 1.3 ft away from the transverse joint, which is approximately one third of the length of the panel. The cracking patterns along the wheelpath are shown in Figure 35 and Figure 36. The Main Street test section was constructed using a 6-ft x 6-ft joint pattern. Corner breaks were the primary distress that developed in this test section, although very little cracking was exhibited compared to the sections with a 4-ft x 4-ft joint layout. The corner breaks were typically located in the outside panel adjacent to the lane/shoulder joint intersecting the transverse joint at the wheelpath. A few corner breaks also developed in the inside panels. Again, the corner break typically intersected the transverse joint at the wheelpath and then intersected the longitudinal joint separating the two panels. Both of the corner breaks exhibited in the inside and outside panels intersected the longitudinal joint at the nearest wheelpath. Figure 37 shows the typical pattern of the corner cracks in the Main Street test section. The pattern of the corner cracks of Cell 98 (4ft x 4ft) is comparable to the performance of Cell 93 to 95 in the MnROAD test sections. The distress pattern in the US-169 test sections validated the fact that joint layout optimization is important to avoid corner cracks.

Figure 35: Transverse crack and corner breaks in the Jackson Street test section (03.30.98).  
(Vandenbossche, 2003)

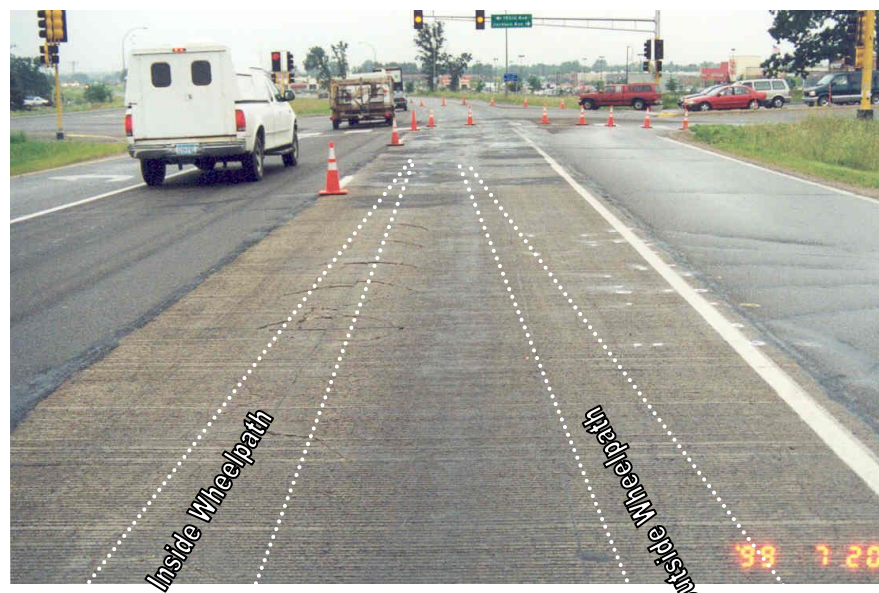
Figure 36: Corner breaks in the inside wheelpath at the Jackson Street test section.  
(07.20.99) (Vandenbossche, 2003)

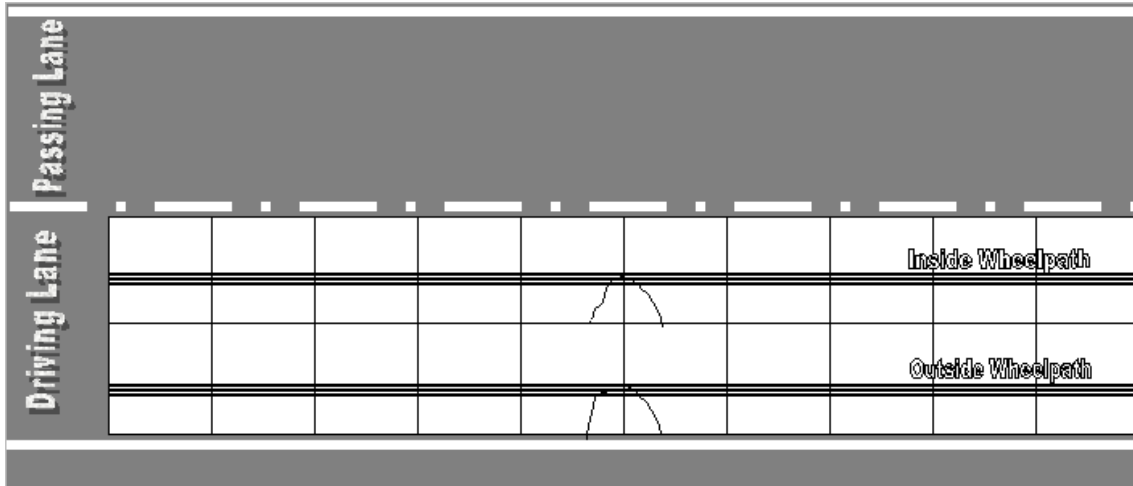
Figure 37: Typical distress patterns that developed at the 6 ft x 6 ft Main Street test intersection. (Vandenbossche, 2003)

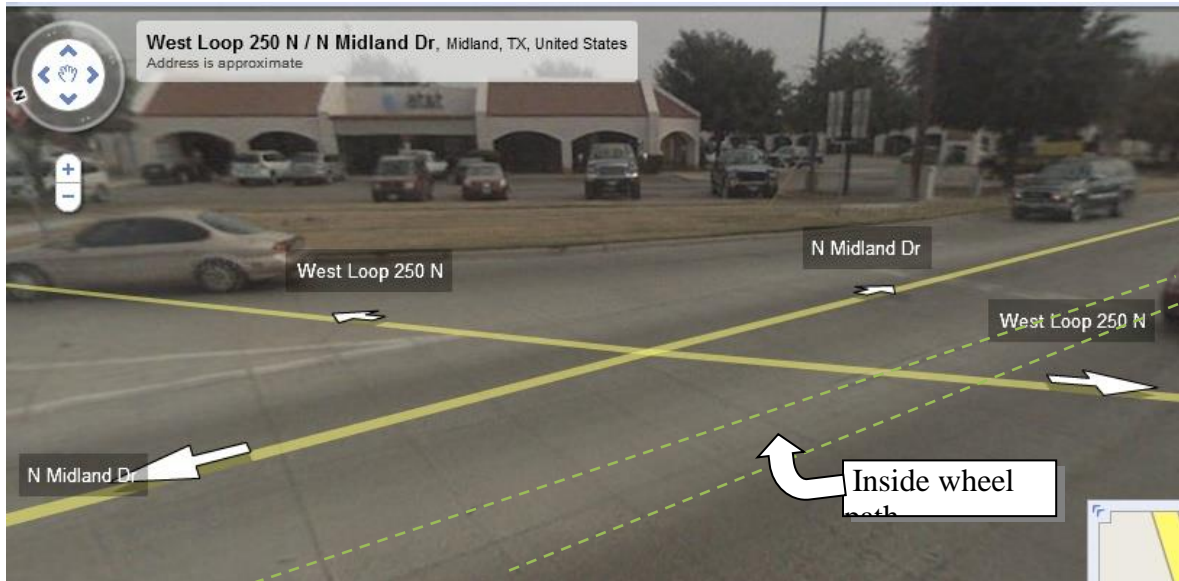
Figure 40 and Figure 41 are two pictures of the intersections at Midland Drive and Wadley Avenue obtained from Google Street View in February of 2009. The figures clearly show that the inside wheel path is along the longitudinal joints.

Figure 40: UTW at the intersection of LP-250 and Midland Drive at Odessa District. (Google Street view (February/2009))

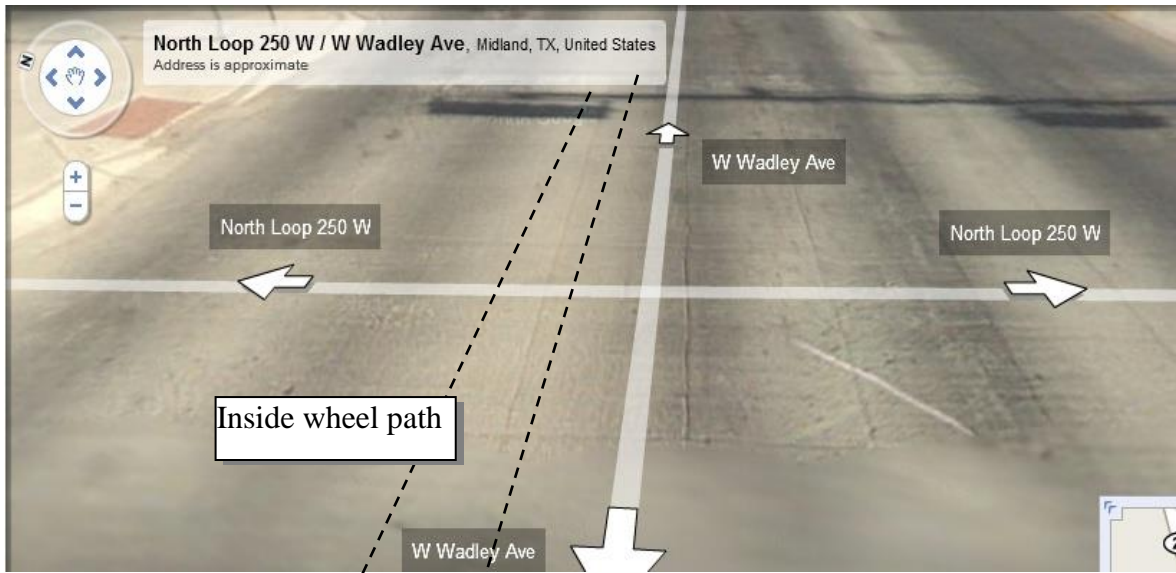
Figure 41: UTW at the intersection of LP-250 and Wadley Avenue at Odessa District.  
(Google Street view (February/2009))

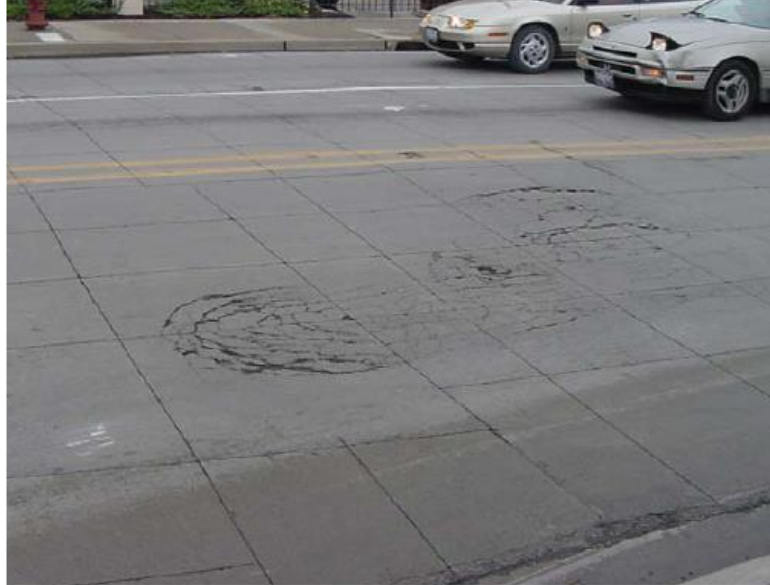
Figure 44 shows some of the distressed panels with high severity. It seems that the cracks developed in the shape of a spider web. A little bit of depression is observed as well. The distress initiation at this location is unknown; but, it was reported that the underlying layers did not show any considerable defects. The severe distresses indicate that non-uniform support conditions may have been the trigger. Additionally, the progression of the debonding between the layers might have caused the distresses to spread across multiple slabs.

Figure 44: Distressed panels at the intersection. (Winkelman, 2005)

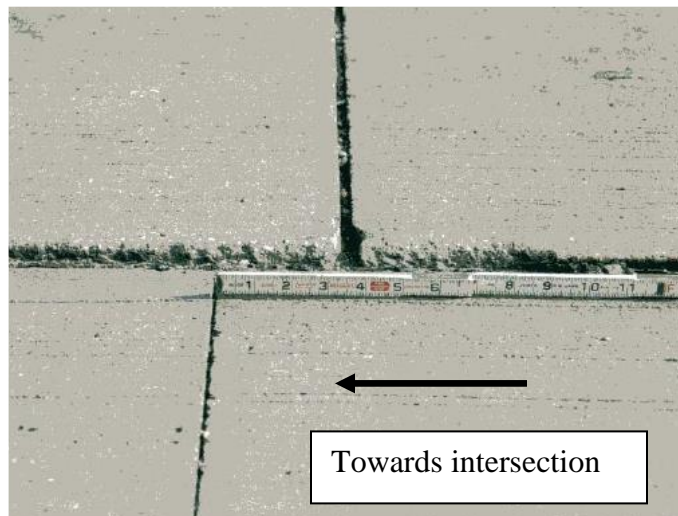
Figure 45: Movement of the panels toward the intersection (Winkelman, 2005).

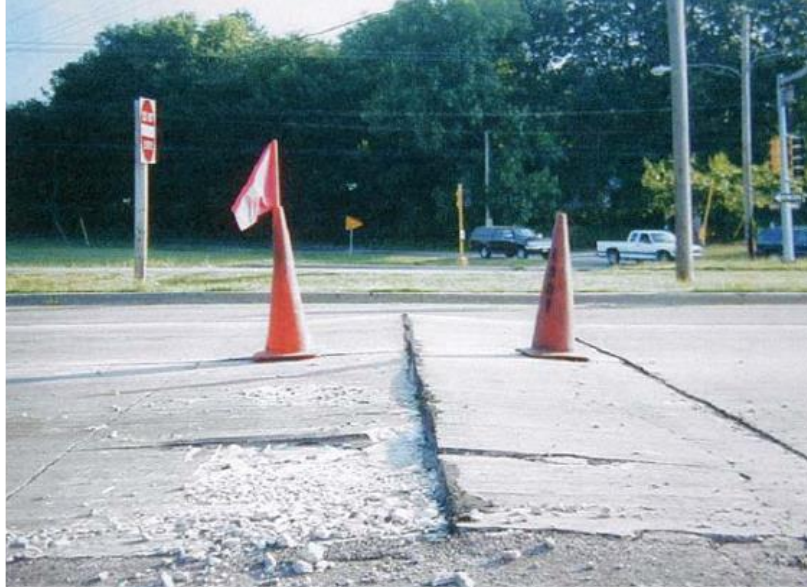
Figure 46: Blow up of the UTW slabs (Winkelman, 2005).

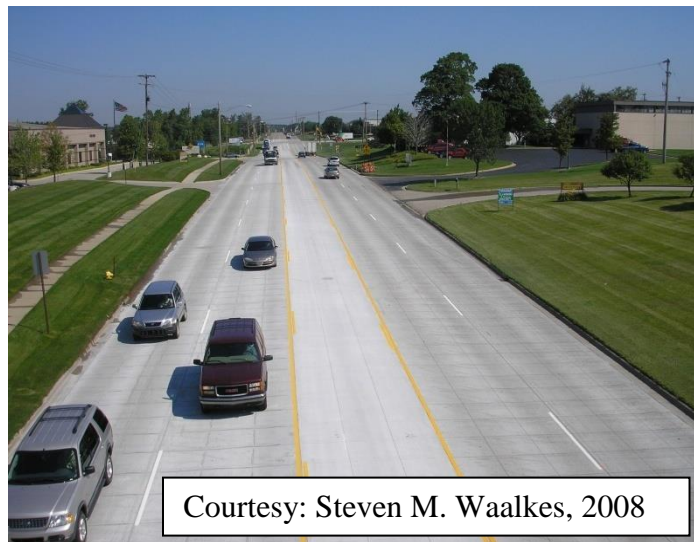
***Distress data:*** There are two distressed areas: the intersection at Patterson Avenue and 36th Street and the southbound lanes of Patterson Avenue at Danvers Drive. The intersection at Patterson Avenue and 36th Street was widened in 2006 along with the application of whitetopping. The underlying asphalt edge did not line up properly with the joint between the whitetopping and the full-depth widening. The southbound lanes of Patterson Avenue at Danvers Drive were gapped halfway when the whitetopping was placed. This area coincides with a manhole. There is some distress around the manhole that is indicative of poor support/poor compaction of the base/subbase/asphalt around the structure, as well as debonding of the PCC from the asphalt. However, the overall condition of the project is good. A photograph taken in 2008 as shown in Figure 48 presents the condition of the road.

Figure 48: Condition of the UTW after two years (2008).
