Performance, Analysis, and Repair of Ultrathin and Thin Whitetopping at Minnesota Road Research Facility

Julie M. Vandenbossche and Aaron J. Fagerness

Thin and ultrathin whitetopping overlays are becoming a more common method of pavement rehabilitation. It is important to gain information on the types of distresses that occur in the overlays and effective repair techniques. In 1997 the Minnesota Department of Transportation constructed several thin and ultrathin whitetopping test cells at the Minnesota Road Research (Mn/ROAD) facility. Typical distresses included corner breaks, transverse cracks, and reflective cracks. The finite element program ISLAB2000 was used to investigate stress patterns and their relation to the distresses. Different techniques for repairing ultrathin whitetopping were investigated. Various techniques were also used to deter reflective cracking, including various bond-breaking materials and full-depth sawing at strategic locations along the longitudinal joint to prevent cracks from propagating into adjacent panels at misaligned transverse joints. Four of the six sections had present serviceability indexes (PSIs) greater than 3.5 before the repairs, showin

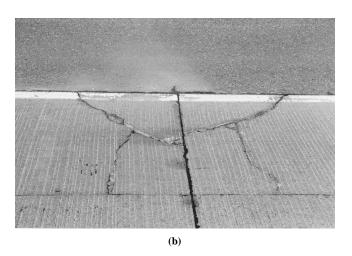
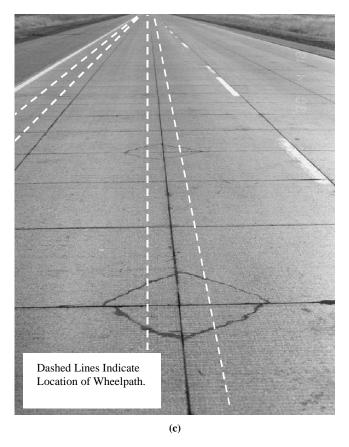
Figure 1a summarizes the distress data for the 102-mm (4-in.) overlay with $1.2 - \times 1.2$ -m (4- \times 4-ft) panels. Since the time of construction, 7% of the panels have exhibited cracking: 34% of the observed distresses are corner breaks, and the remaining 66% are transverse cracks. Most of the corner breaks occurred along the inside longitudinal joint because of its location directly in the inside wheelpath (see Figure 2c). Transverse cracks often occur in the outside wheelpath near a transverse joint (Figure 2a). At times, these transverse cracks were intercepted by corner breaks that initiated at the intersection of the wheelpath and the transverse joint (Figure 2b). Of the cracking in this section, 73% occurred in the driving lane.

FIGURE 2 Ultrathin whitetopping with 1.2- × 1.2-m panels: (a) load-related transverse cracks, (b) load-related corner breaks and transverse cracks, and (c) corner cracks in wheelpath.

The amount of cracking and the cracking pattern that occurred in each section are directly influenced by the joint layout. The longitudinal joint of a 1.2- \times 1.2-m (4- \times 4-ft) joint layout is located in the inside wheelpath. This location resulted in corner cracking for both the 76and 102-mm (3- and 4-in.) overlays. The performance of the 76-mm overlay with 1.5- \times 1.8-m (5- \times 6-ft) panels was significantly better than that of the 76-mm overlay with $1.2-\times 1.2$ -m panels because the longitudinal joints were located outside of the wheelpaths, thereby reducing the edge loads. A comparable performance was obtained with the 76-mm overlay with 1.5- \times 1.8-m panels and the 102-mm overlay with $1.2 - \times 1.2$ -m panels. This finding indicates that an optimum joint layout can provide an increase in the performance of the overlay equivalent to an increase in the thickness of the overlay by 25 mm (1 in.). The 76-mm overlay with $1.5-\times 1.8$ -m panels is also more economical than the 102-mm overlay with 1.2- \times 1.2-m panels because less concrete is needed and there are fewer joints to construct and maintain.

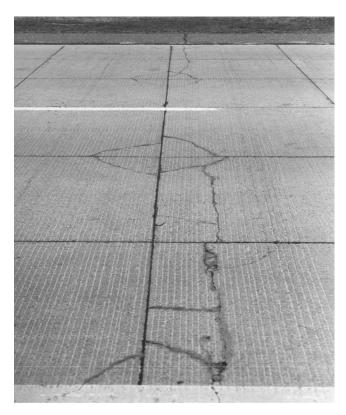
FIGURE 3 Reflective cracking in ultrathin whitetopping.

Many of the transverse cracks appearing in the overlays are a result of previously existing temperature cracks in the asphalt that reflect up through the concrete. Reflective cracking is a function of both uniform temperature- and load-related stresses. The thermal contraction of the asphalt in the winter creates a stress concentration at the bottom of the concrete in the region near the tip of the crack in the asphalt. The magnitude of the tensile stress at the bottom of the concrete is then increased as a result of vehicle loads, thereby causing the crack in the underlying asphalt to propagate up through the concrete overlay.

Panel size and overlay thickness also affect the development of reflective cracking. The section with the shortest joint spacing and the thinnest overlay (76-mm overlay with 1.2- × 1.2-m panel spacing) experienced the highest percentage of cracks reflecting through the overlay, whereas no cracking occurred in the 152-mm (6-in.) overlays. The 102-mm (4-in.) overlay with the same panel size $(1.2 \times$ 1.2 m) had a slightly lower percentage, but this difference might not be statistically significant. The 76-mm section with larger panels $(1.5 \times 1.8 \text{ m})$ had the lowest percentage of thermal cracks propagating through the overlay among the three ultrathin test sections. As previously discussed, the load-related stress is higher in the ultrathin overlays with $1.2-\times 1.2$ -m panels because the longitudinal joint lies in the wheelpath. The load-related stresses coupled with thermal stresses generated during the colder months of the year work together to promote the reflection of cracks from the asphalt into the overlay.

Repairing areas with corner breaks and transverse cracking consisted of removing the distressed panels using a milling machine and chisel-hammers, as described above, and placing concrete back into the repair area. Repairing panels with reflective cracks presented additional difficulties. Several techniques were implemented to deter the reoccurrence of reflective cracking. The first approach was to place a bond-breaking material over the cracks in the asphalt to prevent cracks from reflecting up into the repaired panel. Two different types of debonding materials were tested, duct tape and roofing paper.

Several repairs contained reflective cracks in the overlay that were near the sawed transverse joint. After milling, it was revealed that a crack would still propagate down from the joint into the asphalt even when a full-depth transverse reflective crack was near the joint. The reflective crack tended to be the working crack, so the new joint made in each repair was sawed over the reflective crack. Small strips of roofing paper were placed over these cracks and stapled to the asphalt as a bond breaker. This treatment was necessary to prevent reflective cracking in the areas where the meander of the crack would not follow the straight joint sawed into the repair. Roofing paper was used in lieu of duct tape if the cracks tended to meander significantly because the pieces of roofing paper could be tailored to fit the shape of the crack. Duct tape was placed as a bond breaker over the straight cracks in the asphalt that propagated down from the joints sawed into the overlay during initial construction. The duct tape was also stapled to the asphalt to prevent it from moving while the concrete was being placed.

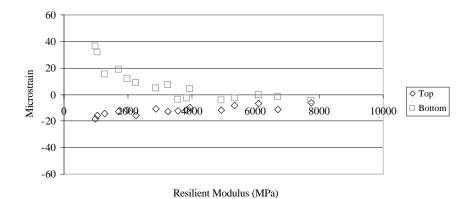
is around 4,000 MPa (580,000 psi), and the entire concrete overlay is in compression when the resilient modulus is above 4,000 MPa (580,000 psi). The resilient modulus is 4,000 MPa (580,000 psi) when the asphalt temperature is 6°C (43°F) and 3,000 MPa (435,000 psi) when the temperature is 11°C (51°F). The average monthly temperature is greater than 6°C (43°F) for 7 months of the year in Minnesota and greater than 11°C (51°F) for 5 months of the year (6). Therefore, compressive stresses will be generated at the bottom of the overlay under an applied load the majority of the time for 4 months of the year. The bottom of the overlay will be in tension under an applied load the majority of the time for 5 months of the year. The data in Figure 5 demonstrate the importance of considering seasonal effects when the design life of ultrathin whitetopping is determined.

FIGURE 5 Strain directly under 40-kN falling-weight deflectometer load applied in wheelpath adjacent to transverse joint on 76-mm overlay with 1.5- \times 1.8-m panels.

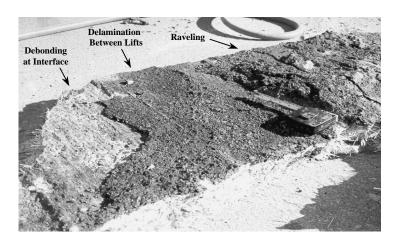
Over time, the combined stiffness of the overlay and the asphalt cross section can decrease. There are three means by which the stiffness of this monolithic section can be reduced: the overlay debonds at the interface between the asphalt and concrete, delamination occurs between lifts within the asphalt, or the asphalt ravels. This decrease in stiffness also leads to less support from the underlying pavement, higher stresses in the overlay, and potentially cracking. The mode of deterioration will dictate the depth of repair required if cracking does occur. These three modes of deterioration are shown in Figure 6, in which the bottom portion of a panel from an ultrathin whitetopping section is shown after it had been removed with a backhoe. The photograph was from a section of ultrathin whitetopping being repaired on US-169 near Mankato, Minnesota, in October 1998.

FIGURE 6 Three different modes of debonding between asphalt and concrete overlay.

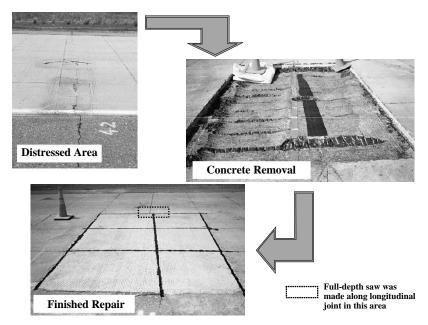
FIGURE 7 Repairing reflective cracks in ultrathin whitetopping.

Figures 7 and 8 show examples of typical repairs performed on the ultrathin whitetopping sections at Mn/ROAD.
