The Use of Small Unmanned Aerial Vehicles (sUAVs) to Evaluate Rock Slope Stability and Assess Performance of Rockbolts on Inaccessible Slopes

SR885 – BOULEVARD OF THE ALLIES – DUQUESNE BLUFF... ROCKBOLT INVENTORY AND ASSESSMENT

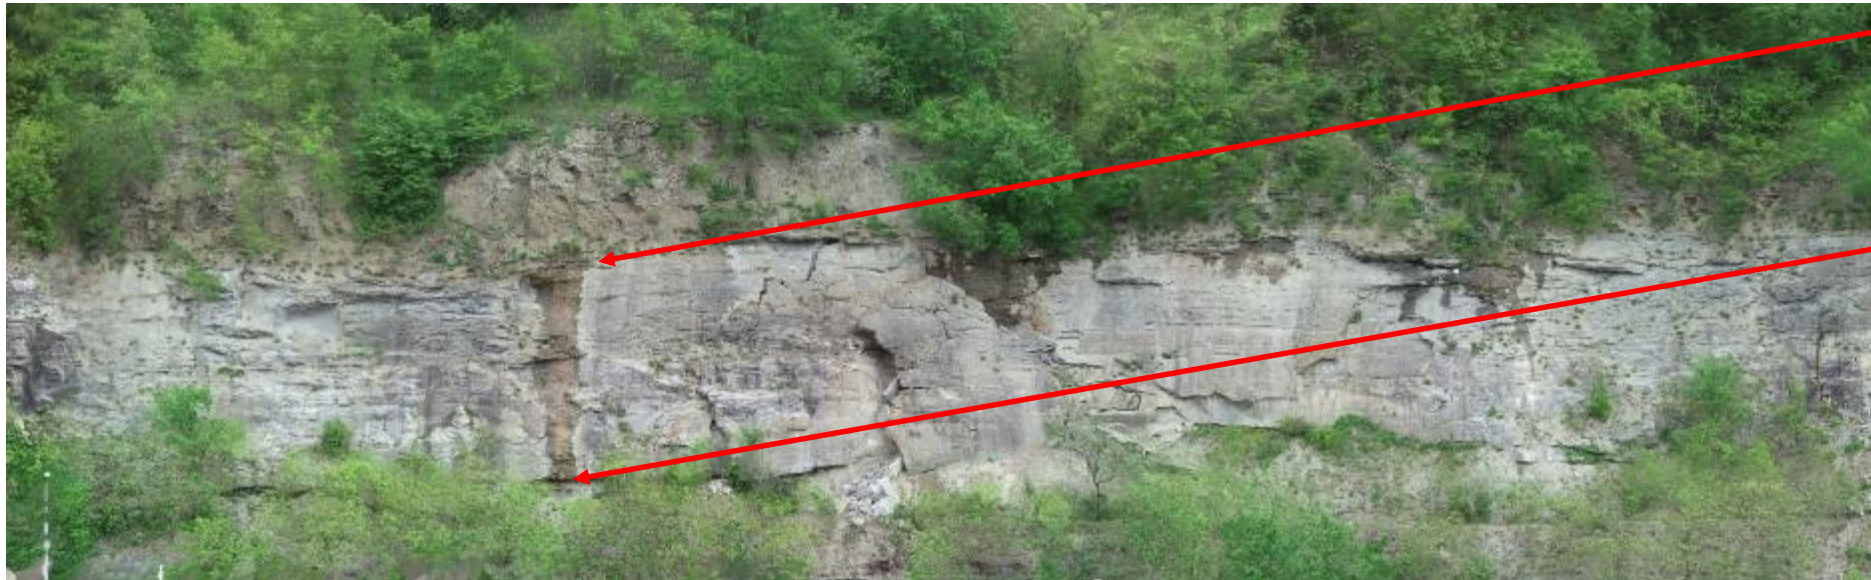
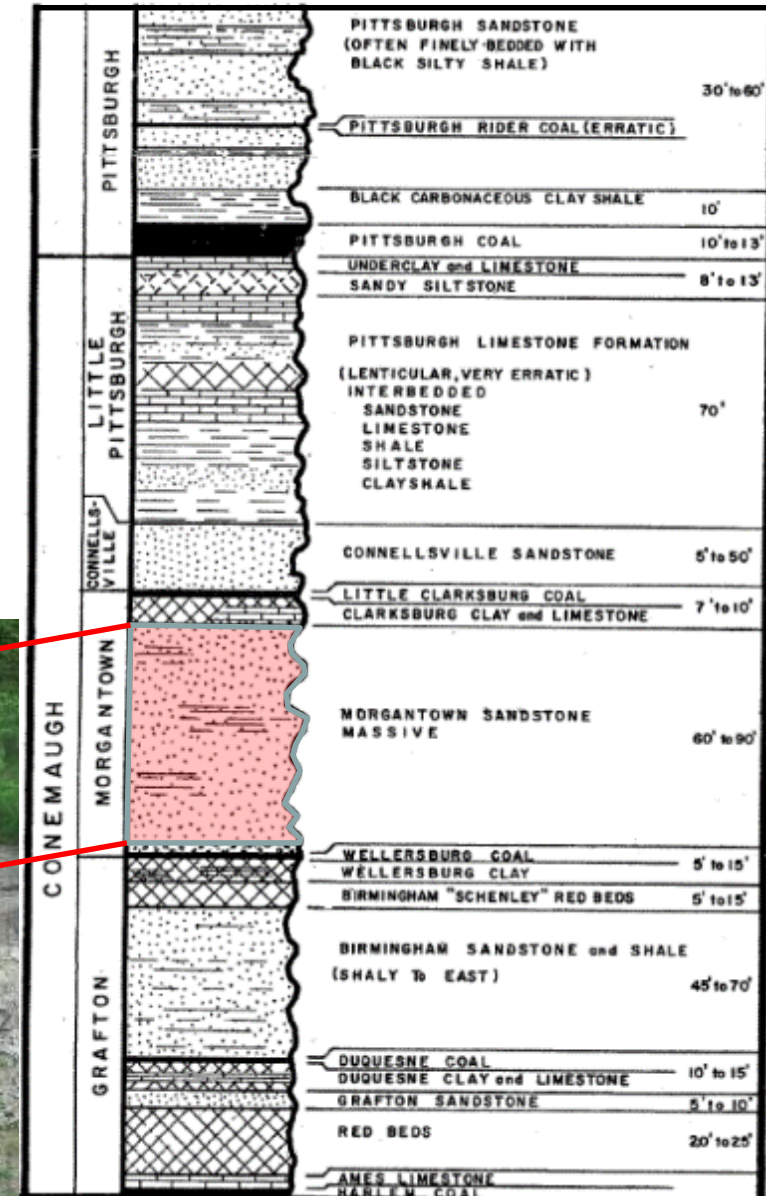
- Thick, resistant, massive layer is the Morgantown Sandstone.
- Overlain and underlain by weak, coal-bearing clay rocks (Clarksburg Clay and Wellersburg Clay).
- Three Problems:
 1. Undercutting of Morgantown Sandstone removes vertical support.
 2. Sub-vertical / slope-face-parallel valley stress relief joints result from ancient and modern removal of lateral support...form sliding wedges, sliding blocks, and toppling blocks.
 3. Erosion of weak rocks above allows water into joints behind the slope face...freeze/thaw separates slabs from intact slope...failure. In this case, a large sliding block / slab.

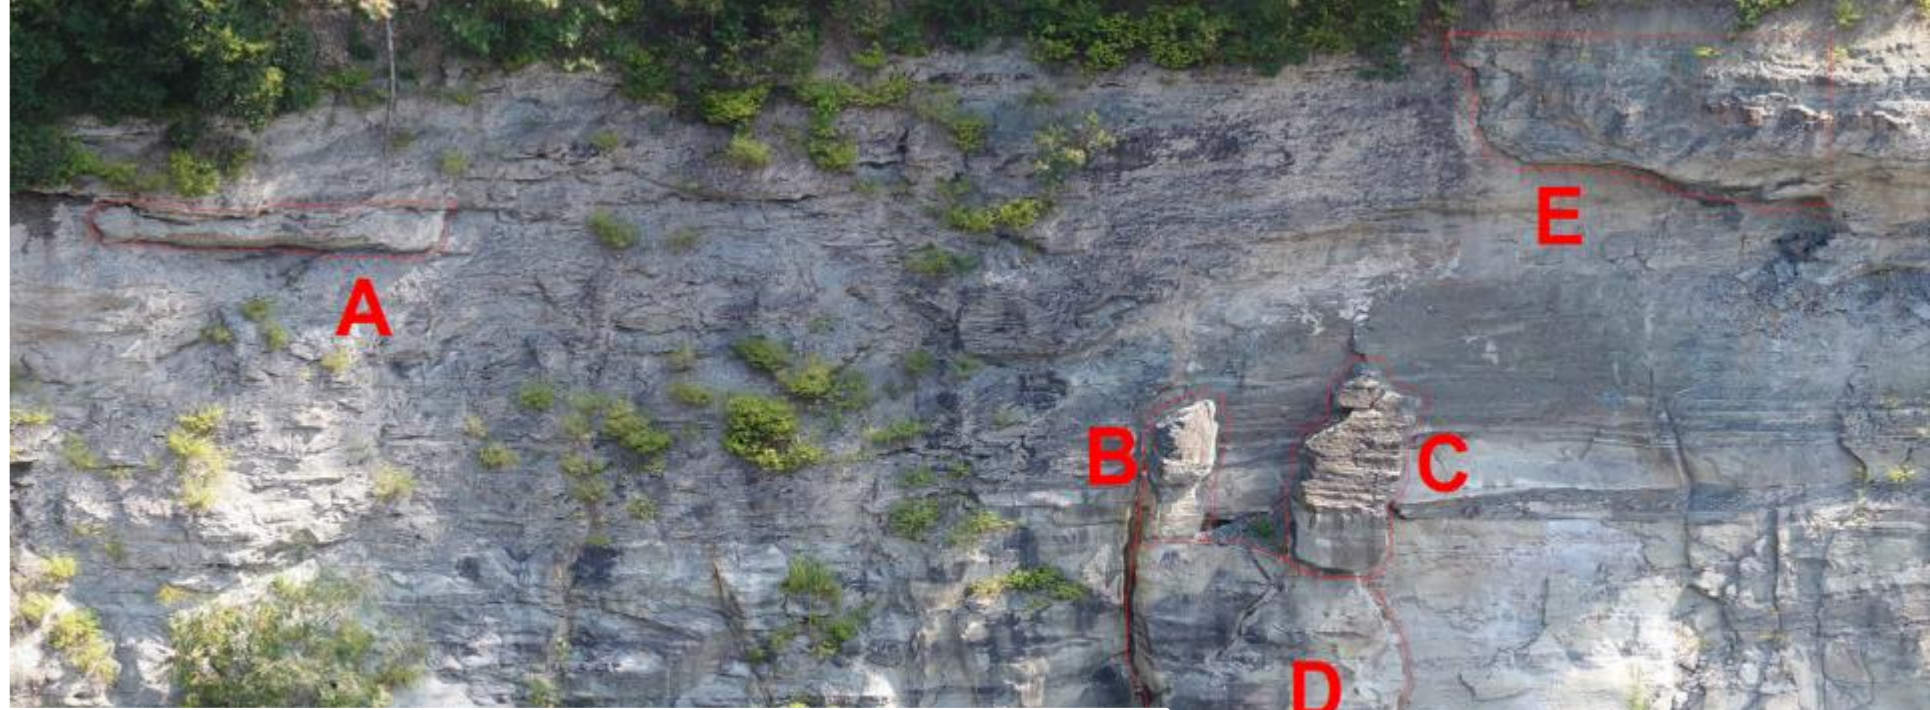
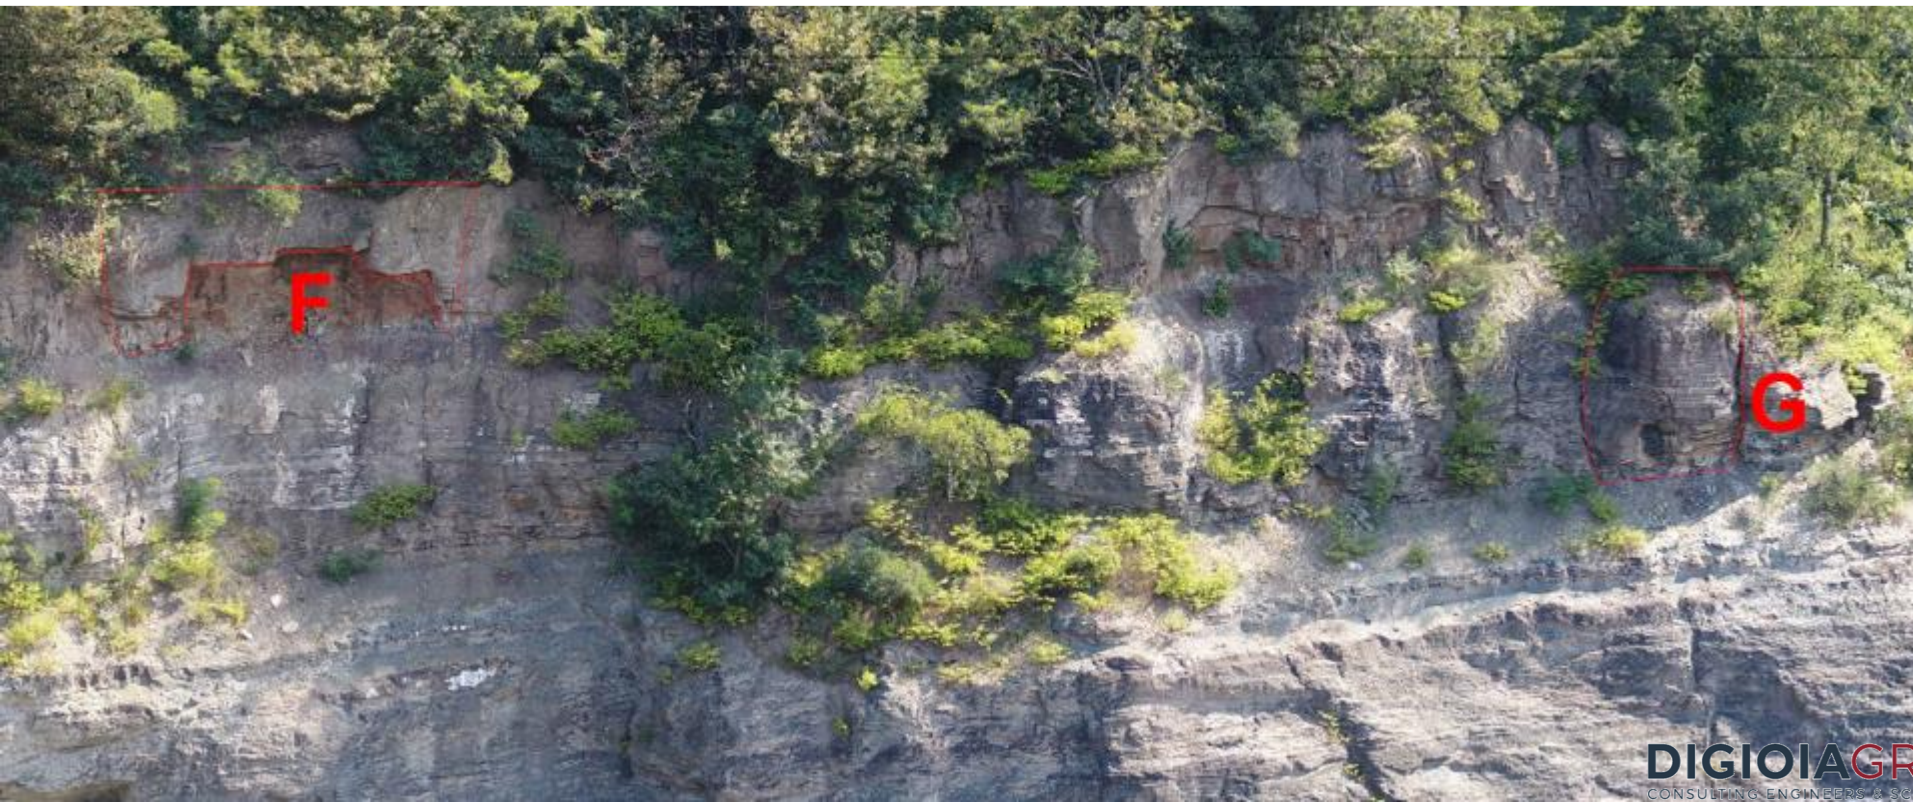
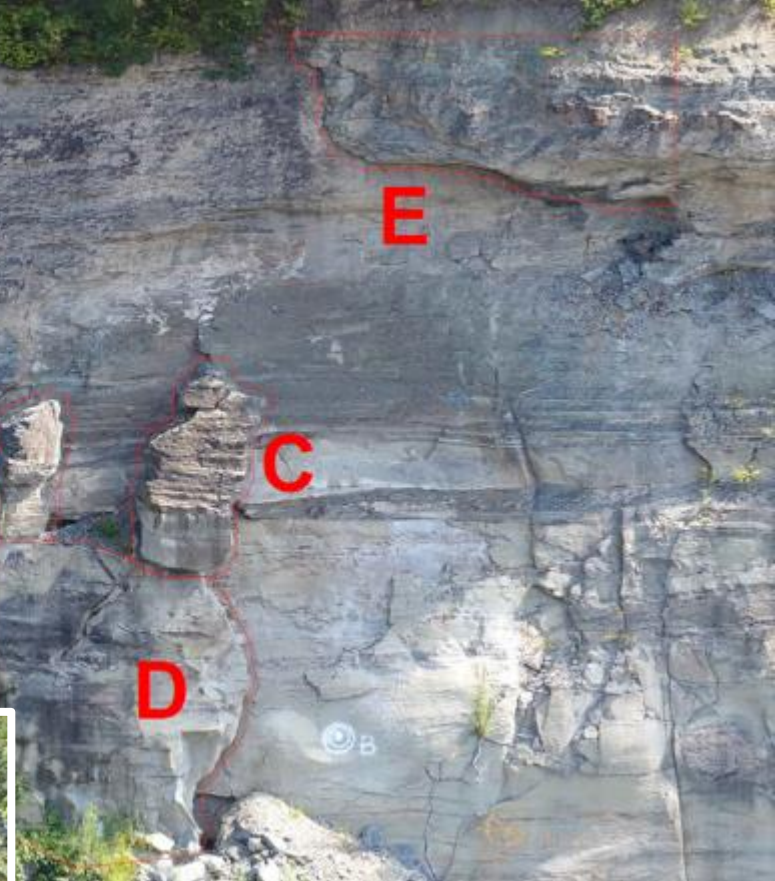
Object	Volume (Cubic Meters)	Rock Mass (Kg)	Height (m)	Potential Energy (Joules)	Lithology
A	2.2	5,257	29.7	1,528,011	Siltstone
B	1.6	3,804	25.3	942,988	Siltstone Sandstone
C	4.8	11,498	25.3	2,850,581	Siltstone Sandstone
D	9.6	22,777	20.7	4,626,395	Sandstone
E	29.1	69,108	31.7	21,468,605	Siltstone Sandstone
F	8.4	19,885	40.8	7,941,224	Claystone
G	5.7	13,507	37.9	5,014,991	Claystone

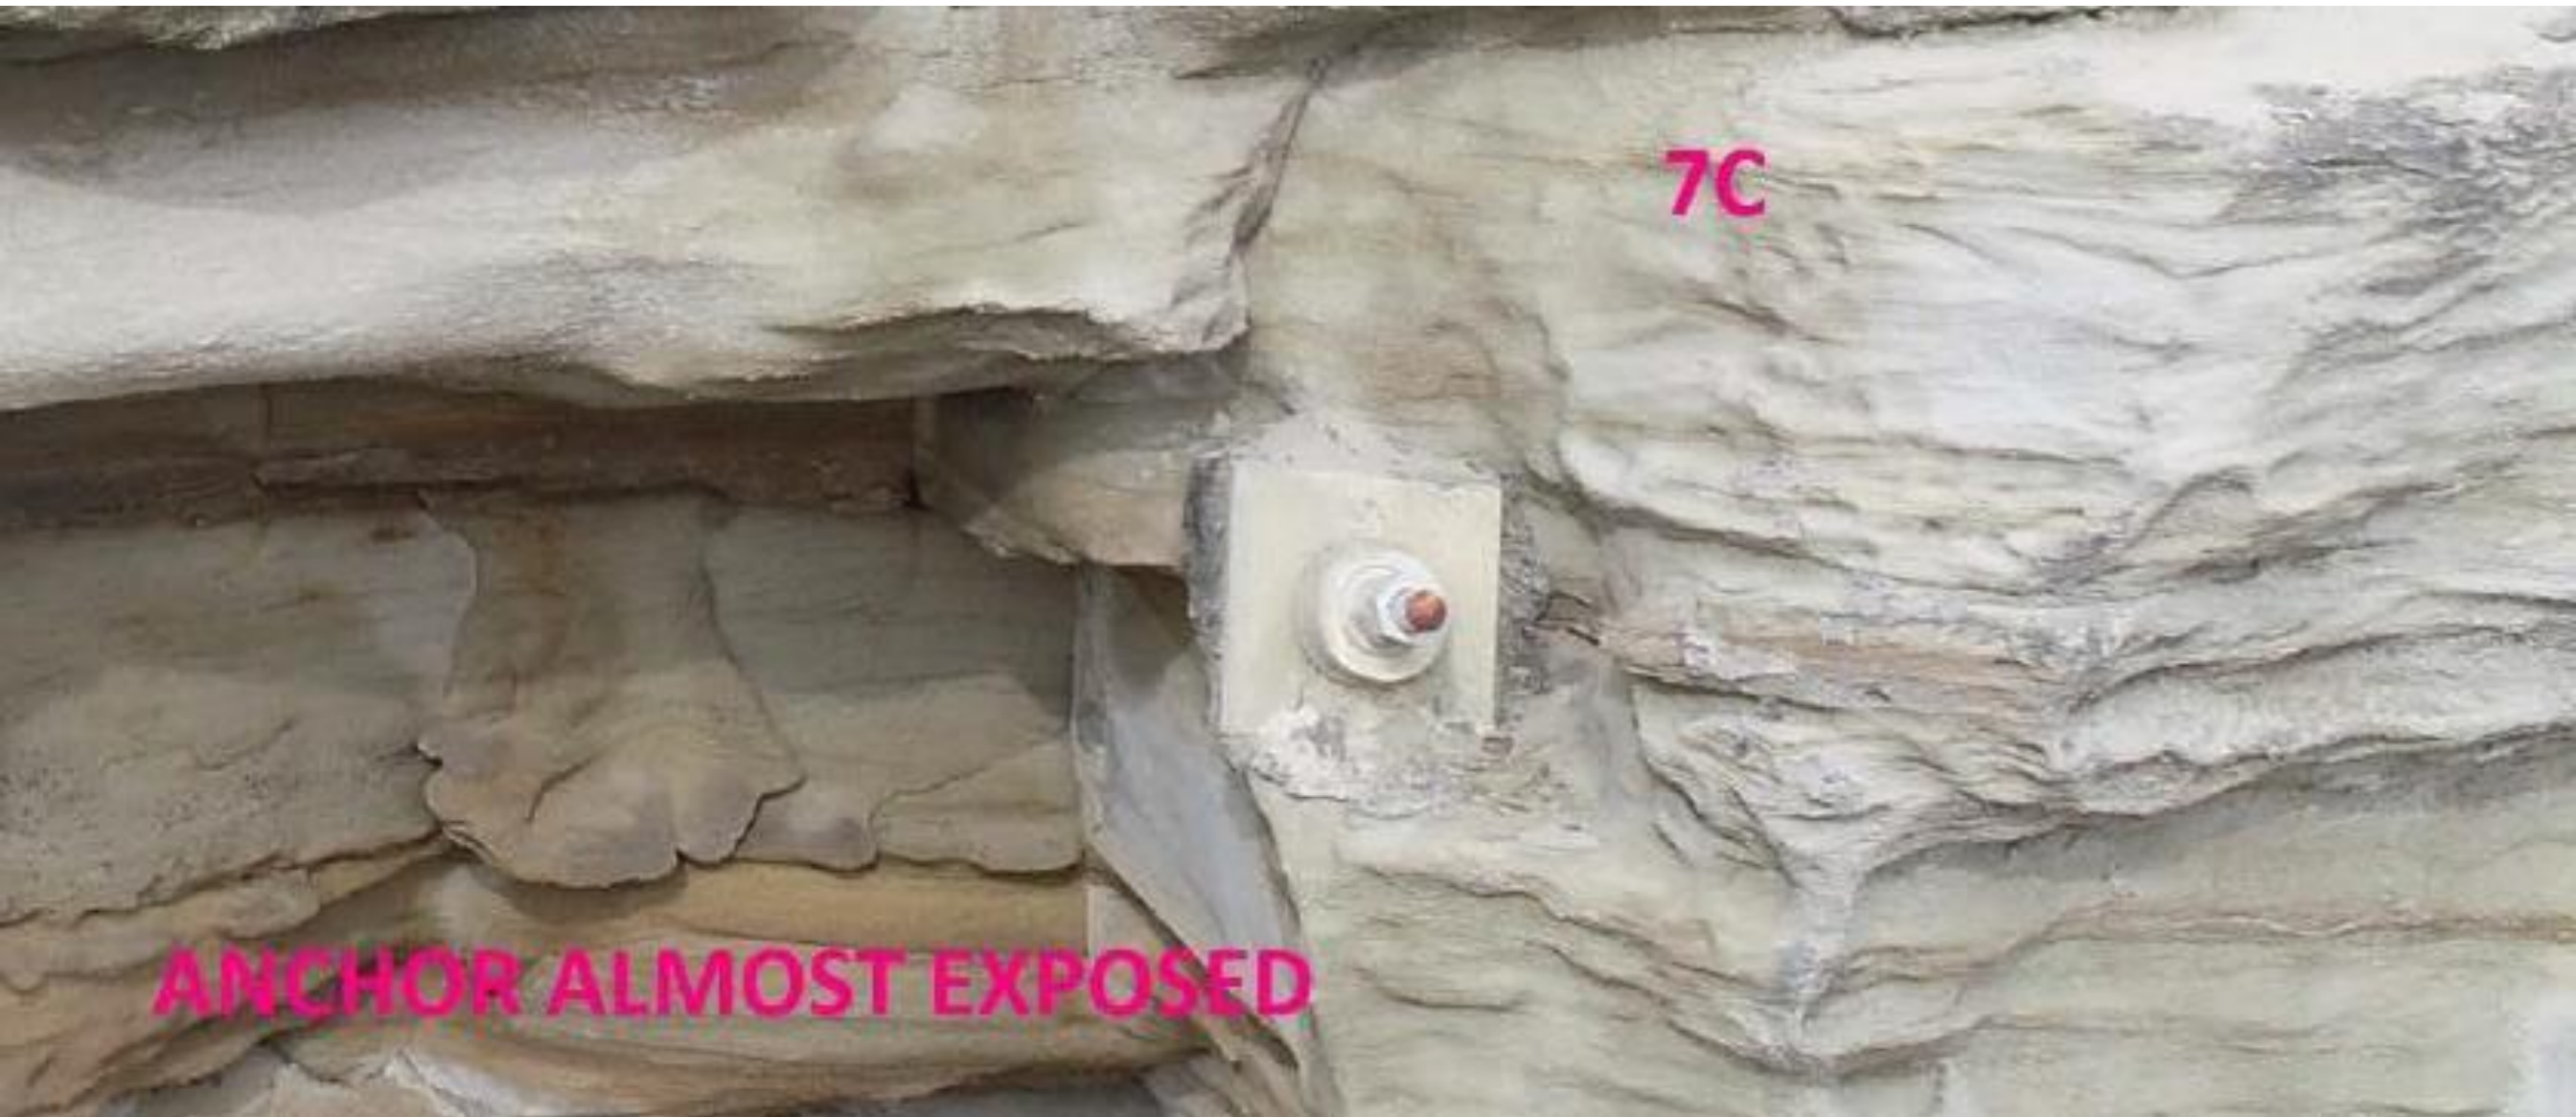
7C

ANCHOR ALMOST EXPOSED

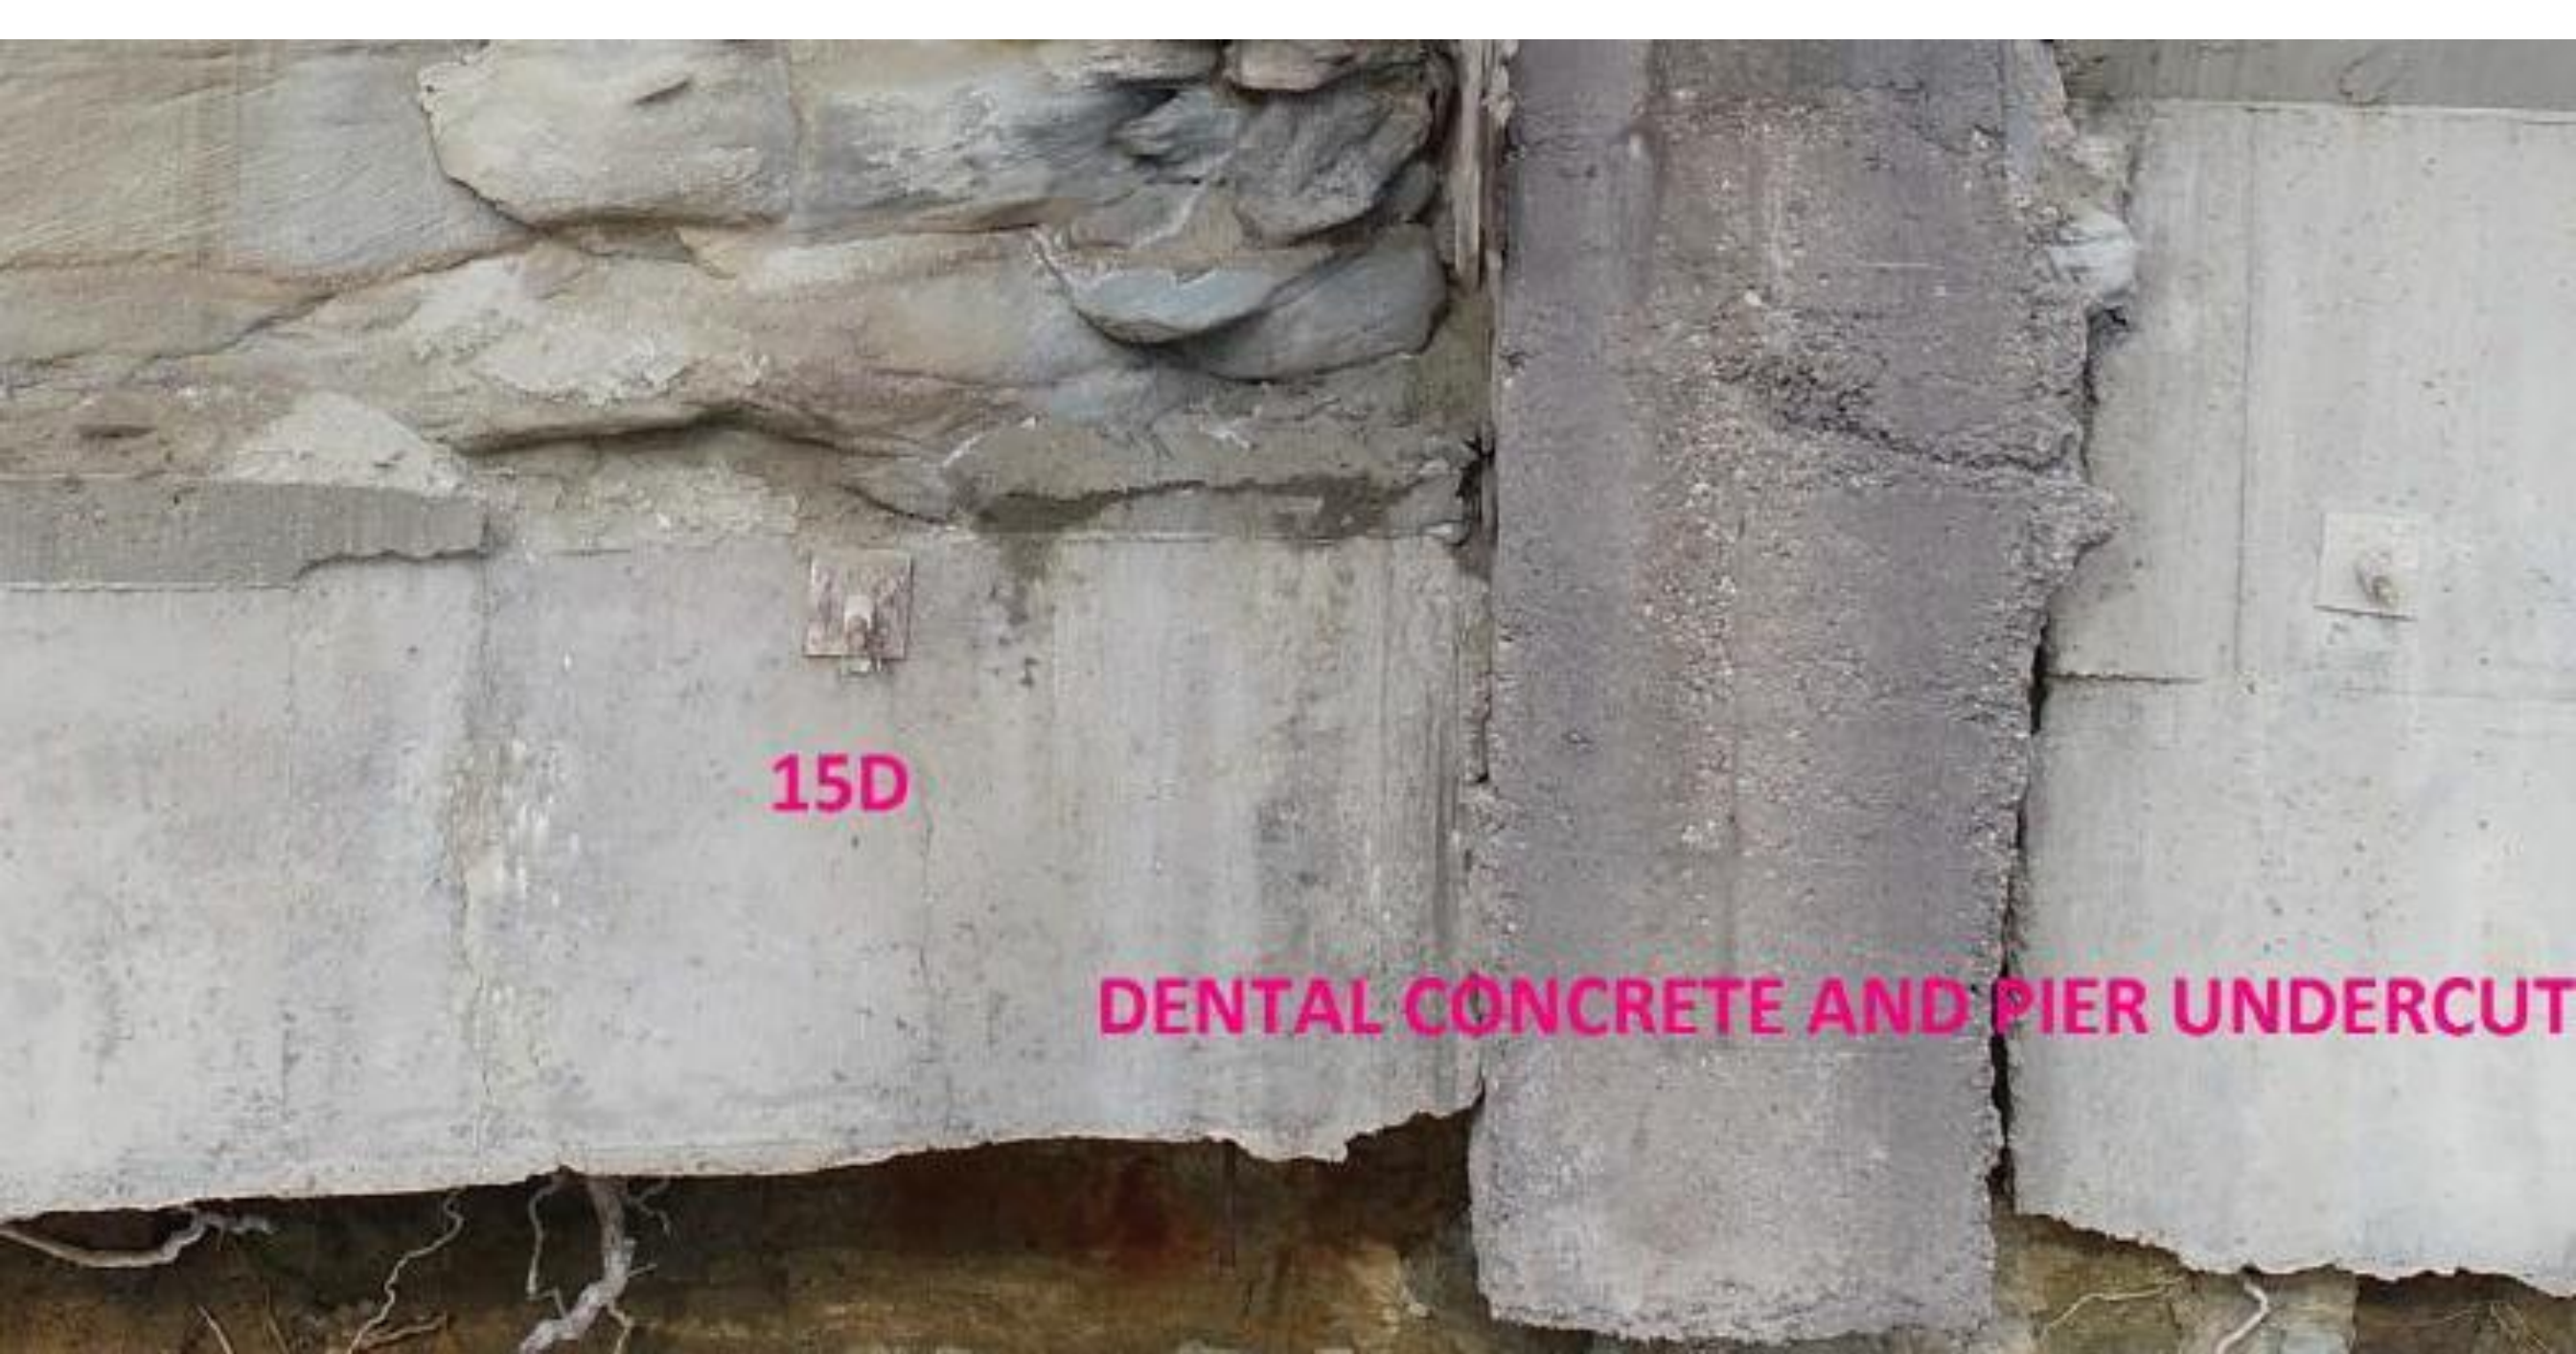
15D

DENTAL CONCRETE AND PIER UNDERCUT

90B EXPOSED ROCK BOLT
