**pennsylvania**

DEPARTMENT OF TRANSPORTATION

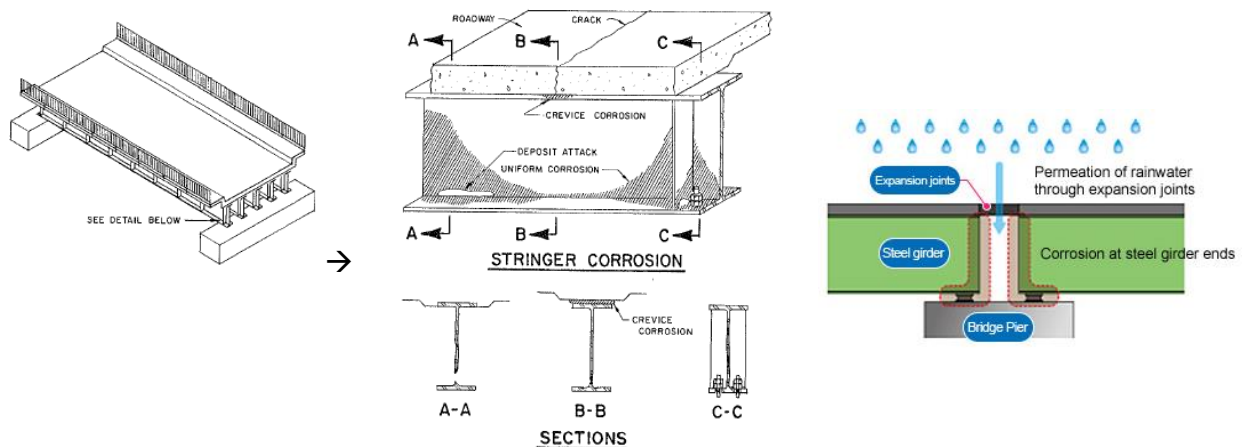
a) description of stringer corrosion in NCHRP Report 333 (1990)

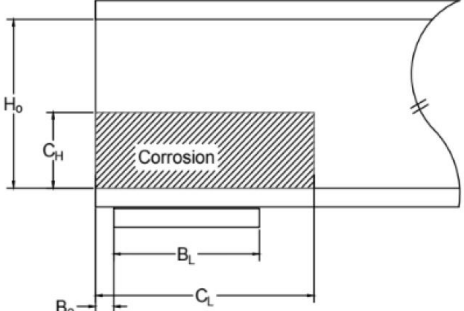
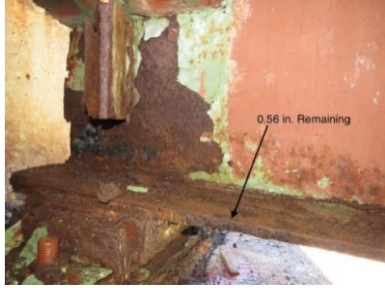
<p><b>W2</b> Similar to W1, with the addition of a triangular-shaped corrosion area at the end of the rectangular shape.</p>

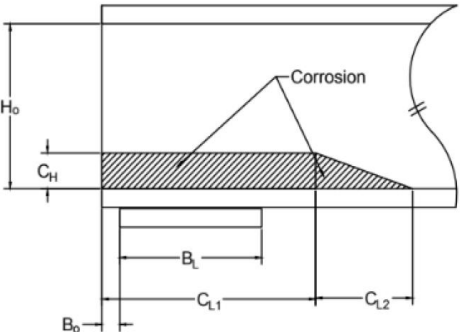
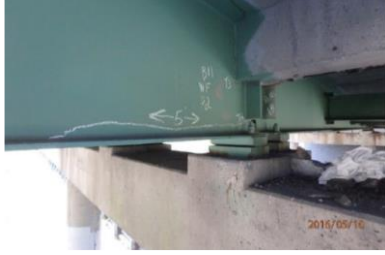
<p><b>W3</b> More complex shape generally described by three areas of corrosion.</p>

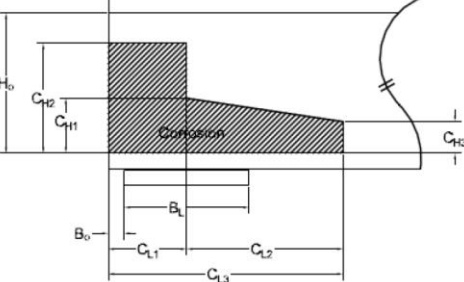
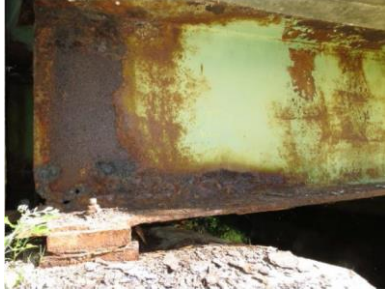
<p><b>W4</b> Modification of W3 to having variation of complex shape.</p>

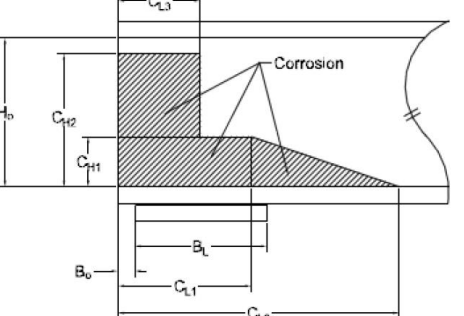
<p><b>W5</b> Triangular shape corroded area.</p>

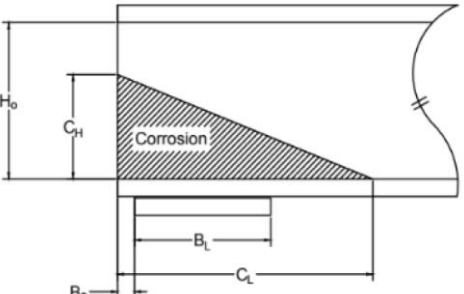
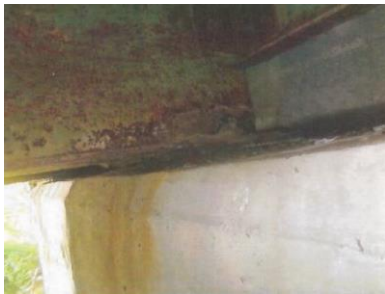
Pattern	Drawing	Representative image
<p><b>W6</b> Corrosion above welded [repair] plate.</p>

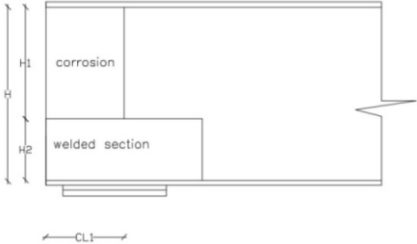
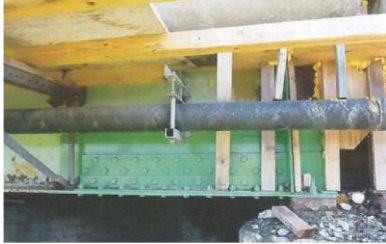
<p><b>M1</b> Hole through lower part of web over bearing.</p>

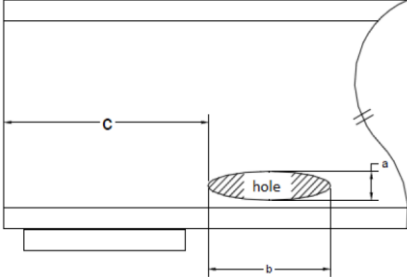
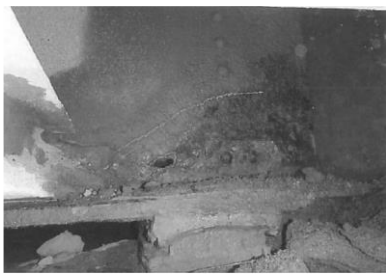
<p><b>E-W1</b> Rectangular shape corrosion pattern at the face of the beam embedment into the diaphragm.  Adding <b>E-</b> to all other patterns shifts point of reference to face of embedment.</p>

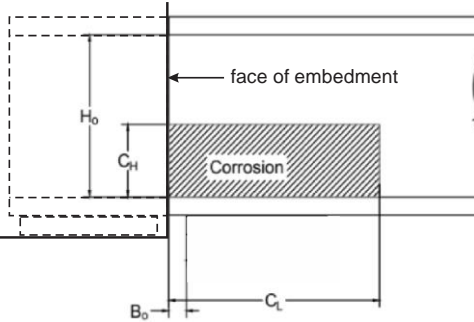
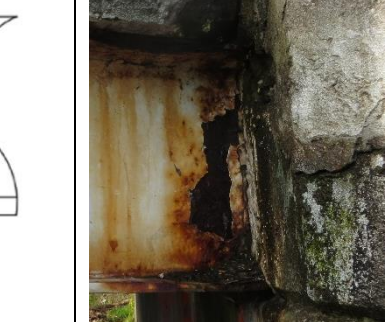
### 1.3 Residual Capacity of Bearing Regions Exhibiting Beam End Corrosion

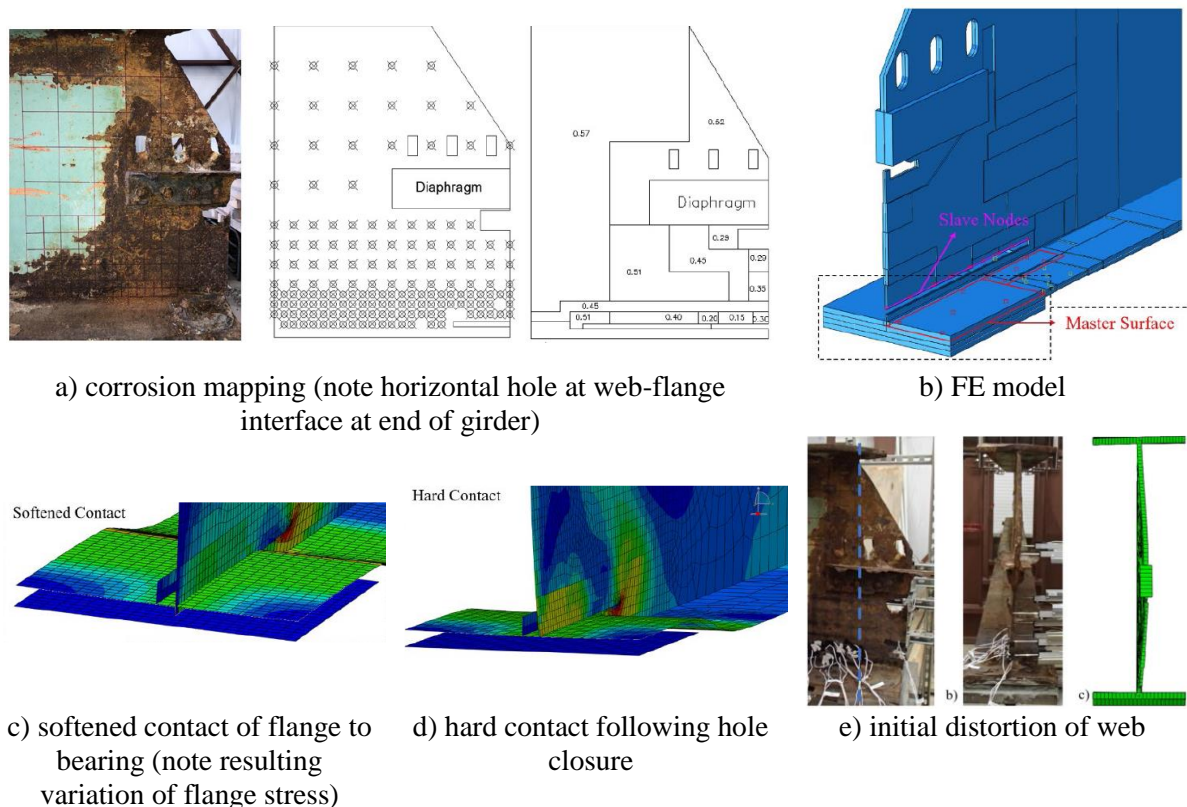
**Figure 3 Details of FE model of Specimen 1 reported by Gerasimidis and Brena (2019).**

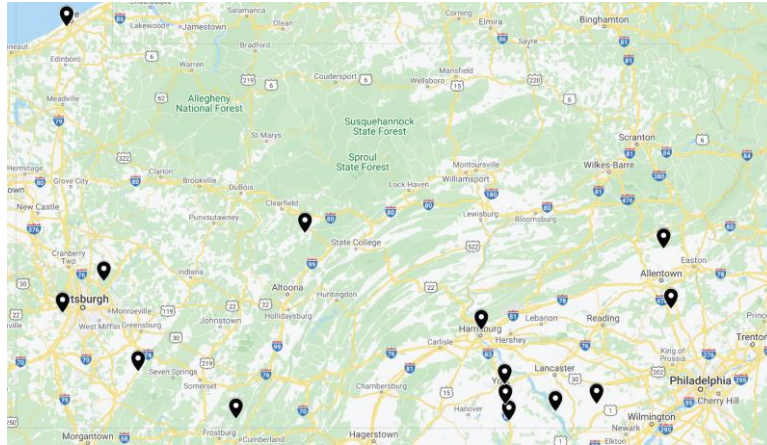
**Figure 4 Geographic distribution of 15 bridges reviewed.**

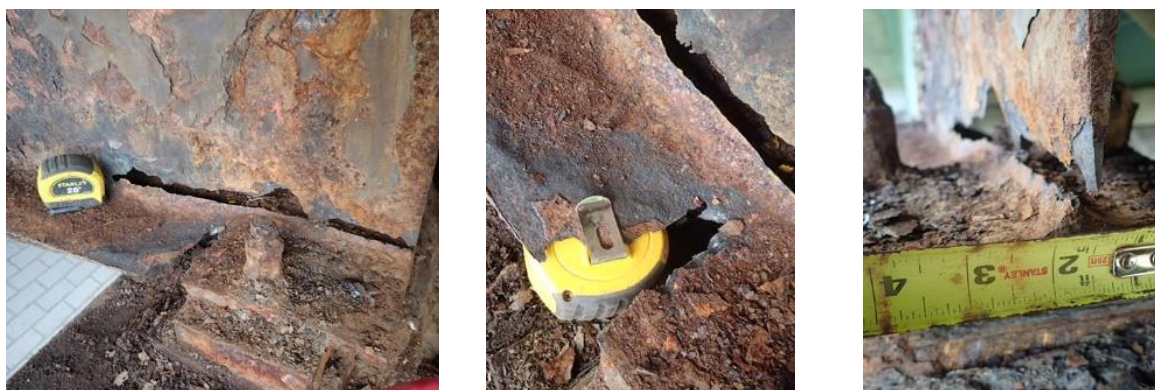
a) Pattern M1 damage  
(b = 17 in.; a = 1.5 in.)

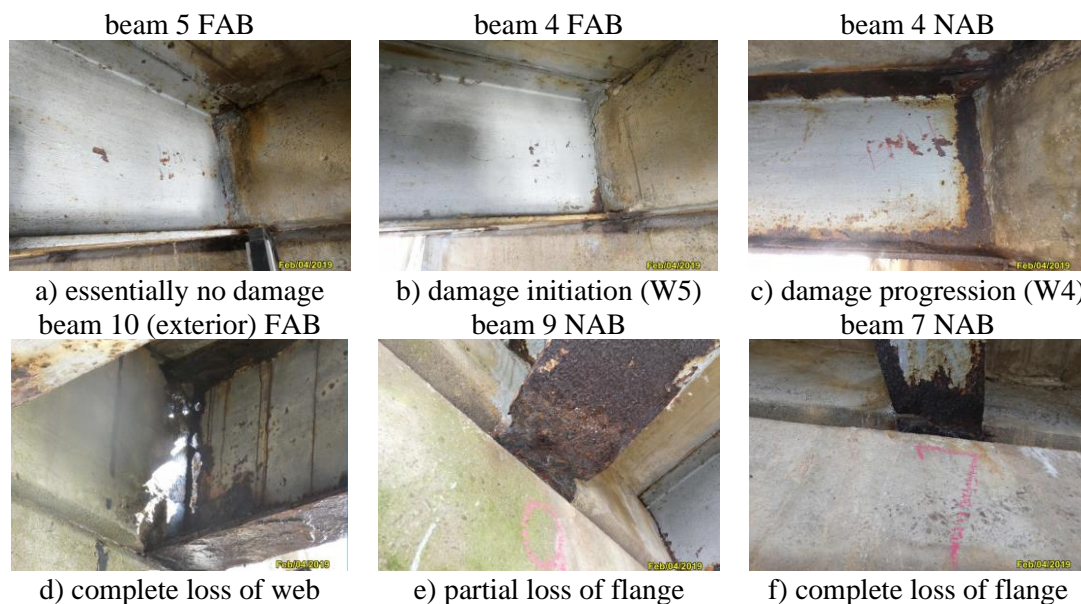
**Figure 7 Spectra of damage at embedded beam ends of single bridge (Bridge O)**

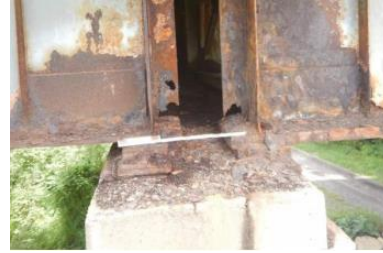
b) Welded patch web plates above bearings at spans 3 and 4 over pier 3 (Bridge D)

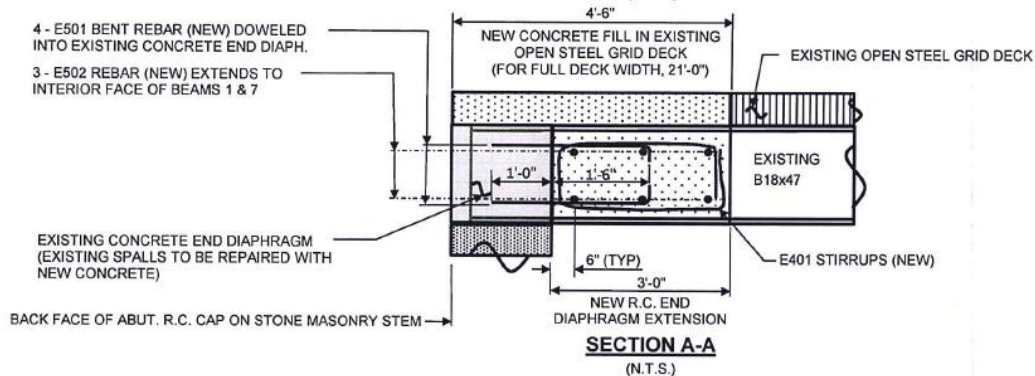
b) detail of steel-formed encasement

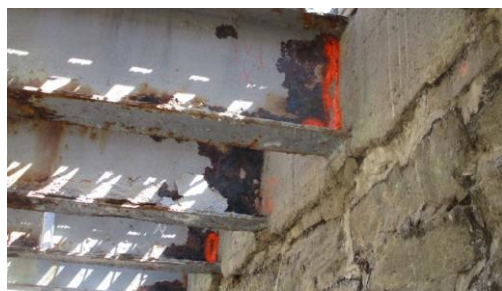
a) beams 4 to 7 reported April 2018

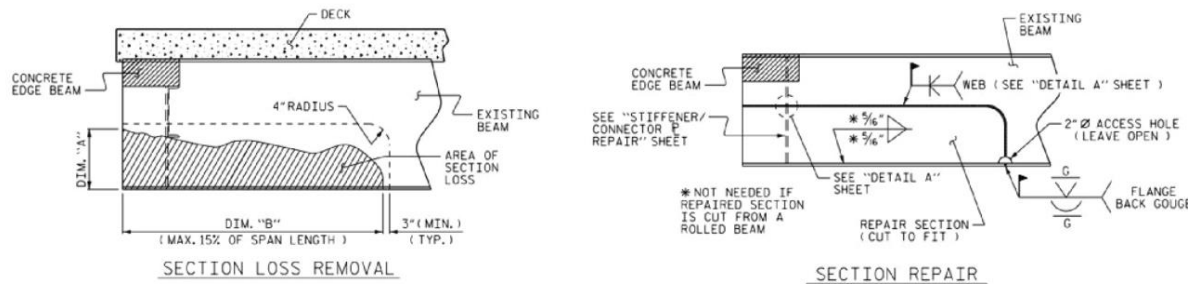
a) schematic representation (Stratton et al. 2021)

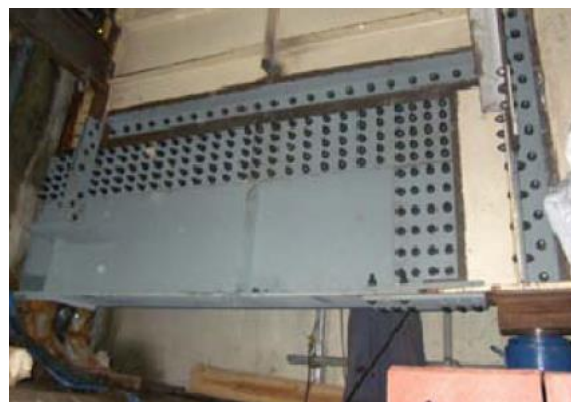
b) bolted beam end replacement (Wakabayashi et al. 2013)  
**Figure 11 Steel beam end repair – replacing deteriorated region.**

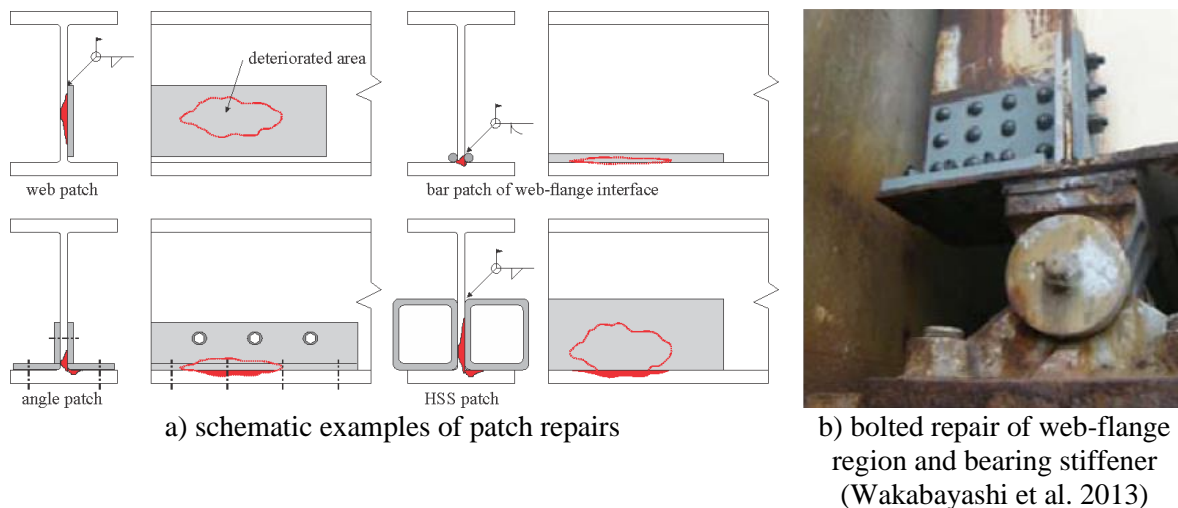
**Figure 12 Steel patch repairs of deteriorated beam end regions.**

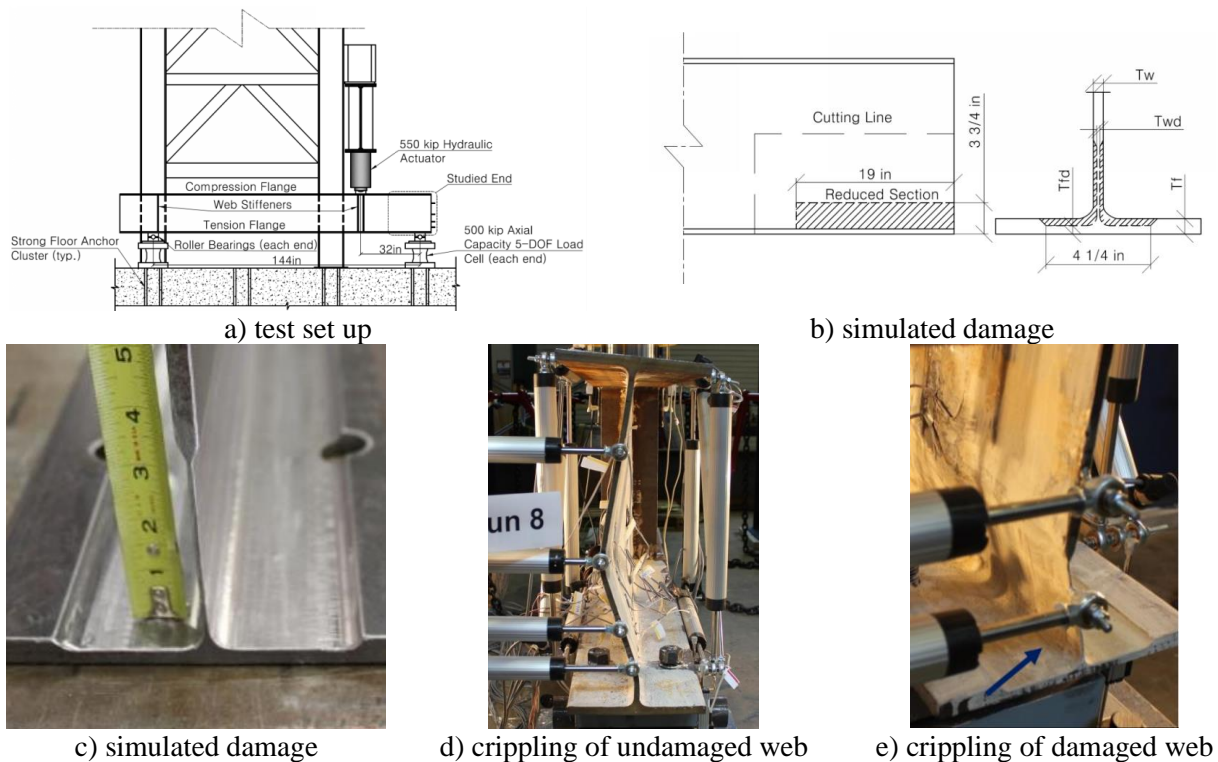
**Figure 13 Test set-up and damaged girders reported by Zmerta (2015)**

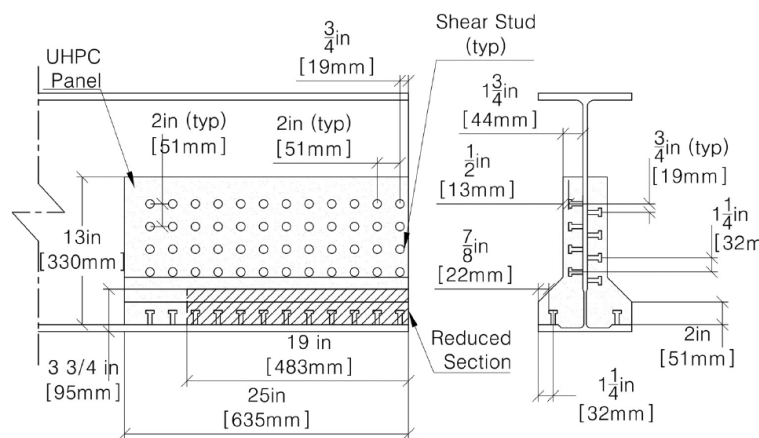
a) headed stud and UHPC layout

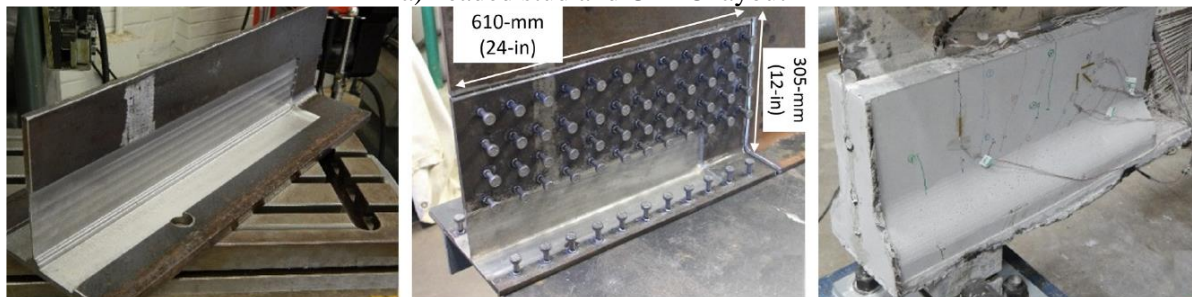
b) progression of repair [note that left image shows only damaged tee region prior to being rewelded into girder]

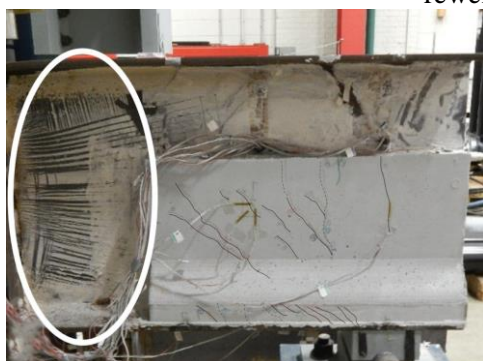
c) cracking of near side of UHPC panel (end of girder at right)

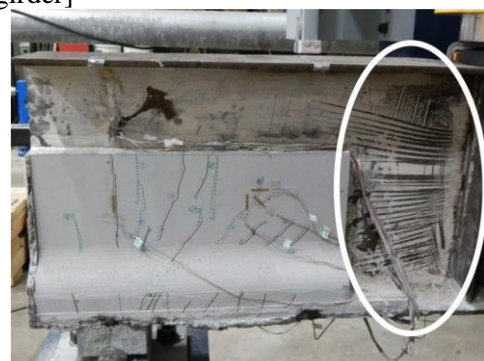
d) cracking of far side of UHPC panel (end of girder at left)

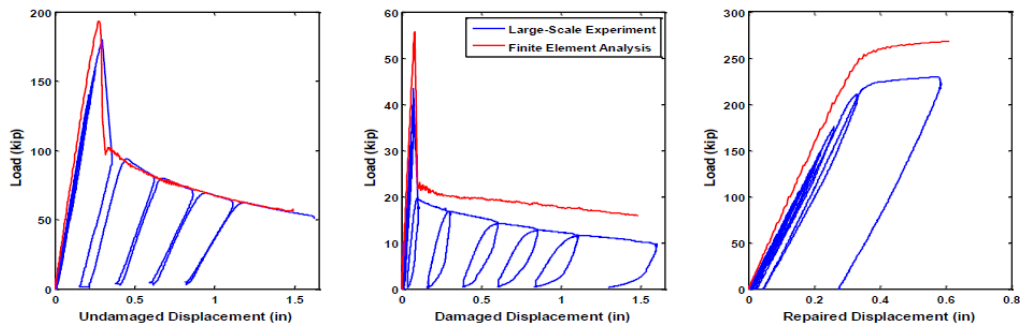
a) FE-predicted (red) and experimental (blue) bearing load versus displacement curves

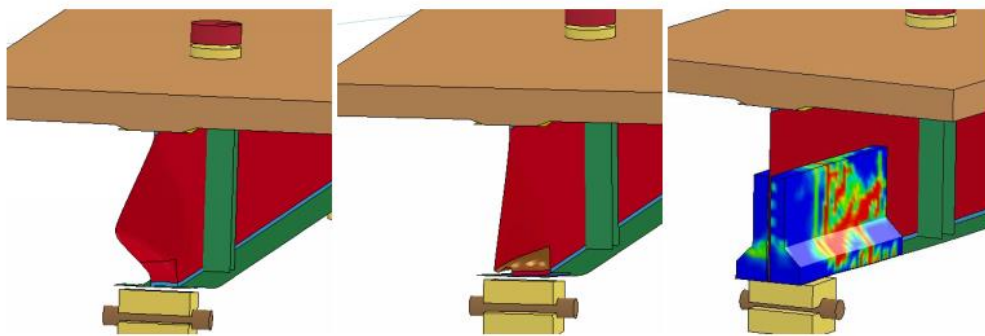
b) FE-predicted failure modes in presence of composite deck

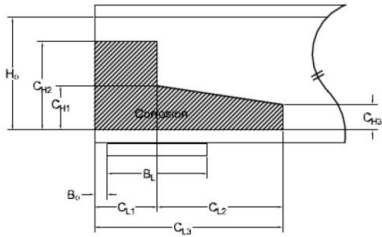
damaged capacity (kips)	18	80	98	
damaged limit state	web crippling	web/stiffener crippling	web/stiffener crippling

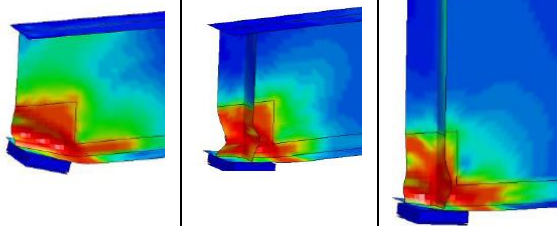
full height repair capacity (kips)	277	278	649

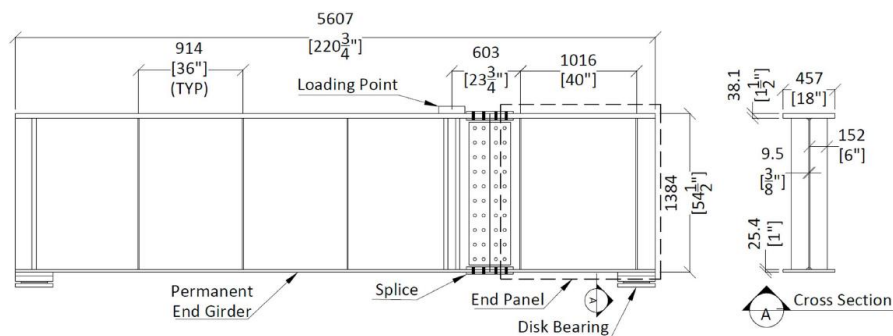
a) test arrangement showing test panel at right of slice and reused girder element to left

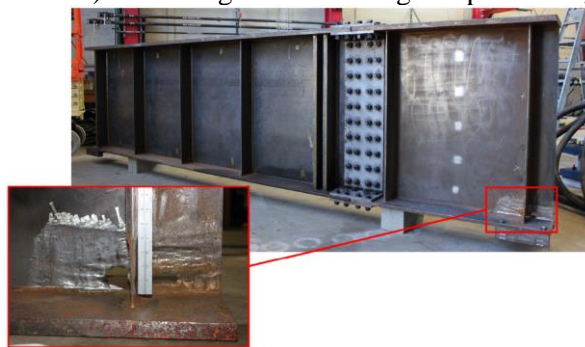
b) specimen with damaged end region

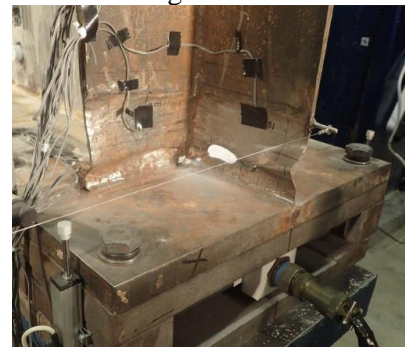
c) end region of damaged specimen following testing showing crippling of web and stiffeners

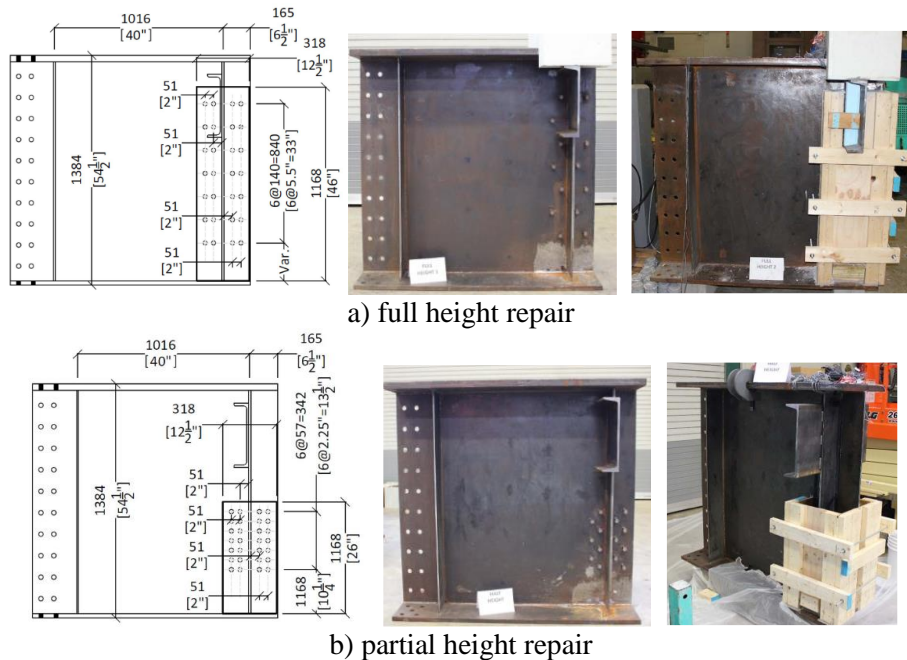
Figure 17 UHPC repairs reported by McMullen and Zaghi (2020)

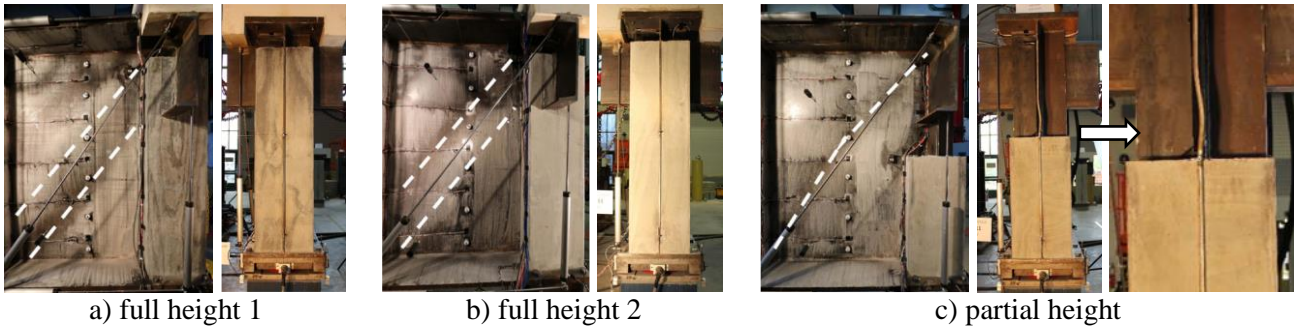
**Figure 18 Failure modes of UHPC encased girders reported by McMullen and Zaghi (2020)**

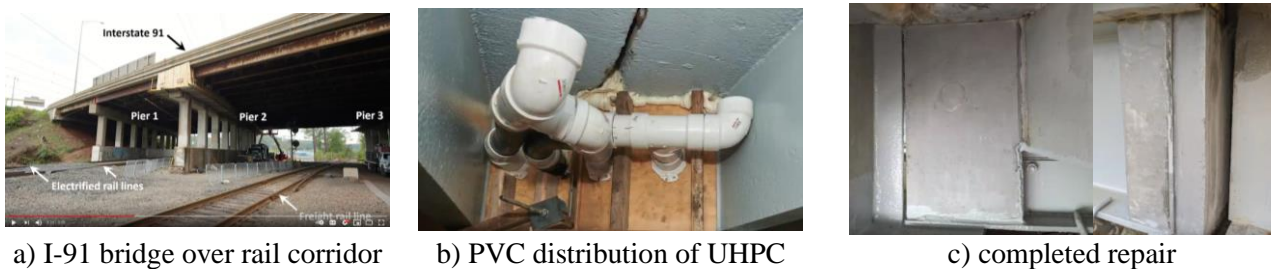
**Figure 19 Field implementation of UHPC repair reported by Hain and Zaghi (2021)**

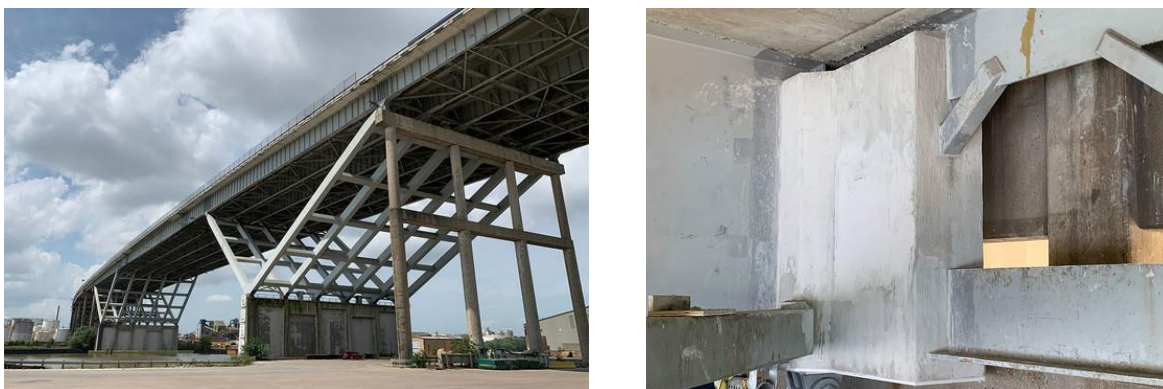
**Figure 20 Field implementation of UHPC reported by TxDOT (2021)**

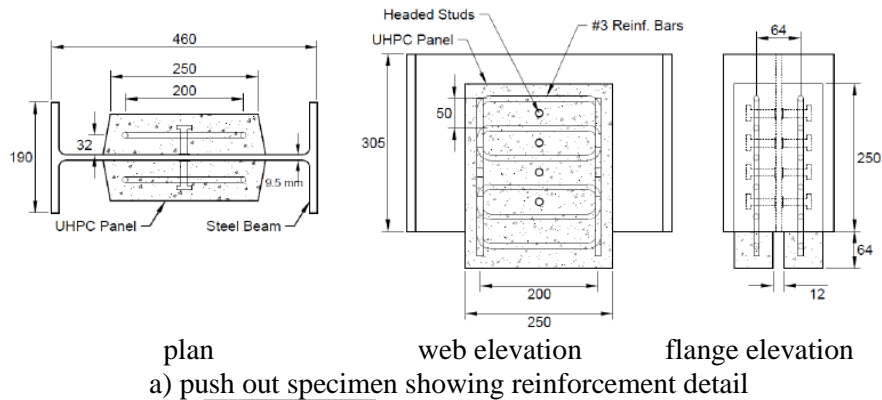
plan web elevation flange elevation  
a) push out specimen showing reinforcement detail

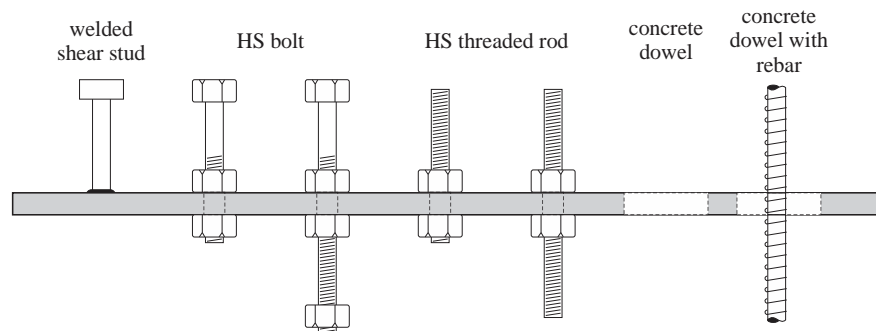
**Figure 23 Variations of shear connectors.**

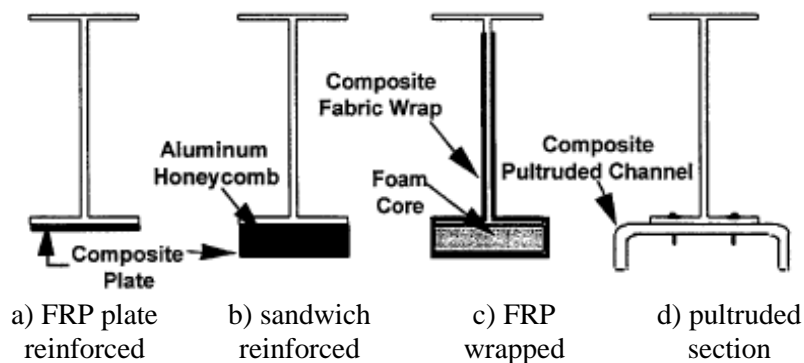
**Figure 24 Small scale specimens tested by Mertz and Gillespie (1996).**

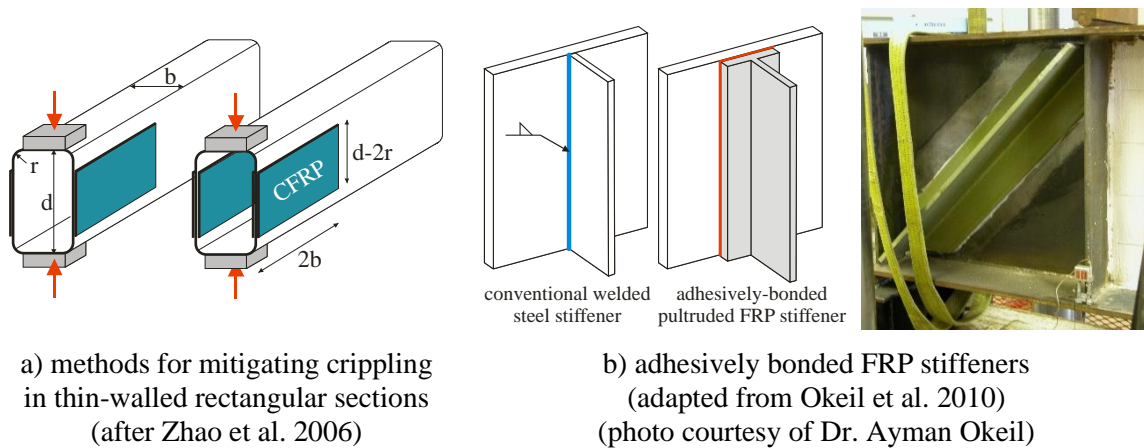
**Figure 25 Use of FRP to mitigate crippling associated with local loads and stress fields.**

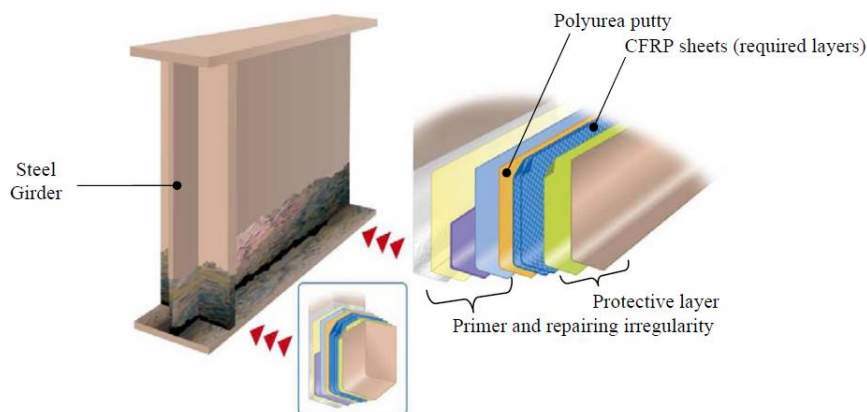
**Figure 26 Schematic representation of CFRP repair of corroded beam end (Wakabayashi et al. 2013).**

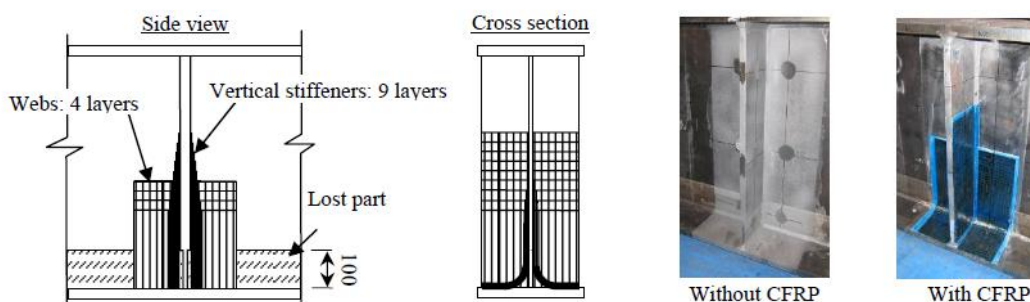
**Figure 27 CFRP repair of corroded bearing stiffener arrangement (Wakabayashi et al. 2013).**

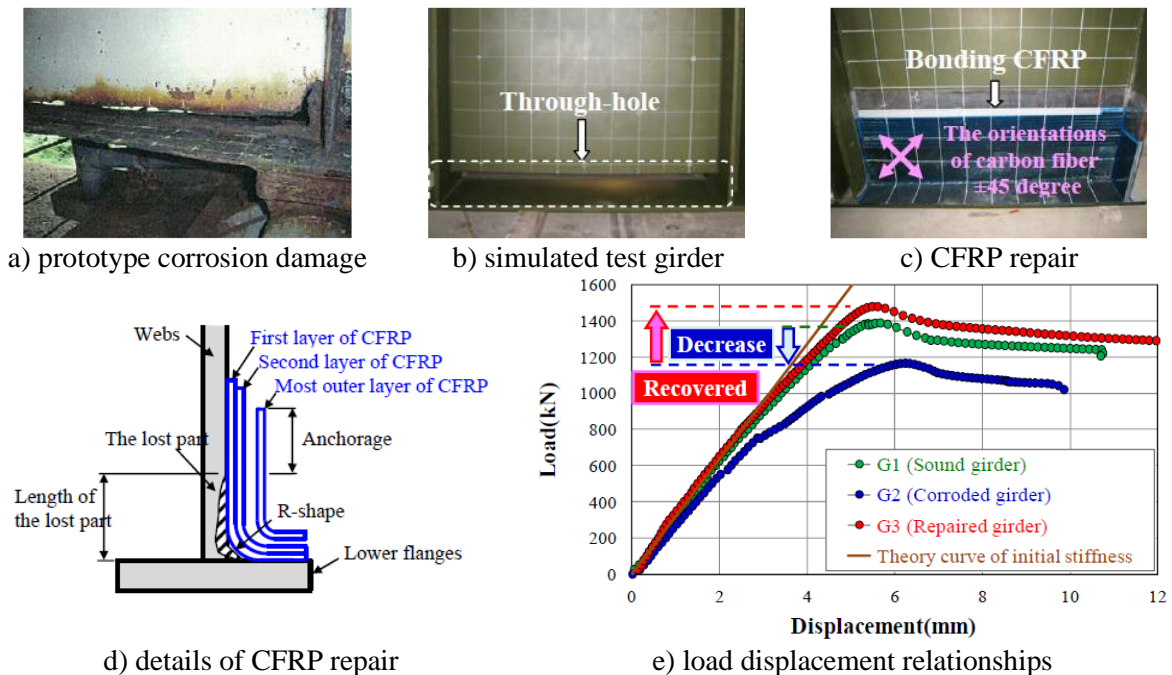
Figure 28 Shear repair of corroded beam end using CFRP (Wakabayashi et al. 2013).

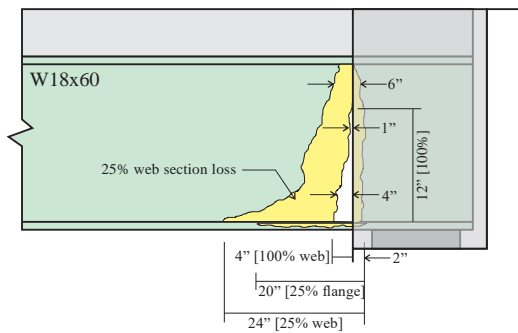
**Figure 29 Archetypal damage cases.**  
(see Appendix A for bridge details)

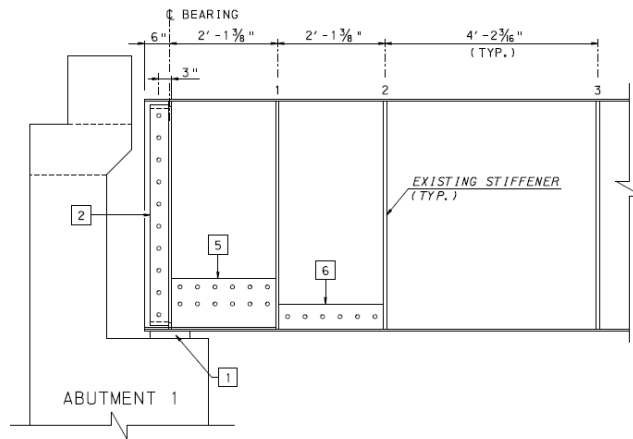
a) bearing region repair

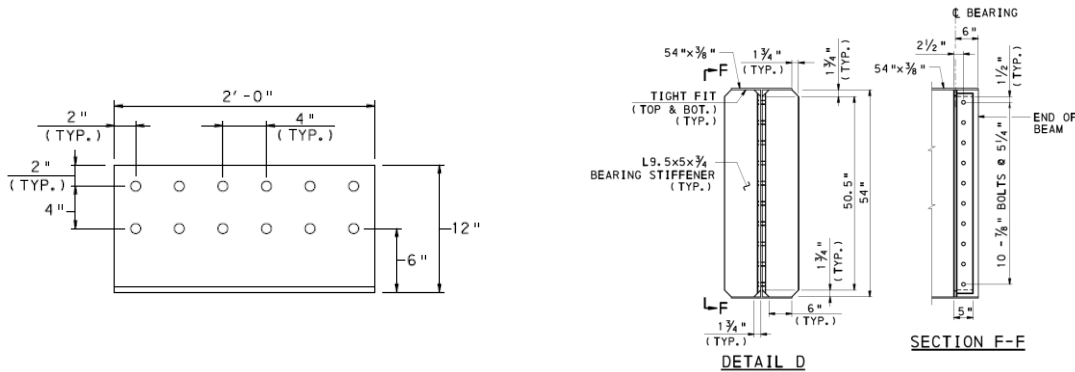
b) Repair 5 shown in Figure a

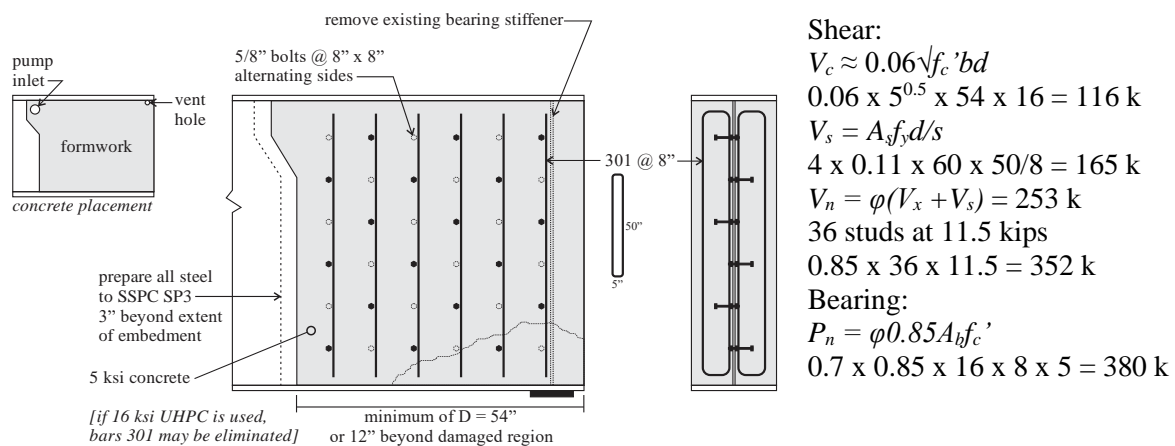
**Figure 31 Conceptual representation of concrete encasement repairs**

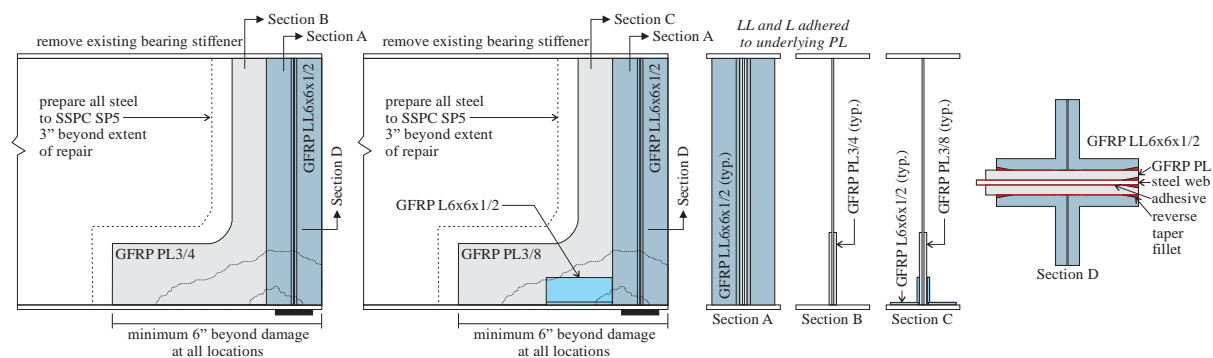
**Figure 32 Conceptual representation of adhesive-bonded FRP repairs for plate girder**

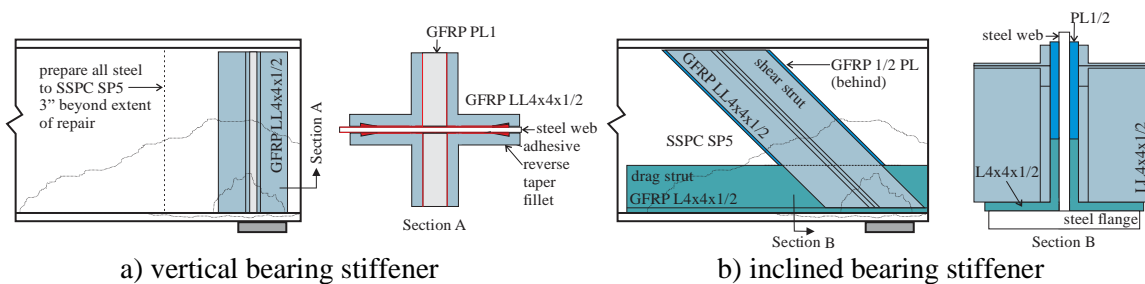
**Figure 33 Conceptual representation of adhesive-bonded FRP repairs for rolled shape.**

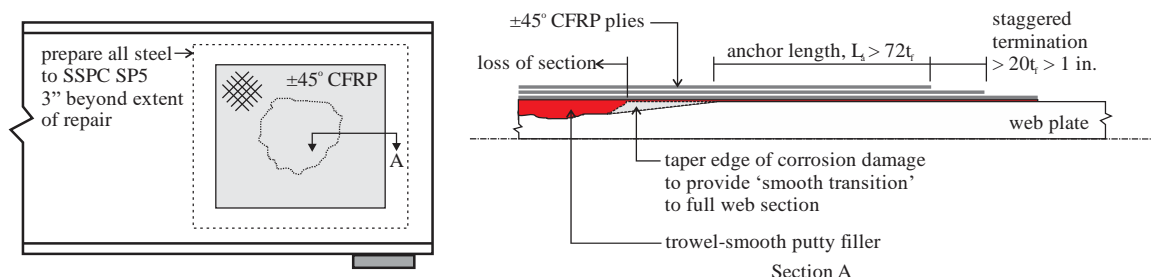
**Figure 34 Details of wet lay-up CFRP web patch.**

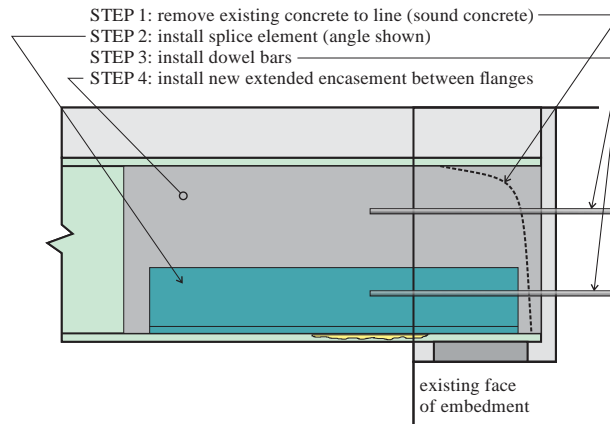
a) schematic representation of spliced region of embedded bearing

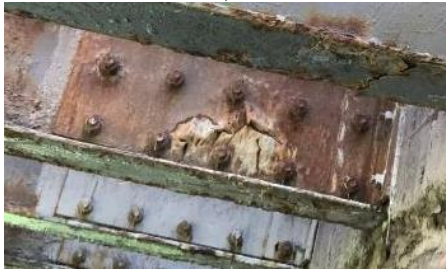
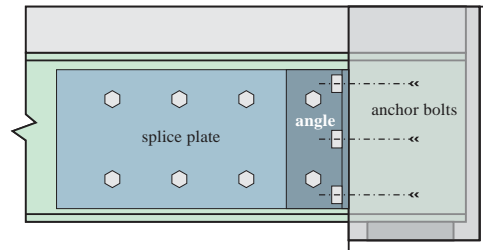
c) bolted steel 'splice' anchored to existing end diaphragm  
**Figure 35 Repair approaches for embedded bearing regions.**

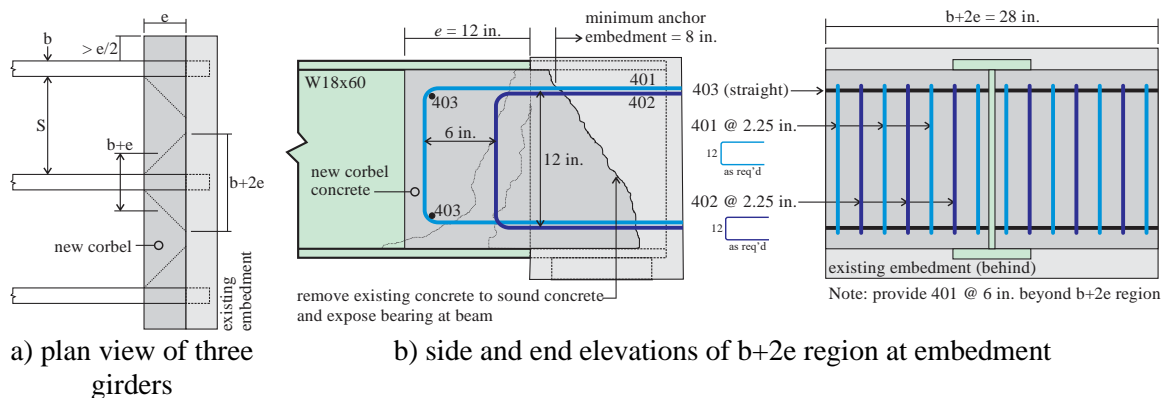
**Figure 36 Conceptual representation of corbel repair.**

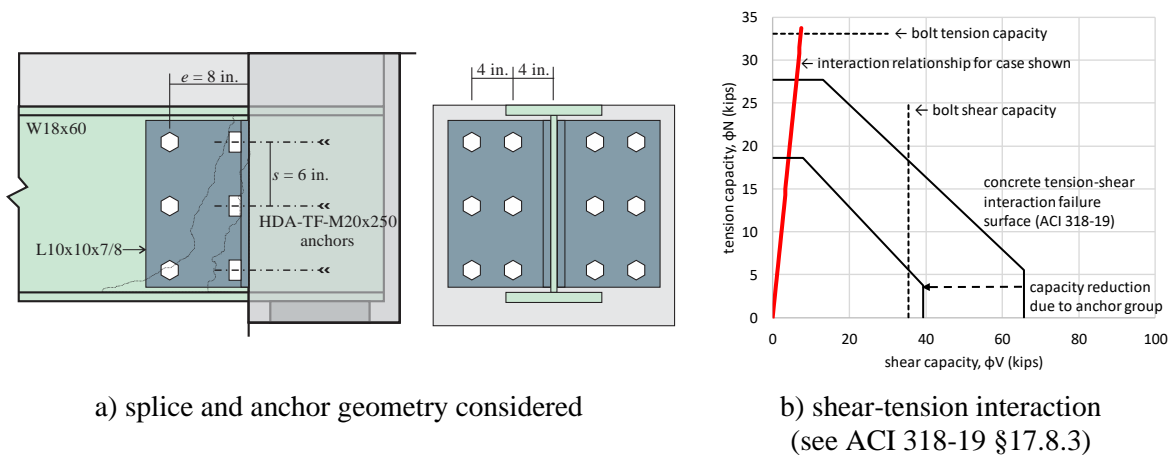
**Figure 37 Conceptual representation of anchored steel splice repair**

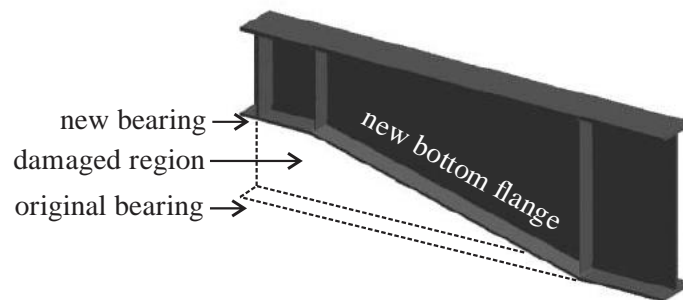
**Figure 38 Dapped-end replacement (based on Fry et al. 2005).**

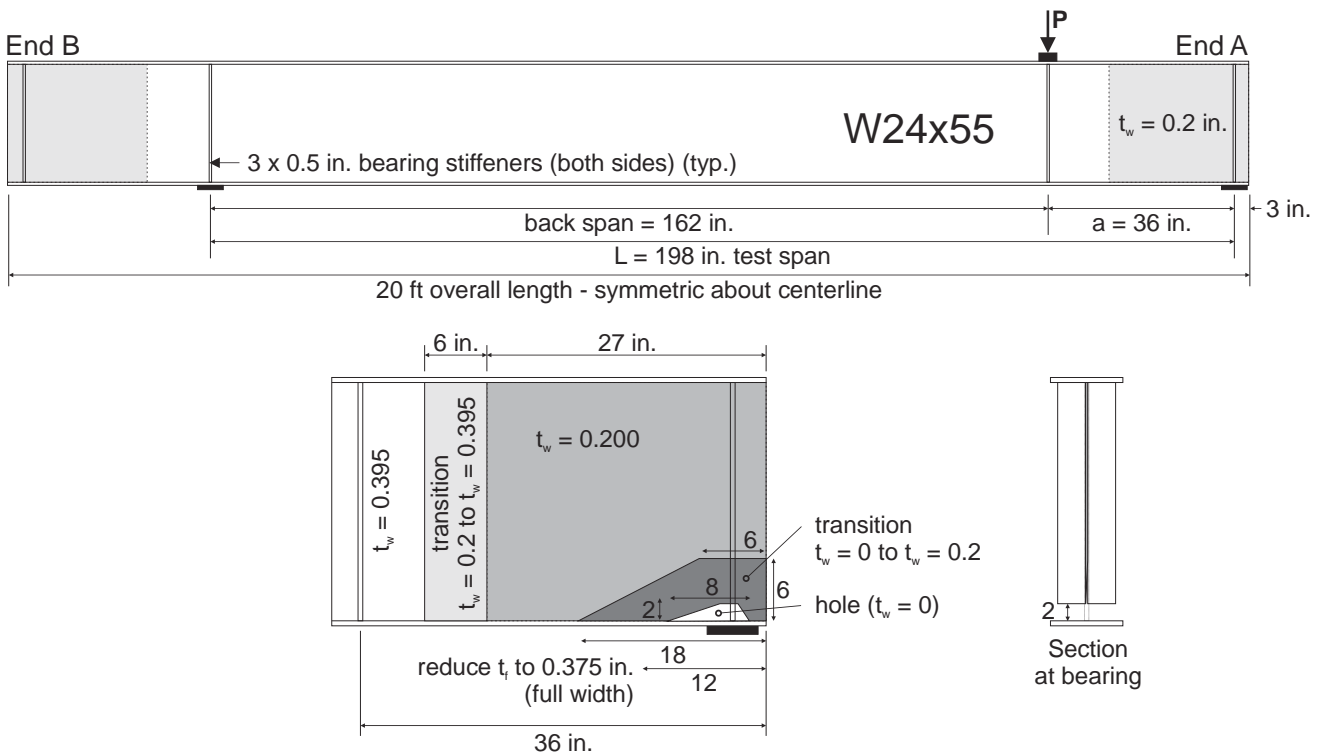
**Figure 39 As-designed W24x55 specimen.**

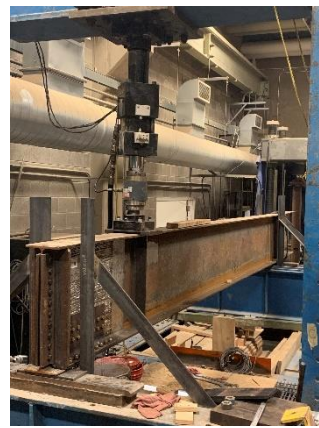
b) Fatigue conditioning of girder Ends B using 50 kip capacity servo-hydraulic actuator

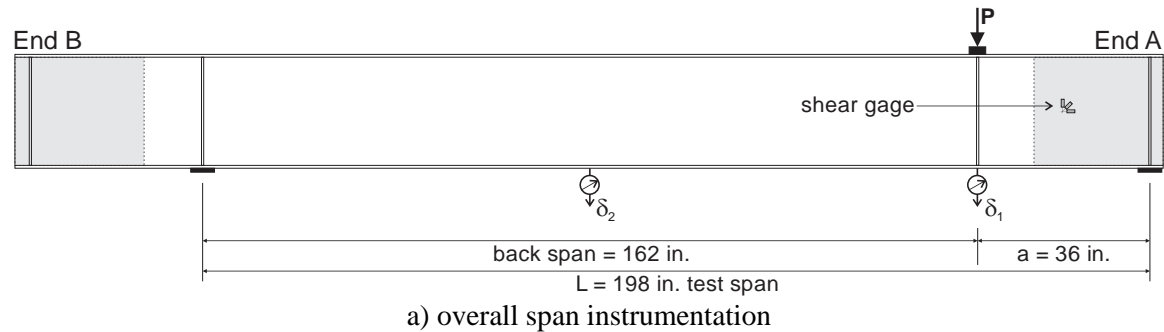
b) draw wire transducers

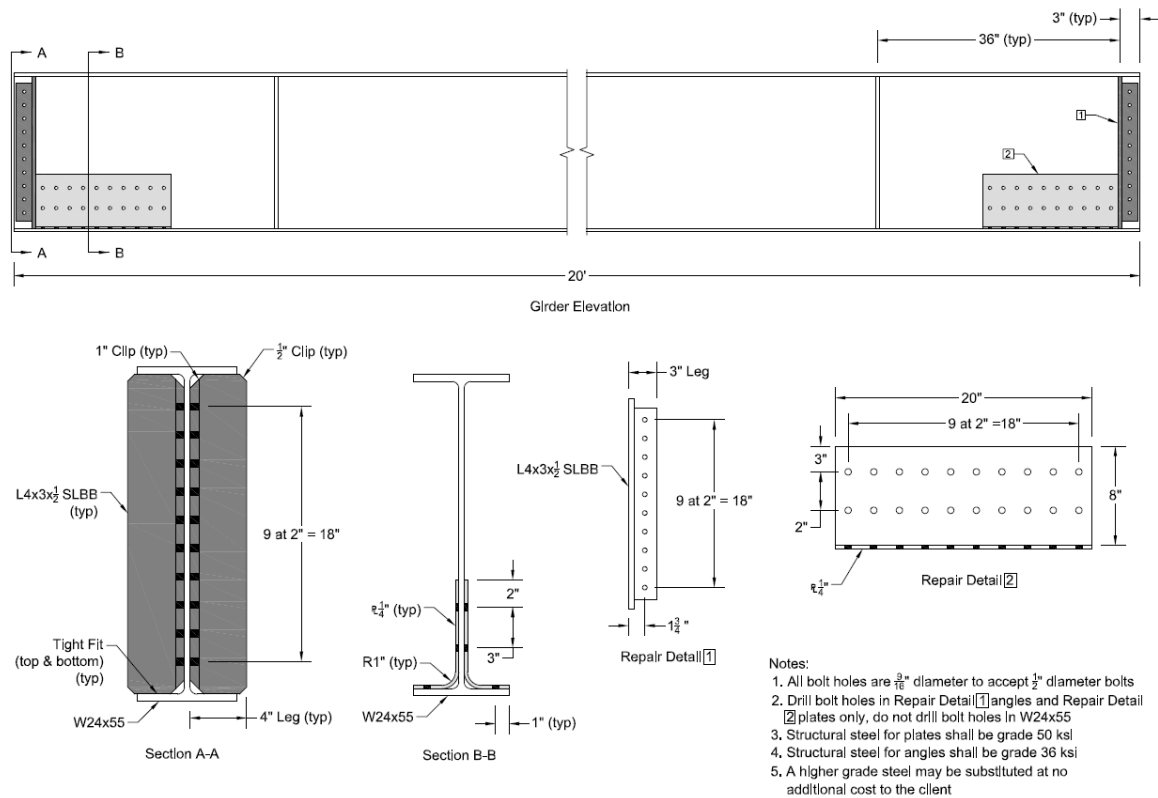
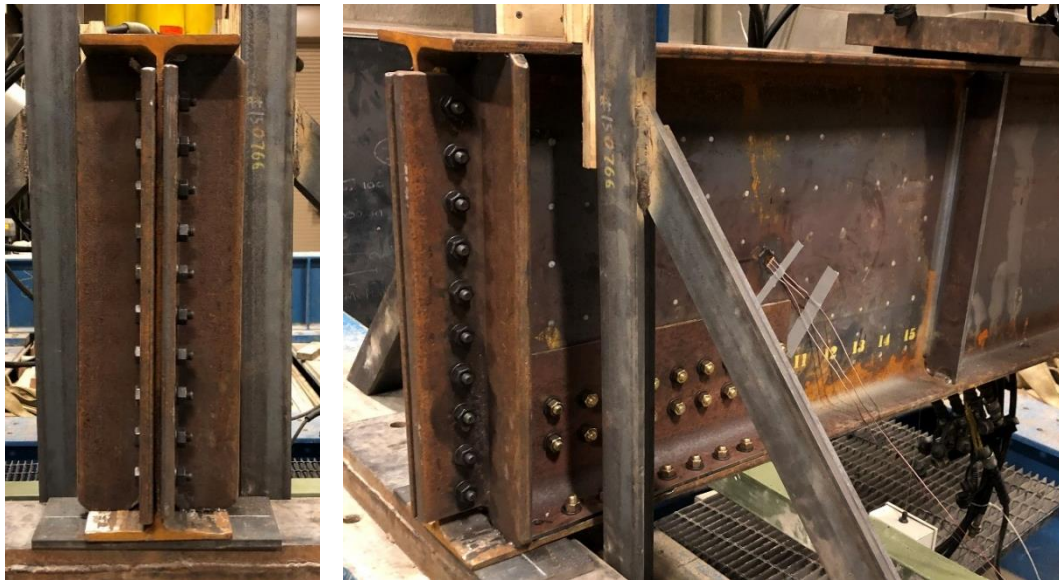
**Figure 43 Bolted steel repair detail for Girder 3.**
