**pennsylvania**

DEPARTMENT OF TRANSPORTATION

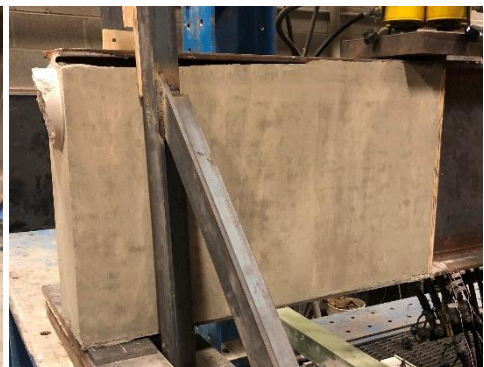
completed concrete encasement

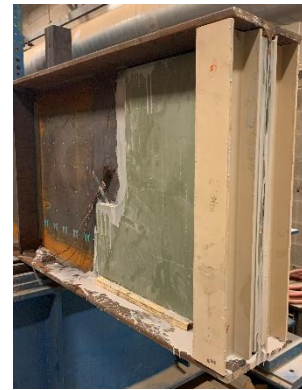
completed FRP repair

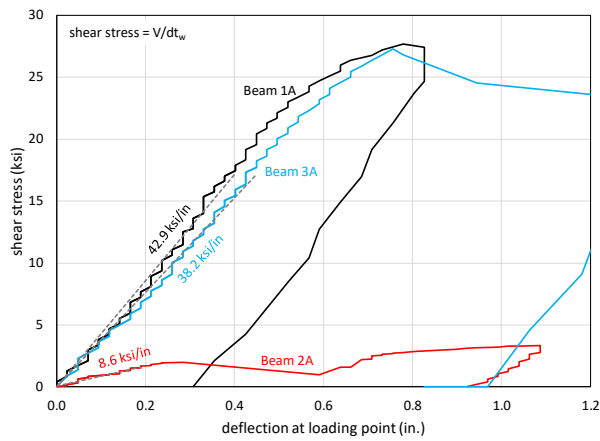
a) Girders 1A, 2A and 3A (bolted steel)

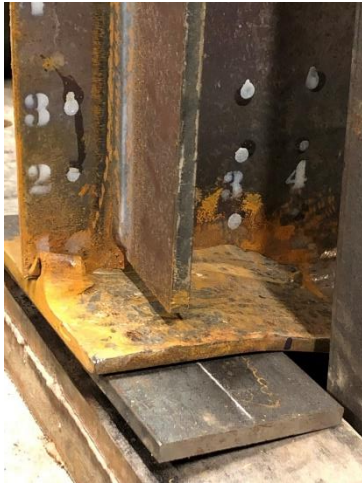
a) bearing region during testing

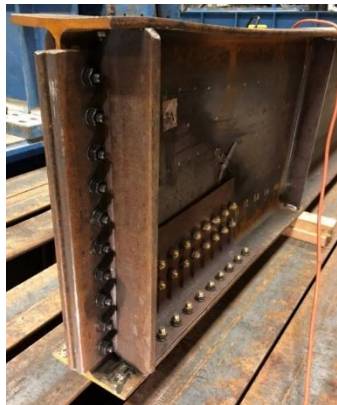
a) bearing region following testing

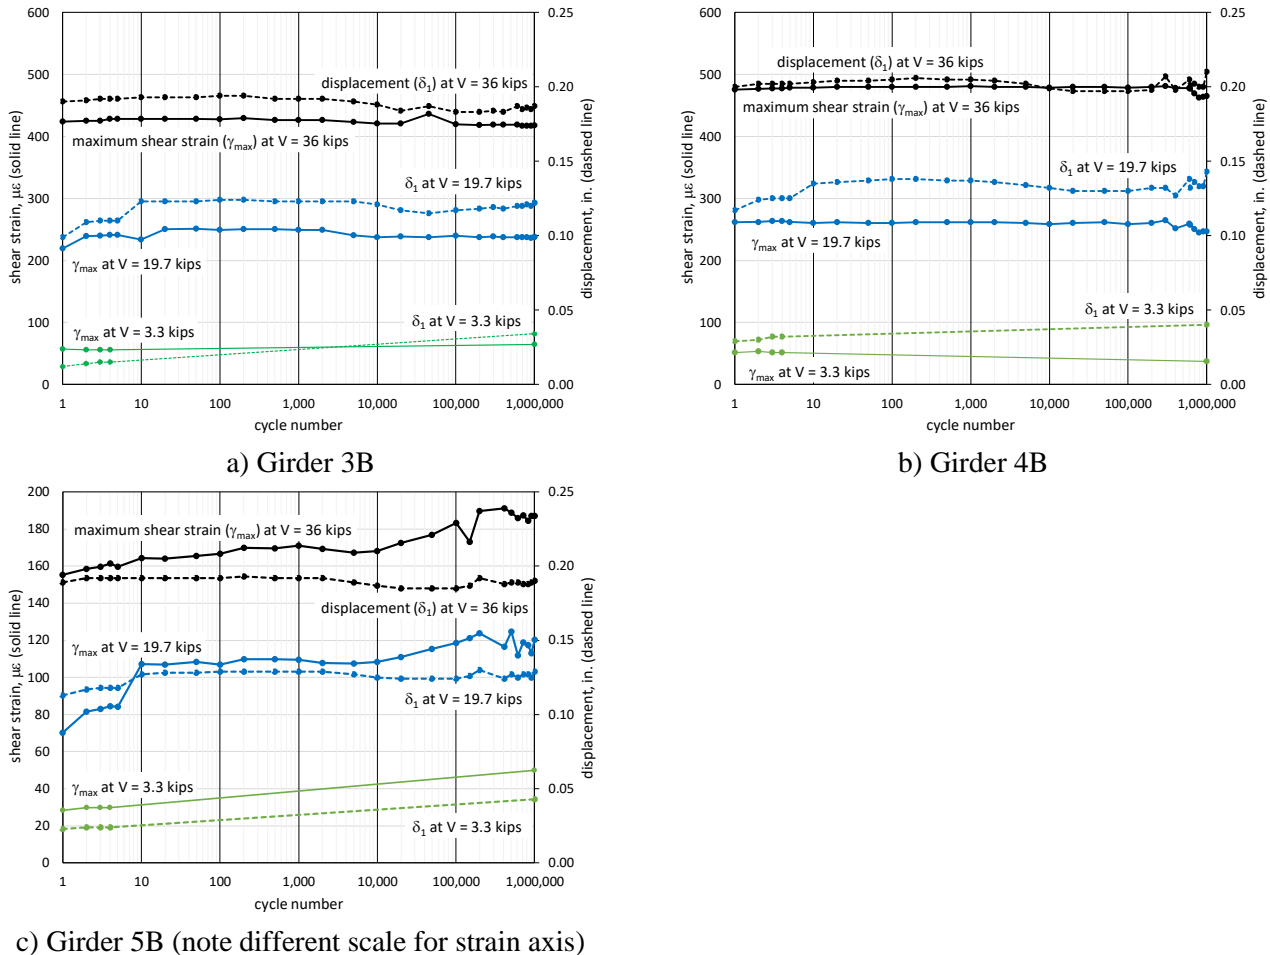
**Figure 55 Shear strain and displacement histories during fatigue conditioning.**

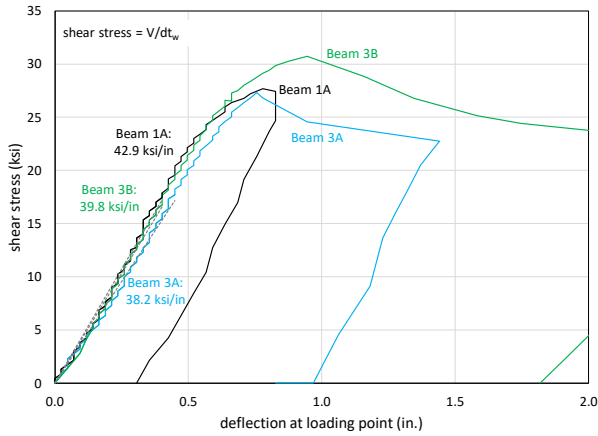
a) Girders 1A, 3A and 3B

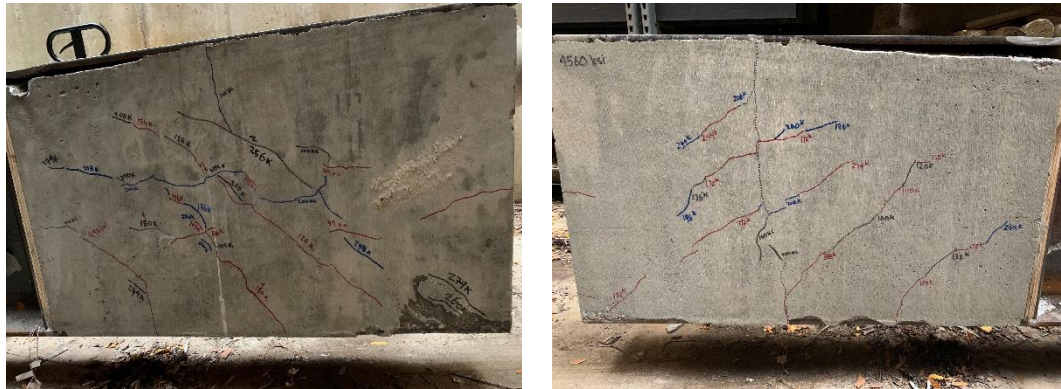
a) East side (support bearing at right)

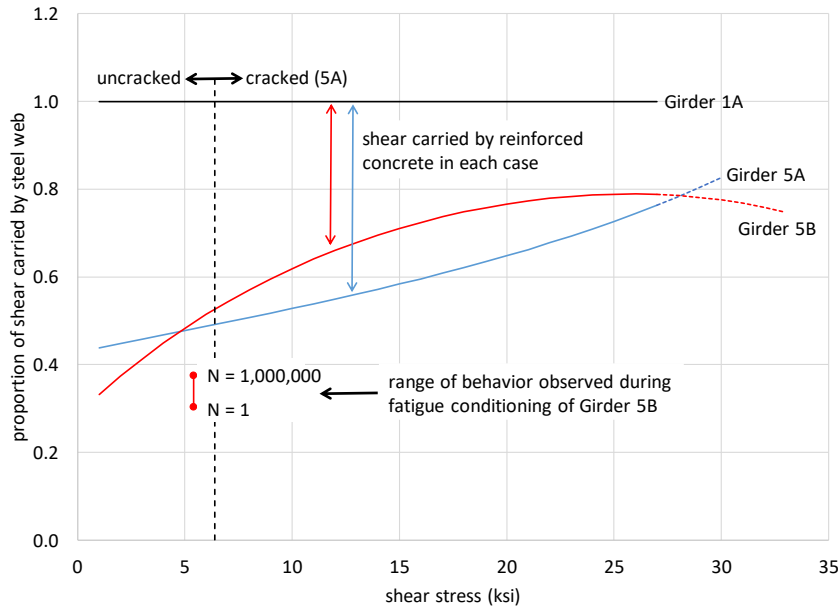
**Figure 62 Proportion of shear resisted by steel web in Girder 5.**

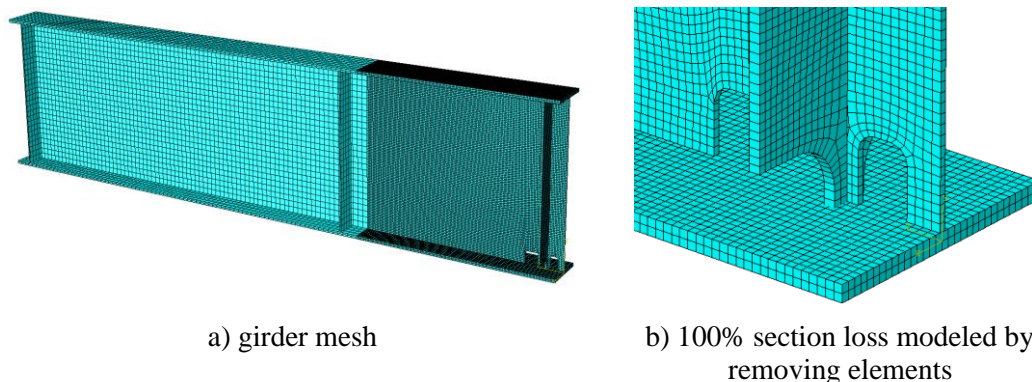
Figure 63 Mesh geometry.

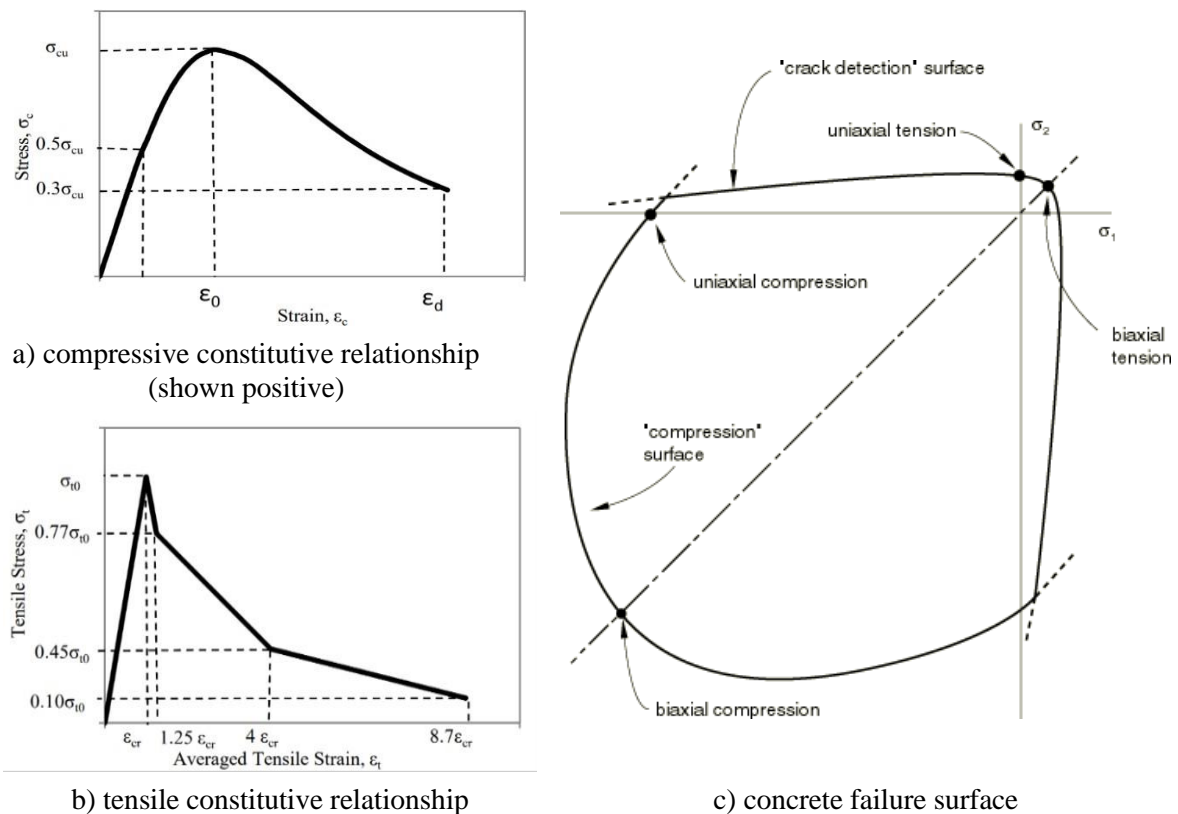
**Figure 65 ABAQUS smeared crack concrete model.**

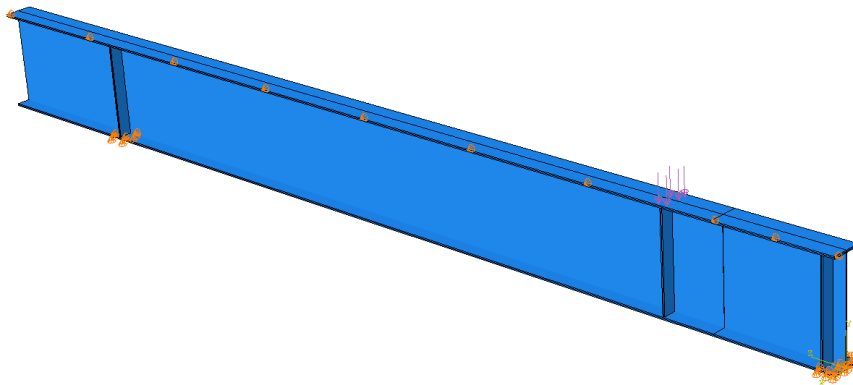
**Figure 67 Numerical model boundary conditions**

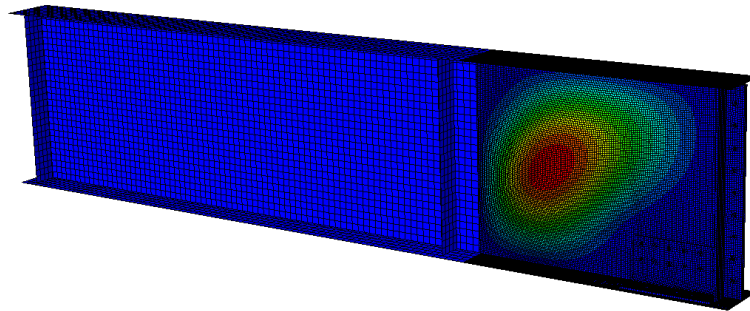
**Figure 68 Girder imperfections based on eigenvalue buckling analysis (deflection amplified).**

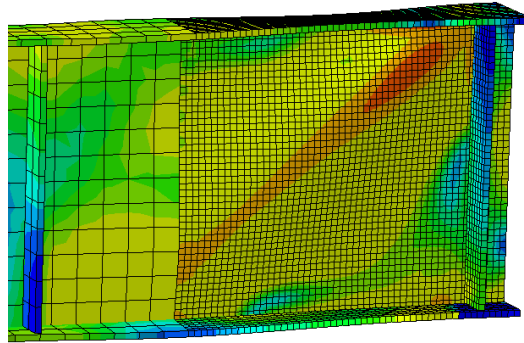
**Figure 69 Girder 1A loaded end elevation with maximum (von Mises) stresses plotted.**

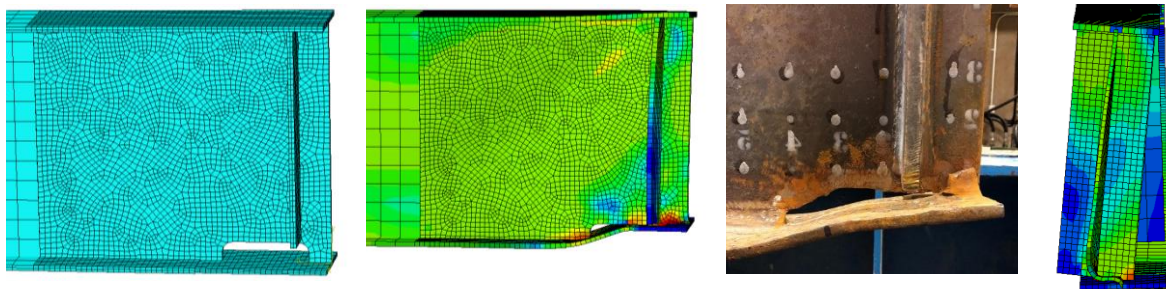
a) girder end prior to loading

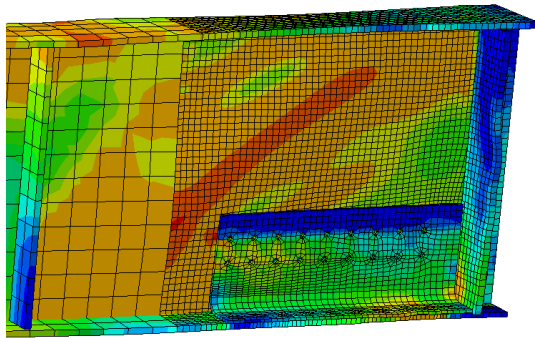
a) girder end view with tension field action evident

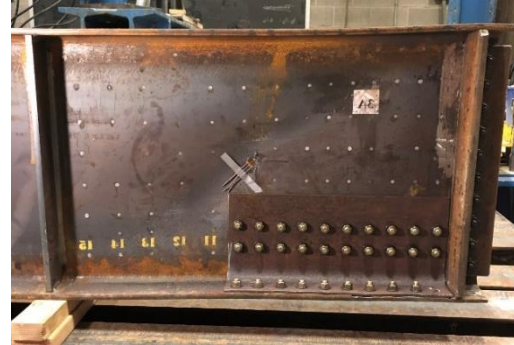
b) observed behavior following testing (image mirrored)

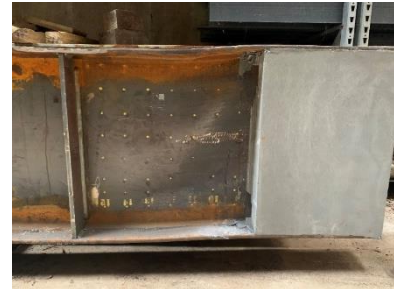
c) observed web buckling behavior (image mirrored)

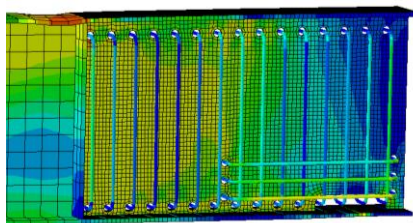
a) bearing region shown with concrete elements hidden

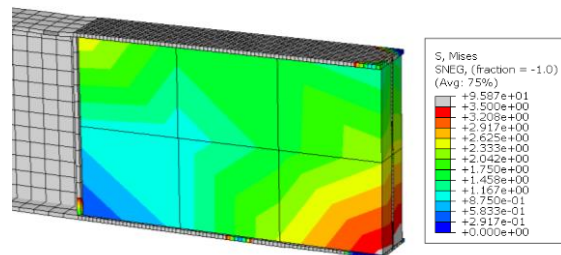
b) concrete crushing ( $f_c' = 3,161$  psi) stress over 3,500 psi grayed out

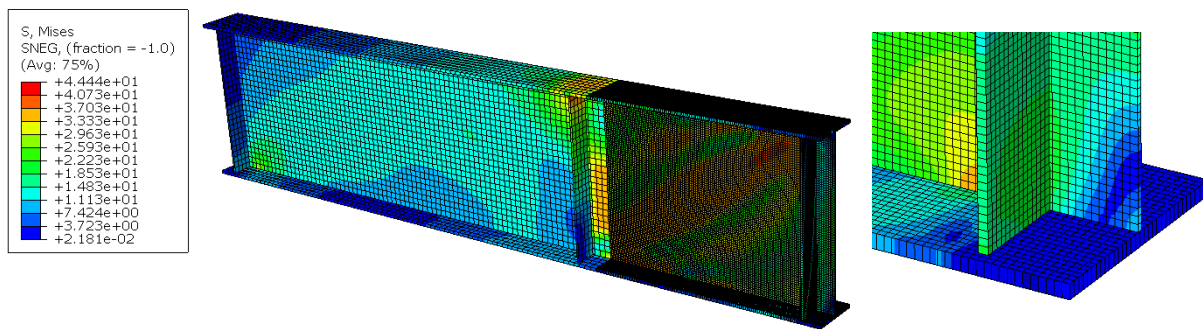
a) girder elevation with maximum (von Mises) stresses plotted; development of tension field is evident

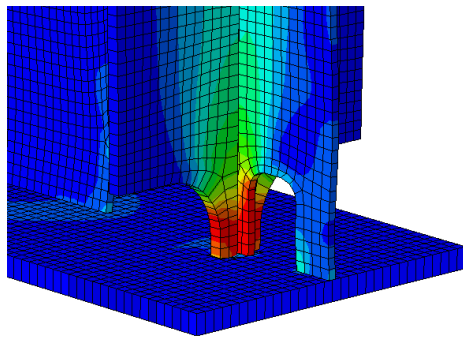
a) with bearing stiffener

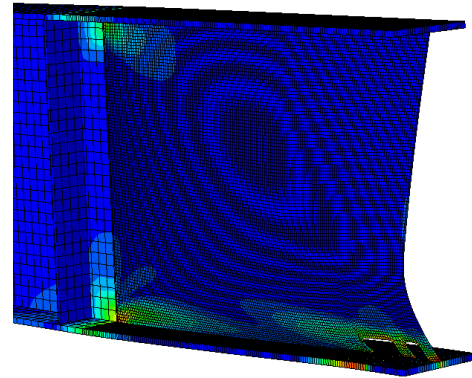
b) without bearing stiffener

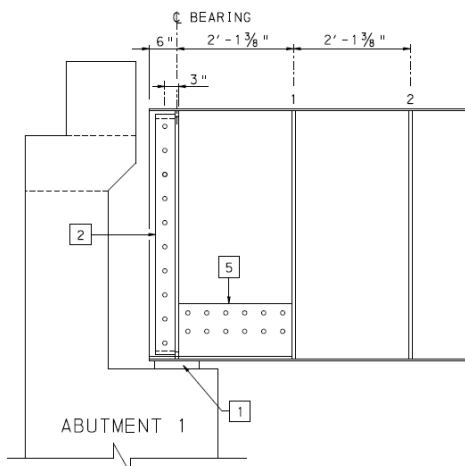
a) Bridge D repair (intermediate stiffeners are not modeled)

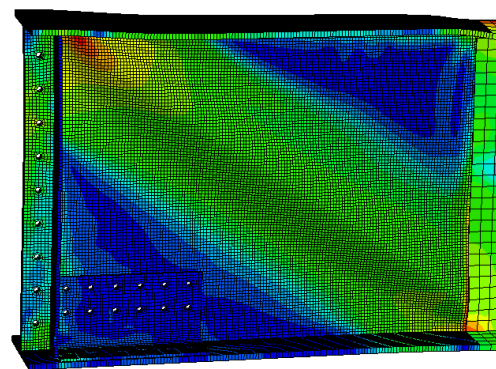
b) stresses at girder end (tension field is evident)

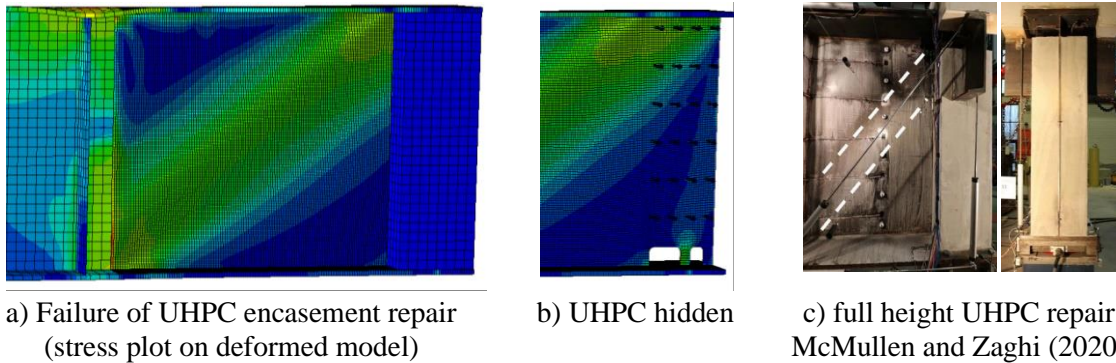
Figure 77 UHPC encasement repair.

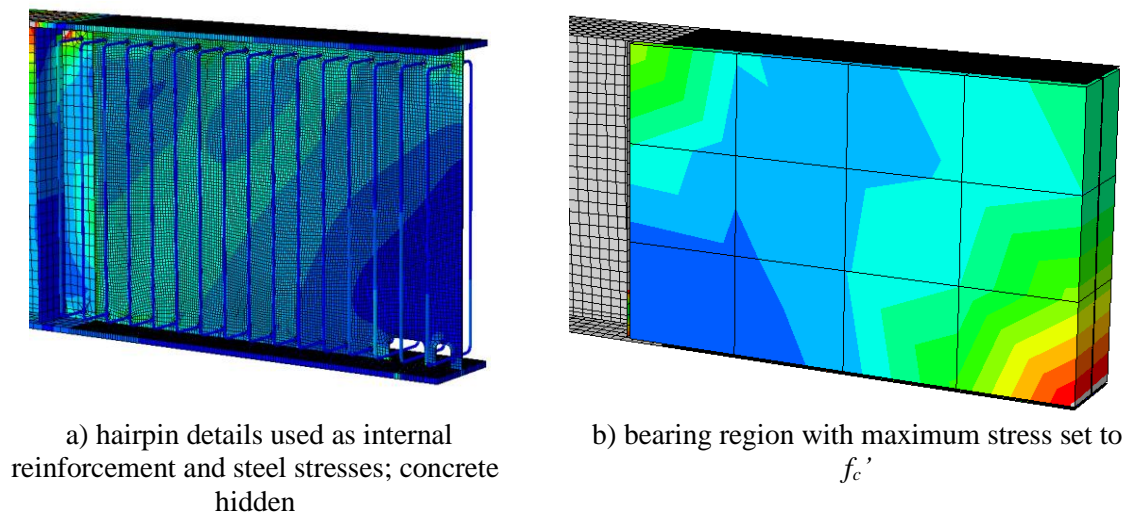
Figure 78 NSC encasement repair.

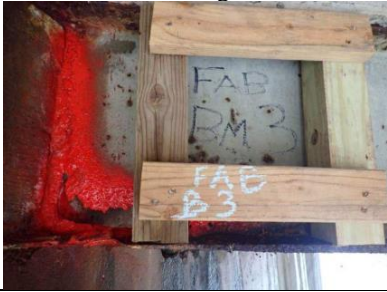
<b>E-M4:</b> b = 1; a = 1 <b>E-W3:</b> C <sub>L3</sub> = 24; C <sub>L1</sub> = 5; C <sub>H1</sub> = 2; C <sub>H2</sub> = H <sub>0</sub> ; t <sub>w min</sub> = 0.125 (28%) >50% loss of flange over 17 in.

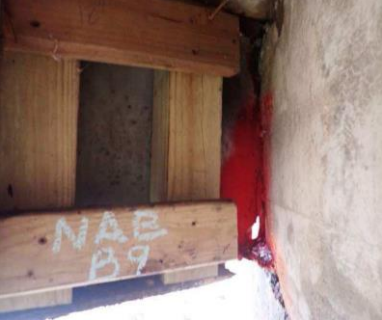
<p data-bbox="778 439 799 468">9</p>	<p data-bbox="1015 439 1230 468">no reported damage</p>

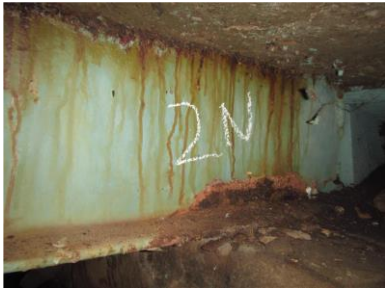
2	Far end <b>W5:</b> $C_L \approx 2B_L$ ; $C_H \approx 8$ ; $t_w = 0.32$ (83%)

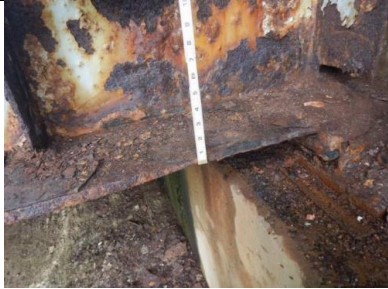
<p>Span 1 Girder 2 Near Abutment</p>	<p><b>M3:</b> b ≈ 2; a ≈ 12; behind CL bearing <b>W1:</b> C<sub>L</sub> ≈ 12; C<sub>H</sub> ≈ 56</p>

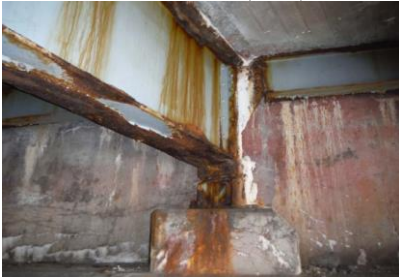
3	no reported damage
<p><b>W1:</b> <math>C_L \approx 36</math>; <math>C_H \approx 12</math>                      no section loss noted</p>

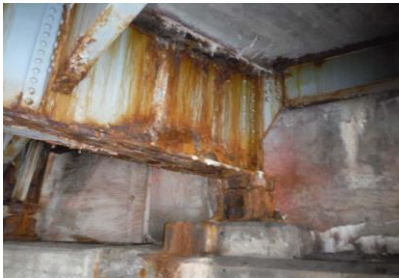
4	no reported damage
<p><b>W1:</b> <math>C_L \approx 144</math>; <math>C_H \approx 24</math>  <math>t_{w \min} = 0.505</math> (81%)  <math>t_{bf \min} = 0.279</math> (31%)</p>

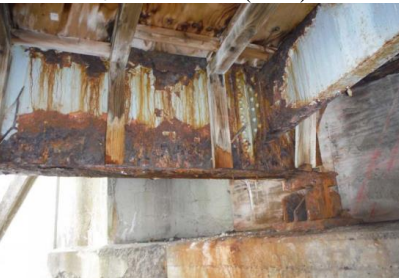
5	<p><b>W1:</b> <math>C_L = 48</math>; <math>C_H = 35.5</math>  <math>t_{w \min} = 0.378</math> (60%)  <math>t_{bf \min} = 0.250</math> (28%)</p>

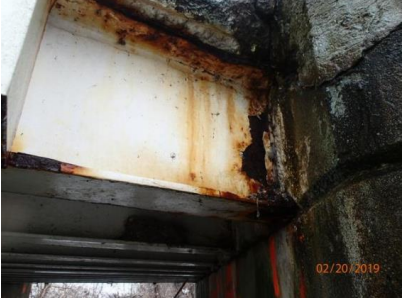
<p>1</p>	<p><b>M1:</b> <math>b = 4; a = 6</math>  <b>E-W5:</b> <math>C_L = 20; C_H = 14</math></p>

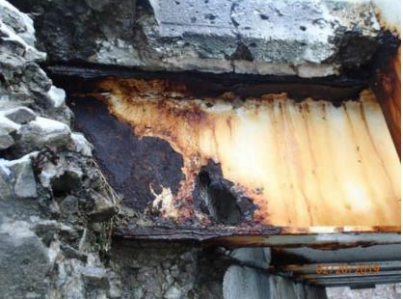
<p>no report damage</p>	<p>6</p>	<p>2" of 100% loss along the right bottom flange</p>

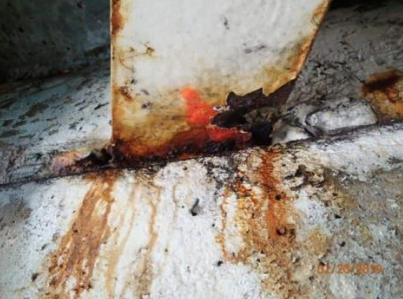
**Inspection Report Summary**

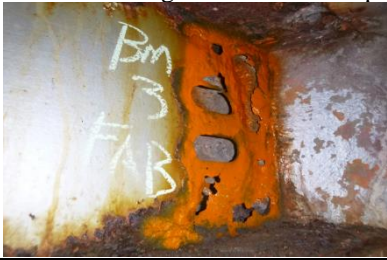
<p>9" of 100% section loss to bottom flange</p>

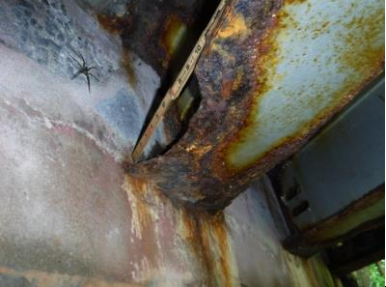
<p>5</p>	<p>no reported damage</p>

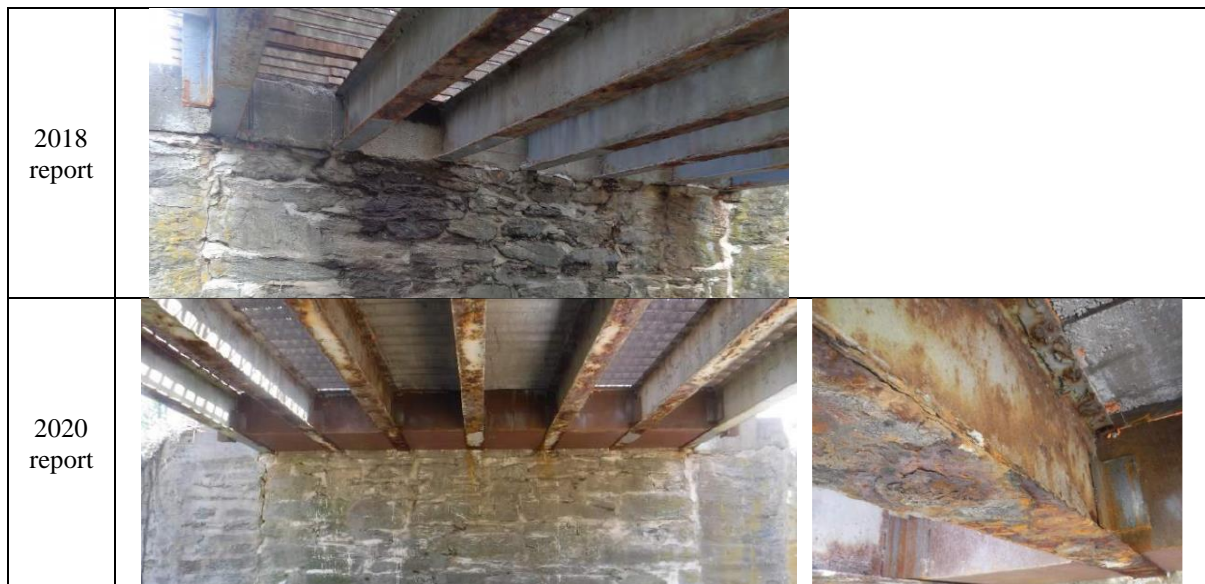
**Beam end conditions:**

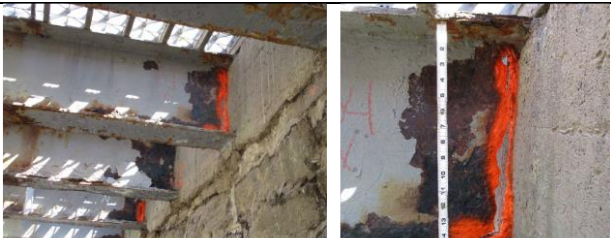
<p>Near Abutment Span 1 Girder 5</p>	<p><b>E-W1:</b> <math>C_L = 6; C_H = 3</math> <b>E-M3:</b> <math>a = 6; b = 1</math></p>

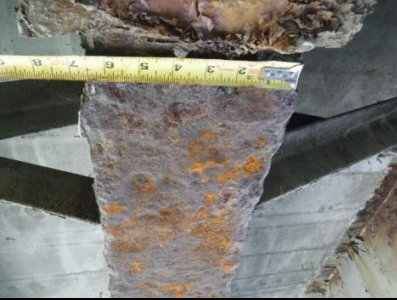
<p>Far Abutment Span 2 Girder 5</p>	<p><math>t_{bf \text{ min}} = 3/8''</math> (86%) no section loss to web noted</p>

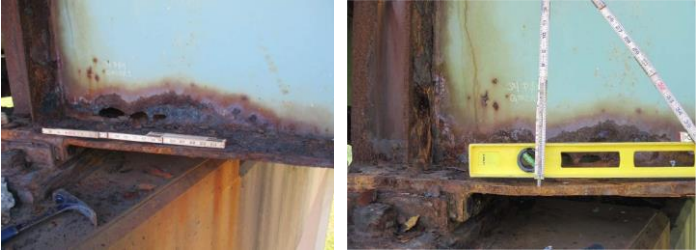
Pier 4 Span 5 Girder 1	<p><b>W1:</b> C<sub>L</sub> = 15; C<sub>H</sub> = 2.5                  t<sub>w min</sub> = 0.813" (81%)</p>	
Pier 6 Span 6 Girder 1	<p><b>M3:</b> b = 5; a = 3  <b>M3:</b> b = 0.375; a = 0.375  <b>W1:</b> C<sub>L</sub> = 10; C<sub>H</sub> = full                  height                  minor section loss noted</p>

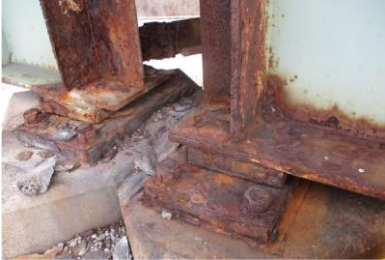
Pier 6 Span 7 Girder 1	<p><b>M3:</b> b = 1.5; a = 1.5  <b>W1:</b> C<sub>L</sub> = 6; C<sub>H</sub> = full                  height</p>	
Pier 9 Span 9 Girder 1	<p><b>W1:</b> C<sub>L</sub> = 24; C<sub>H</sub> = 5                  t<sub>w min</sub> = 3/4" (75%)                  t<sub>stiffener,min</sub> = 1/4" (67%)</p>

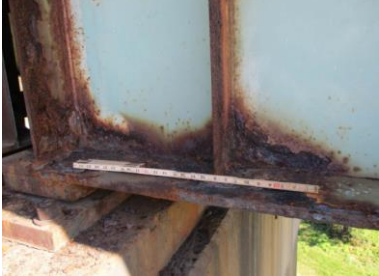
Pier 9 Span 10 Girder 1	<p><b>W1:</b> C<sub>L</sub> = 6; C<sub>H</sub> = 4                  minor section loss noted</p>	
Pier 11 Span 11 Girder 1	<p><b>W1:</b> C<sub>L</sub> = 9; C<sub>H</sub> = full                  height                  t<sub>w min</sub> = 0.813" (81%)                  t<sub>stiffener,min</sub> = 0.189" (50%)</p>	
Pier 13 Span 13 Girder 1	<p><b>W1:</b> C<sub>L</sub> = 15; C<sub>H</sub> = 2                  t<sub>w min</sub> = 7/8" (88%)</p>

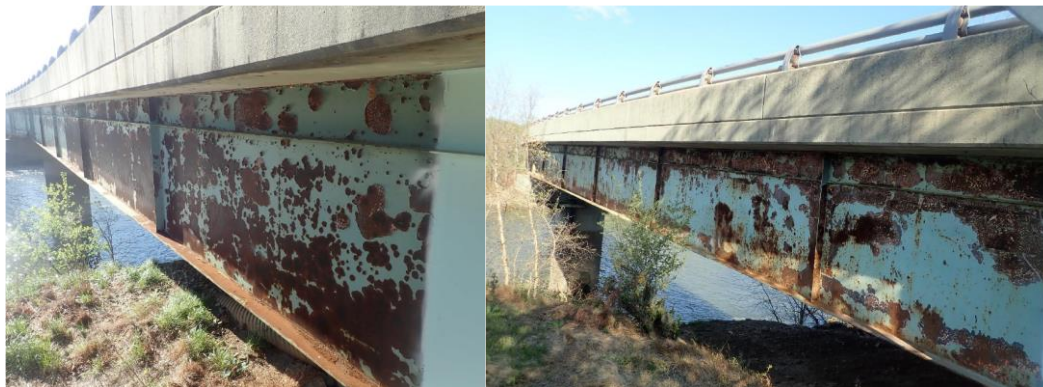
Near Abutment	Beam	Far Abutment
<b>M1:</b> b = 7; a = 3.5 <b>M1:</b> b = 5; a = 4 no other details provided	1	beam end corrosion noted, no other details provided
beam end corrosion and section loss noted, no other details provided	2	<b>M1:</b> b = 9; a = 3 <b>M1:</b> b = 9; a = 4 no other details provided
<b>M1:</b> b = 5; a = 1.5 <b>M1:</b> b = 3.5; a = 1.5 <b>M1:</b> b = 9; a = 4 $t_{w \text{ min}} = 0.113''$ (15%) $t_{bf \text{ min}} = 0.528''$ (70%) no other details provided	3	<b>M1:</b> b = 10.5; a = 2 <b>M1:</b> b = 9; a = 7 no other details provided
$t_{w \text{ min}} = 0.299''$ (40%) $t_{bf \text{ min}} = 0.528''$ (70%) no other details provided	4	<b>M1:</b> b = 7; a = 2 no other details provided
beam end corrosion and section loss noted, no other details provided	5	beam end corrosion noted, no other details provided

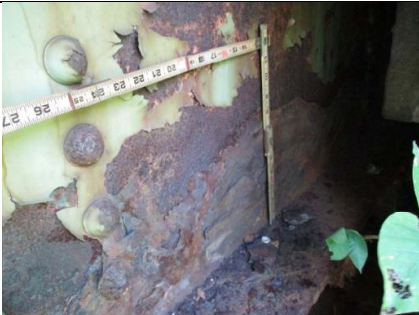
Near Abutment Span 1 Girder 8	<p><b>W1:</b> <math>C_L = 84</math>; <math>C_H = 6</math>  <math>t_{w \text{ min}} = 0.375''</math> (55%)  <math>t_{bf \text{ min}} = 0.538''</math> (49%)</p>	
Pier 1 Span 2 Girder 1	<p><b>W1:</b> <math>C_L = 96</math>; <math>C_H = 5</math>  <math>t_{w \text{ min}} = 0.493''</math> (72%)</p>	
Pier 2 Span 2 Girder 14	<p><b>W1:</b> <math>C_L = 120</math>; <math>C_H = 3</math>  <math>t_{w \text{ min}} = 0.493''</math> (72%)  <math>t_{bf \text{ min}} = 0.913''</math> (83%)</p>

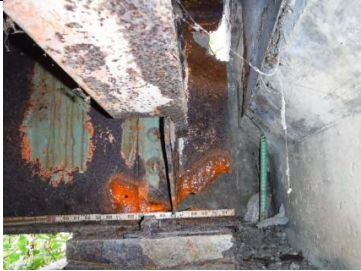
</p> <p>from outside →

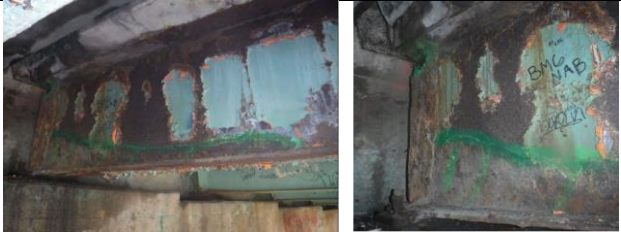
<p>Near Abutment Span 1 Girder 7</p>	<p>beam end corrosion noted, no other details provided</p>	
<p>Pier 1 Span 1 Girders 6/7</p>	<p>beam end corrosion noted, no other details provided</p>	
<p>Pier 2 Span 2/3 Girder 6</p>	<p><b>M1:</b> b = 4; a = 2 (bearing stiffener) <b>M1:</b> b = 2; a = 1.5 (web) <b>W1:</b> C<sub>L</sub> = 48; C<sub>H</sub> = 30</p>

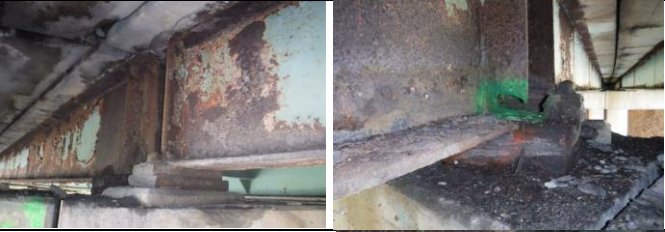
<p>Far Abutment Span 4 Girder 6</p>	<p><b>M1:</b> b = 5; a = 2 (bearing stiffener) <b>W5:</b> C<sub>L</sub> = 60; C<sub>H</sub> = 24</p>

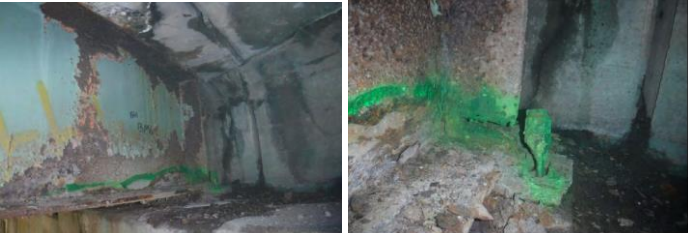
<p>Far Abutment Span 4 Girder 7</p>	<p>beam end corrosion with minor section loss noted, no other details provided</p>
