# Joint Design Optimization

## IRISE ANNUAL MEETING

-May 17, 2023-

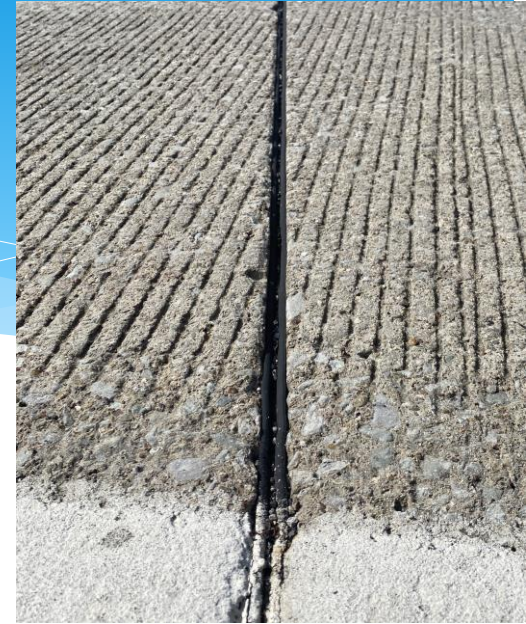
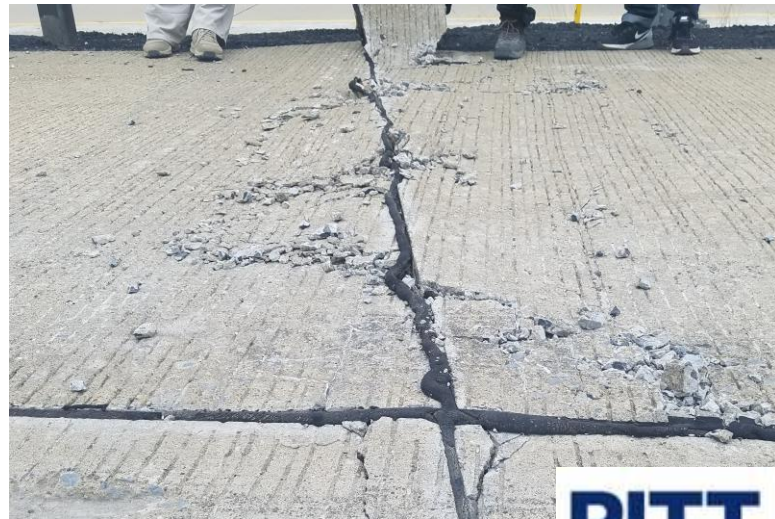
## Premature joint sealant failure

- ❑ Incompressibles:
  - ❑ Spalling
  - ❑ Blow-ups
- ❑ Moisture:
  - ❑ Accelerated dowel corrosion
  - ❑ Faulting

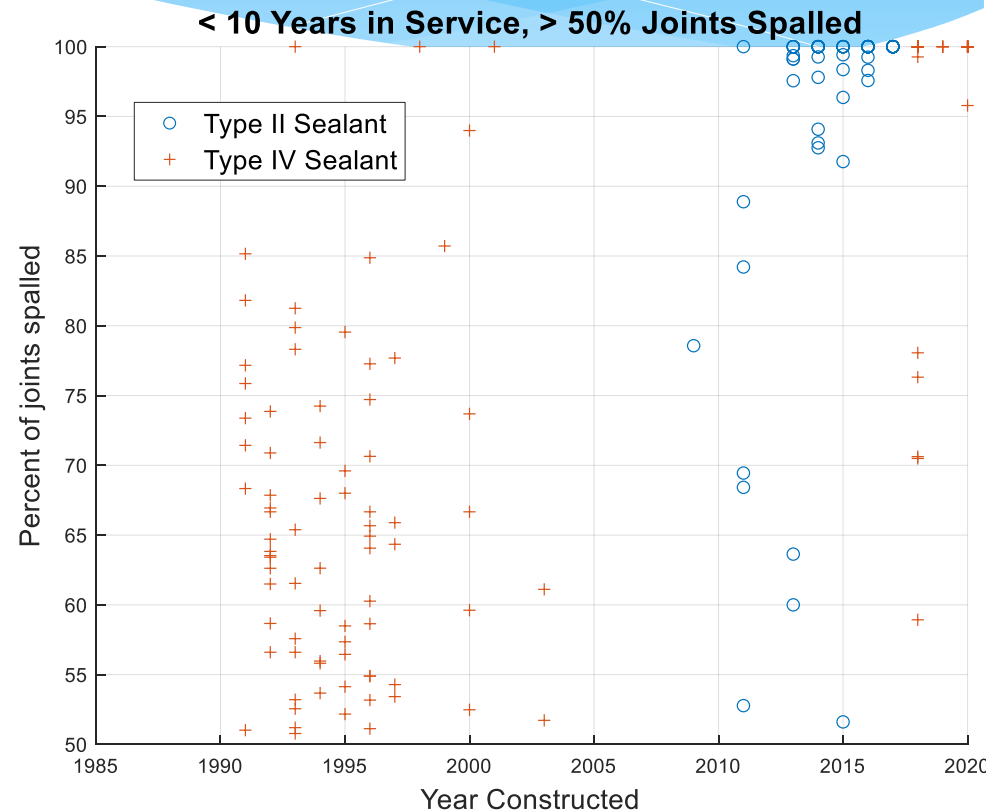
## ❑ Spalling

- ❑ 94% of sections had less than 10% joints spalled (< 10 yrs old)
- ❑ Type II sealants (2008 – 2018) were prone to spalling
- ❑ Spalling occurred as a result of Installation of reflective taping on Turnpike

## ❑ Faulting

- ❑ Does not have precision needed

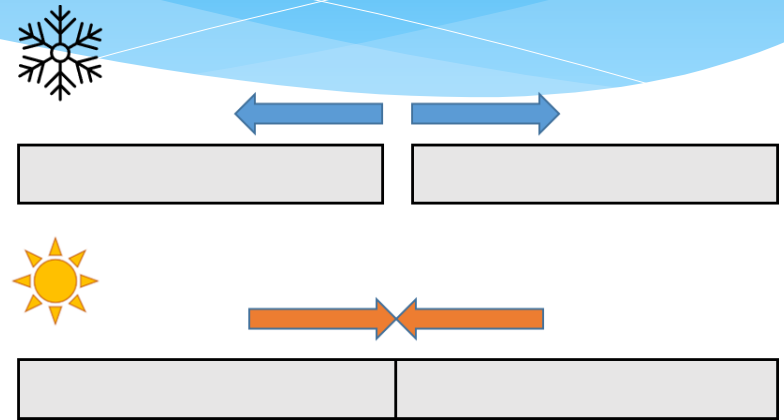
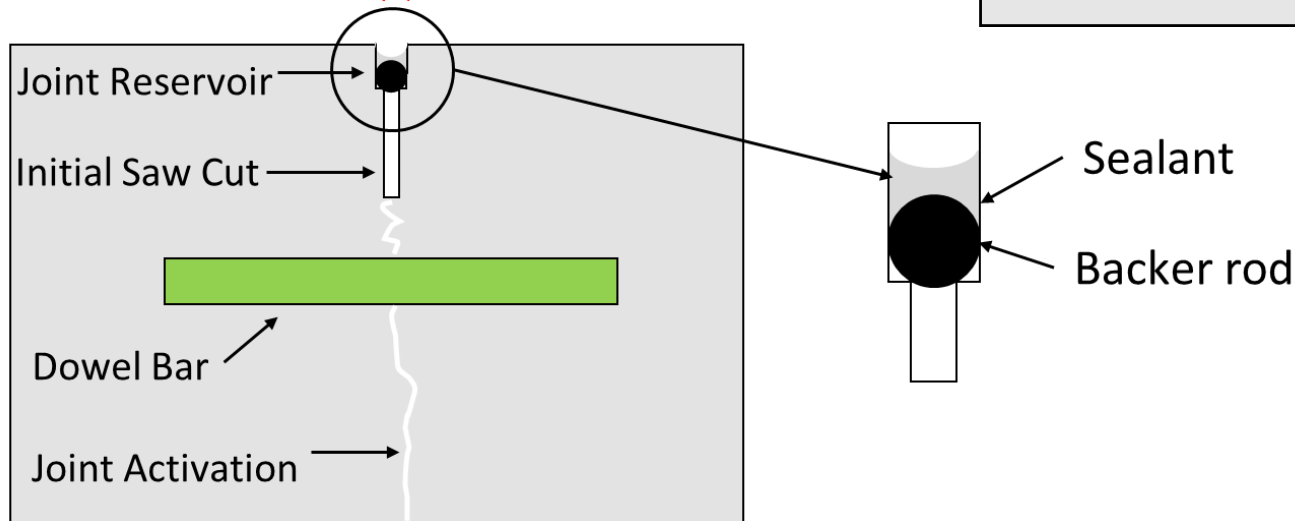
- ❑ Evaluate reservoir design method
- ❑ Jt. open/closing
  - ❑ Ambient temp & RH
  - ❑ Concrete material prop. =  $F(\text{RH} \ \& \ \text{restraint})$
  - ❑ Slab length
  - ❑ Friction factor (?)

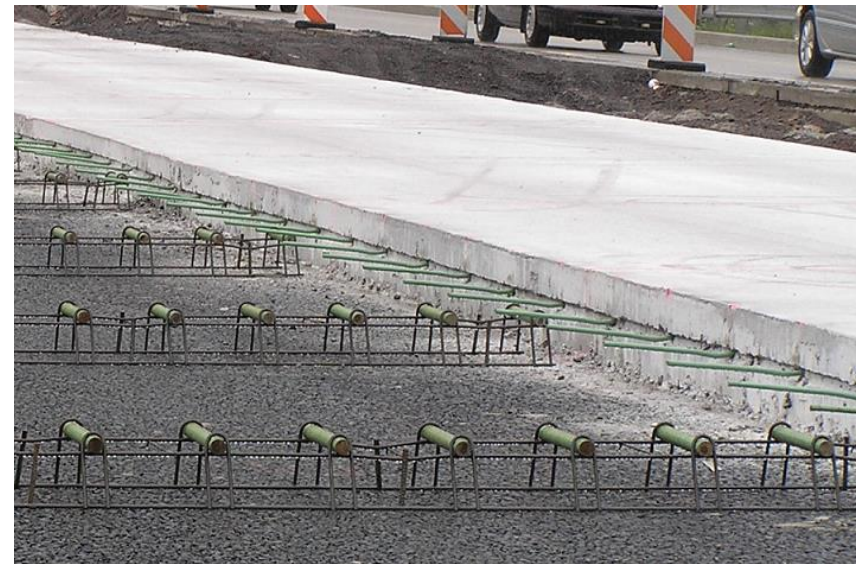
Dowel and tie bars in restrained section

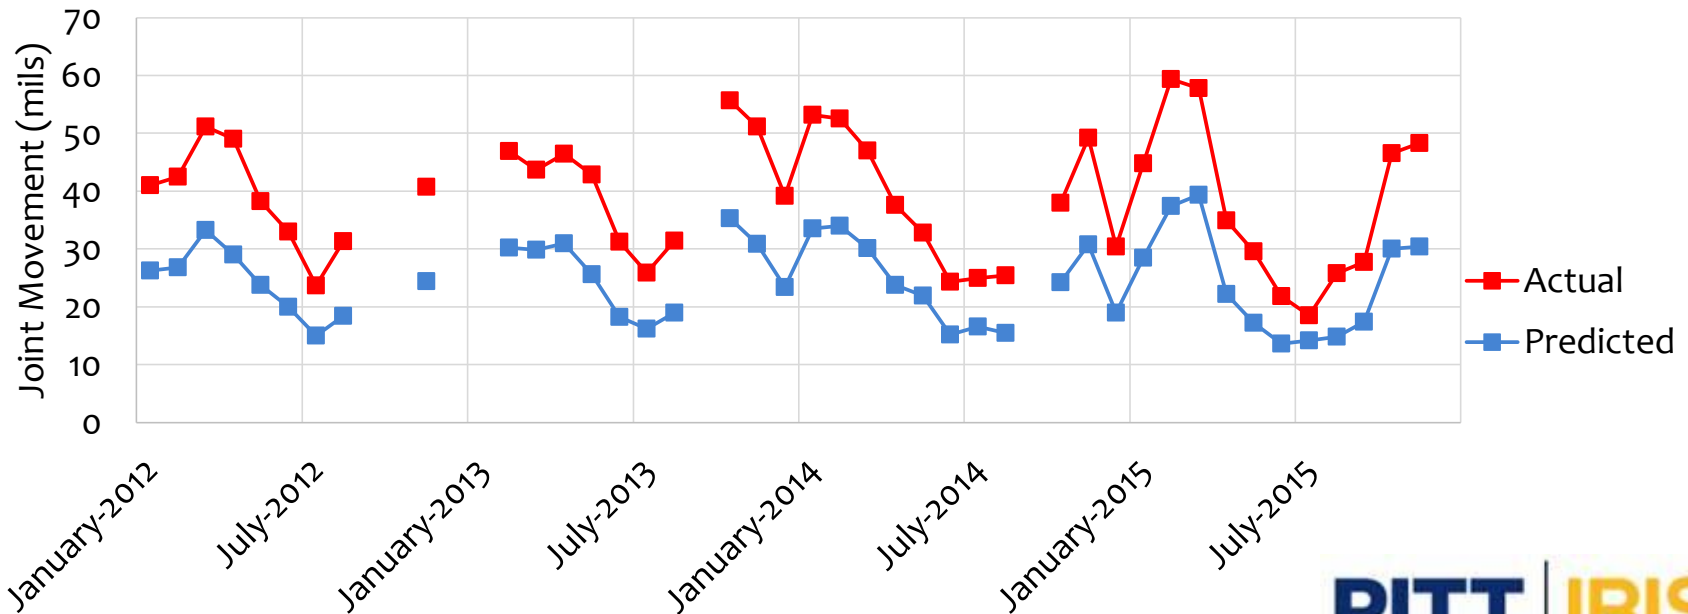
## Findings from Smart Pavement:

- ❑ Not resealed in 20 plus years and still performing well
- ❑ Joint closing restrictions occurred as early at 3 to 5 years
- ❑ CTE in lab similar to CTE in the field
- ❑ Underestimate joint movement with current friction factor by 65%

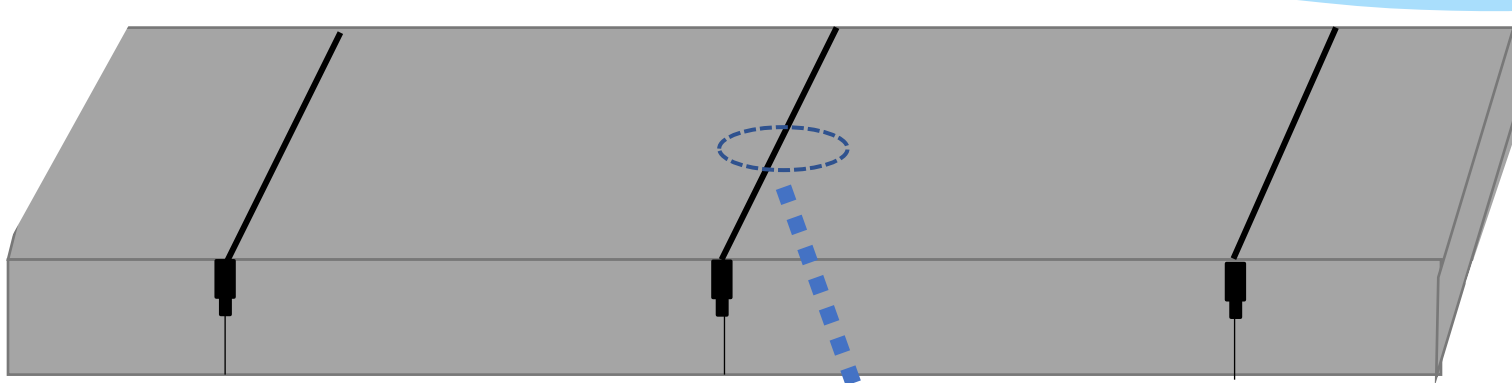
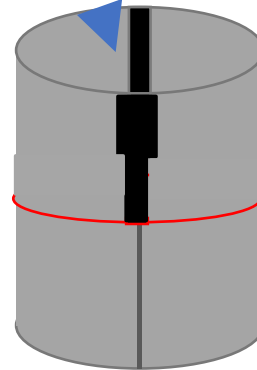
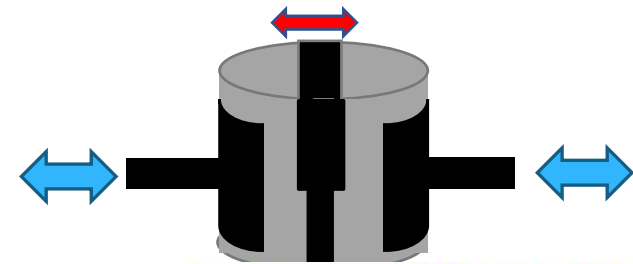
## Key Parameters:

- ❑ Sealant type (II, IV, silicone, neoprene)
- ❑ Reservoir design
- ❑ Joint activation
- ❑ Construction

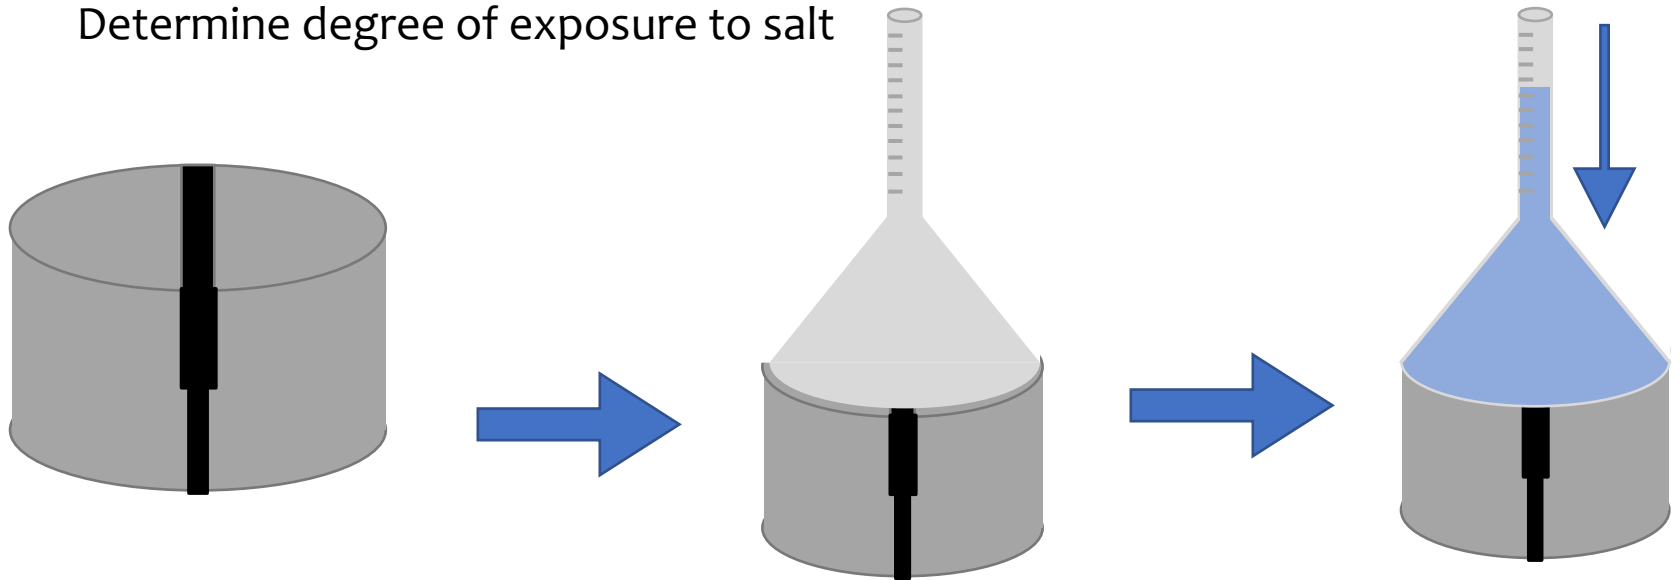
## Modified permeability test

Quantify rate of water entry  
Determine degree of exposure to salt
