Structural Evaluation of Slab Rehabilitation by Method of Hydrodemolition (HD) and Latex Modified Concrete (LMC) Overlay

Kent A. Harries, PhD, FACI, P.Eng

University of Pittsburgh

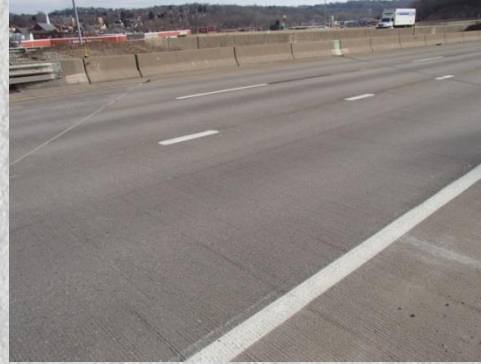
↑ hairline cracking of LMC

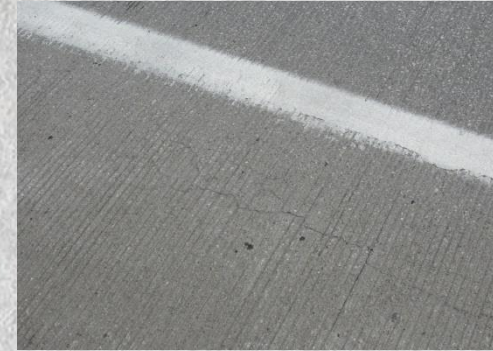
← damage near acute skew

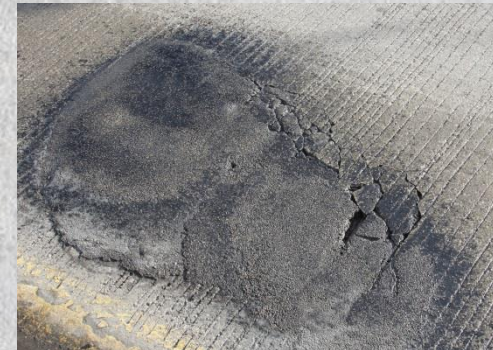
mortar patch of LMC ↑

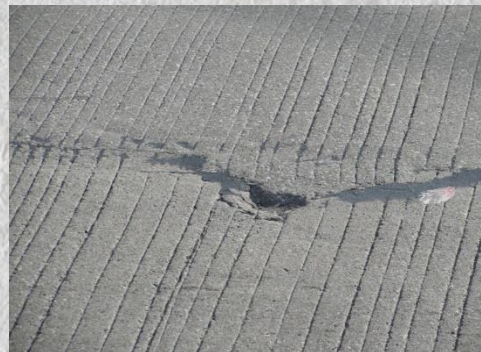
← apparent pop-out

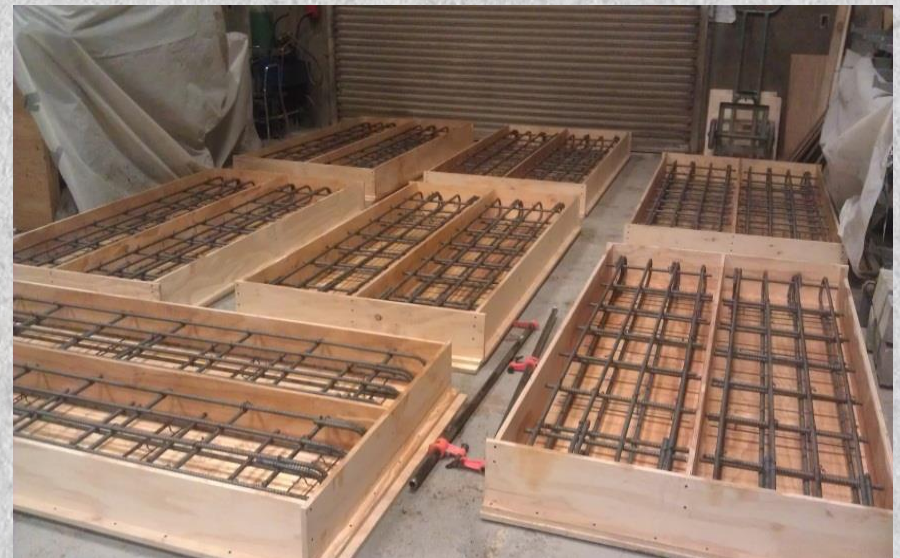
10 laboratory-cast specimens

AAA substrate concrete:

$$f'_c = 6500 \text{ psi}$$

reinforcing steel:

$$f_y = 67.8 \text{ ksi}$$

$$f_u = 107.9 \text{ ksi}$$

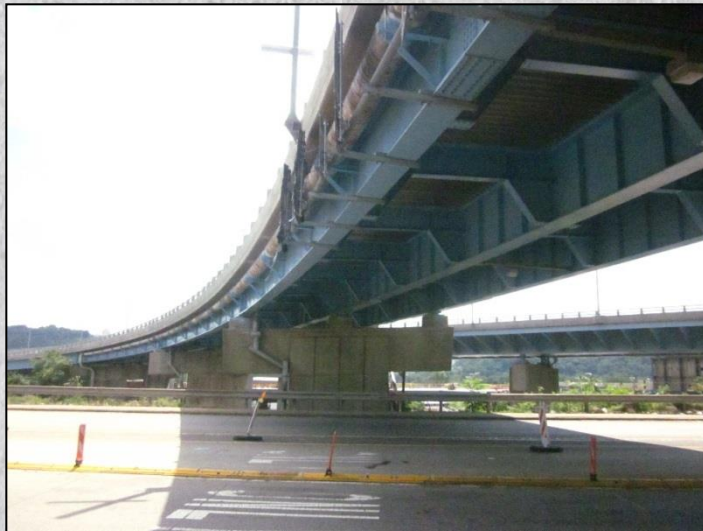
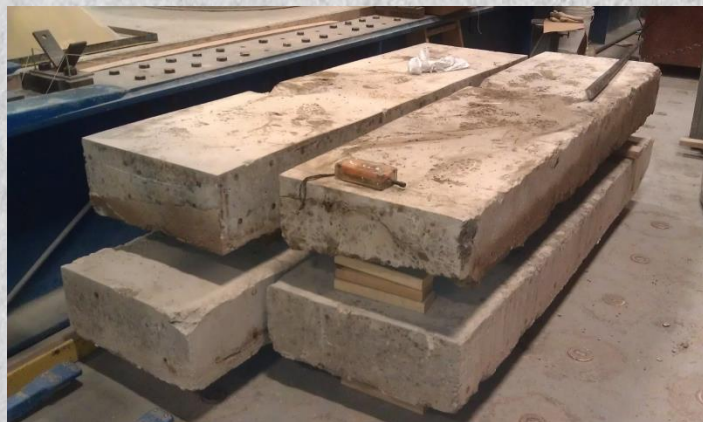
4 - 44 year-old decommissioned slabs

$f'_c = 5015$ psi substrate concrete

$f_y = 43$ ksi reinforcing steel

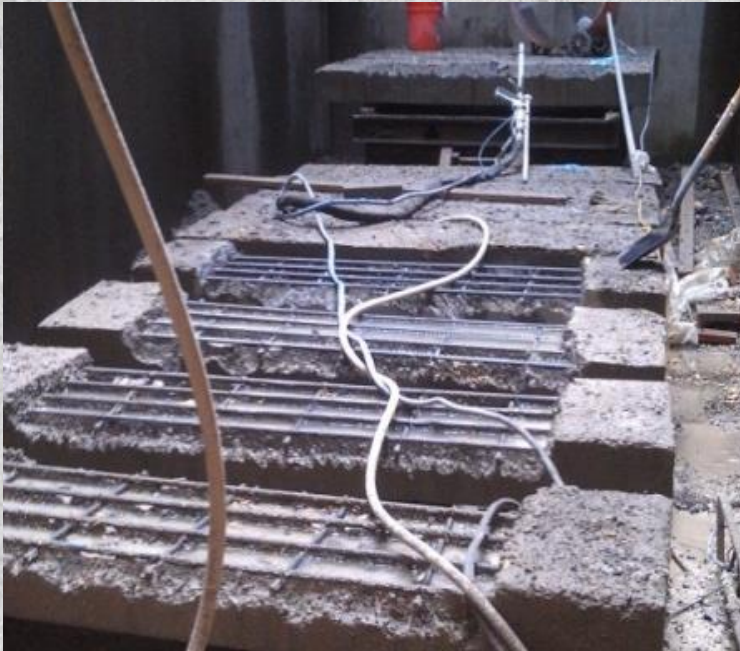
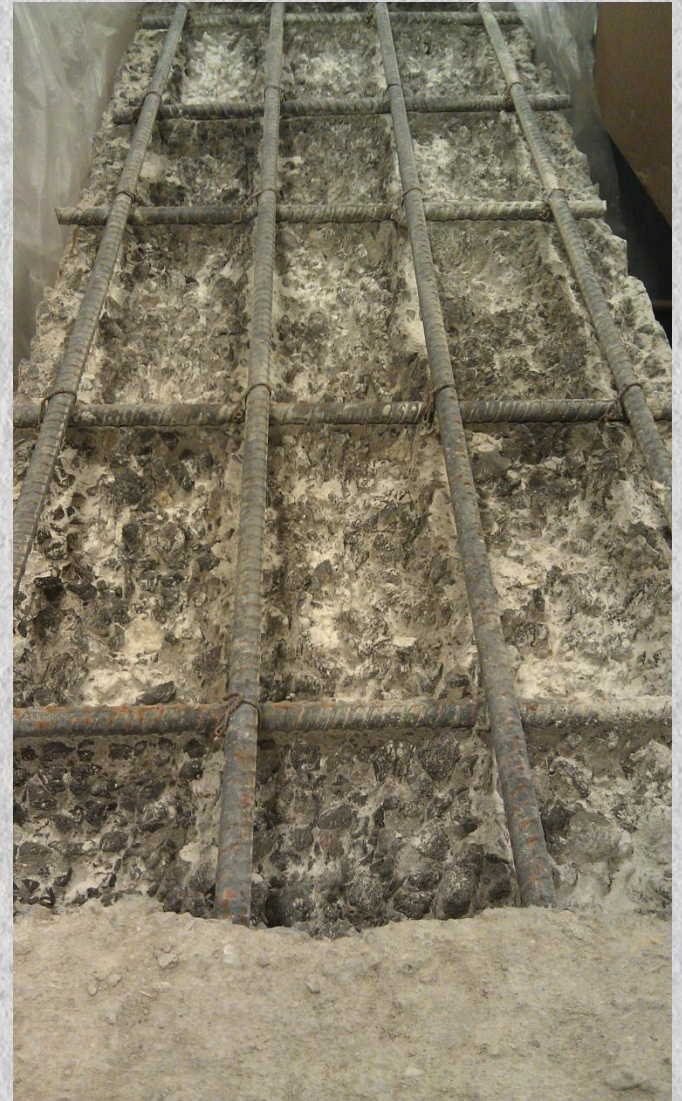
Hydrodemolition

Commercial HD contractor

Excellent control of depth

Lab specimens: 63 days old

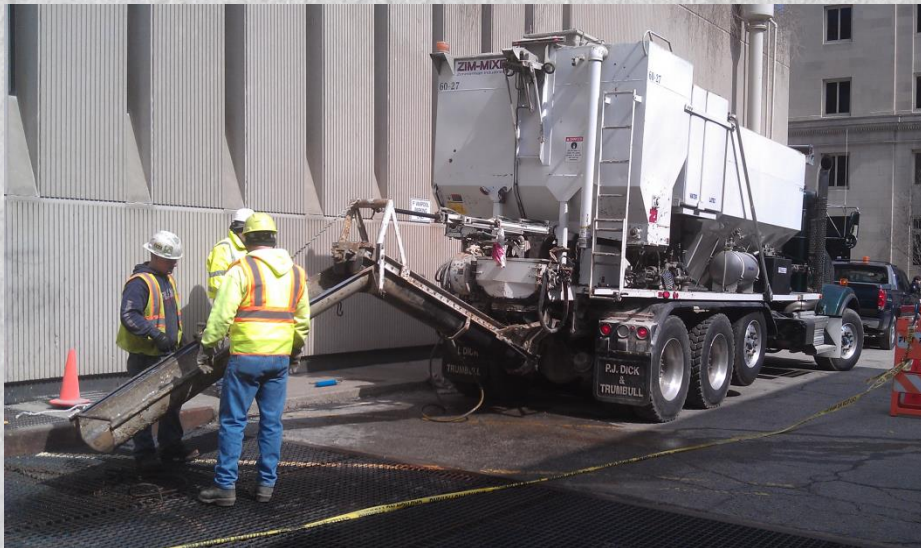
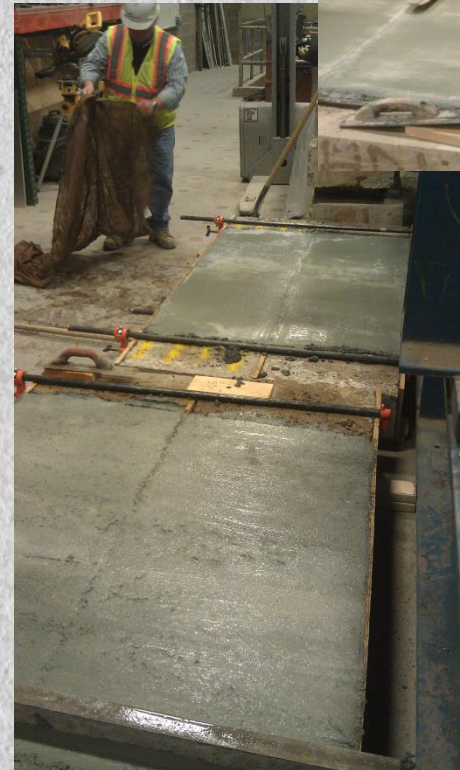
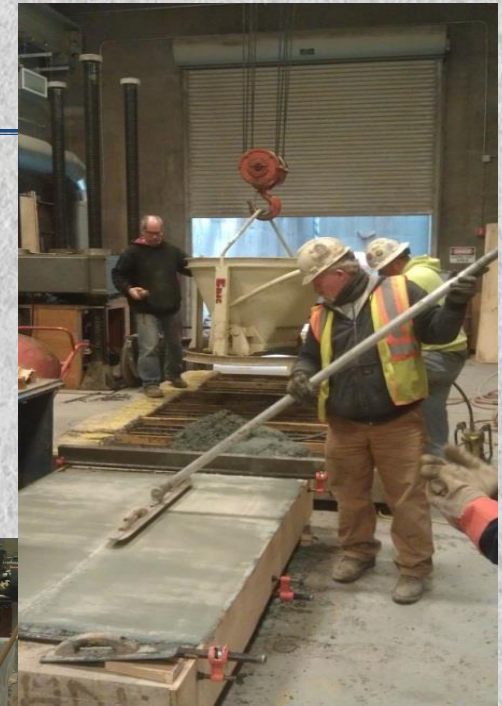
Latex-Modified Concrete

Commercial LMC contractor

LMC mix prequalified under *FHWA RD-78-35*

$f'_c = 6560$ psi

Saturated interface at placement

Seven days moist curing

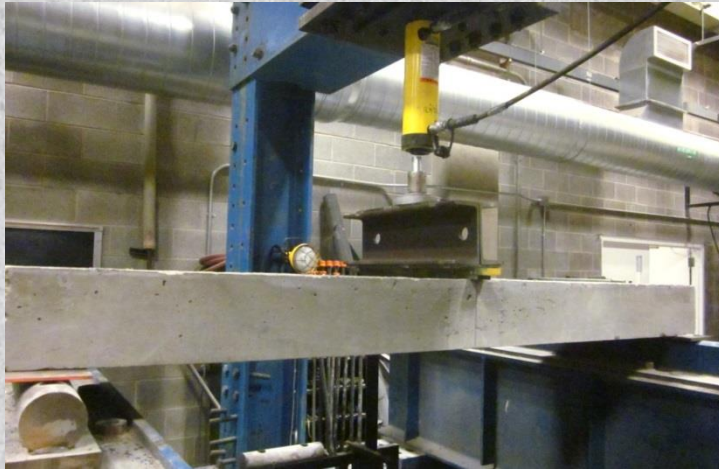
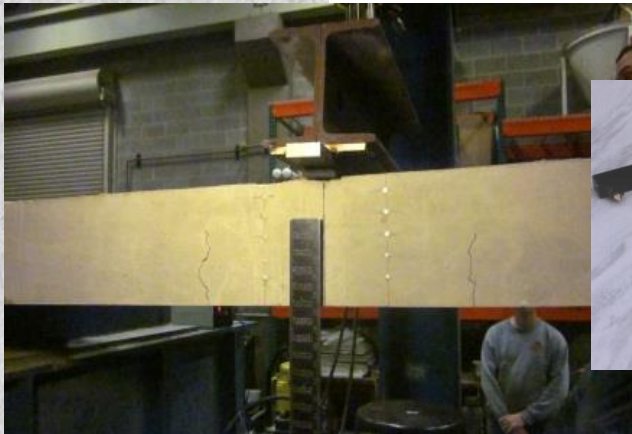
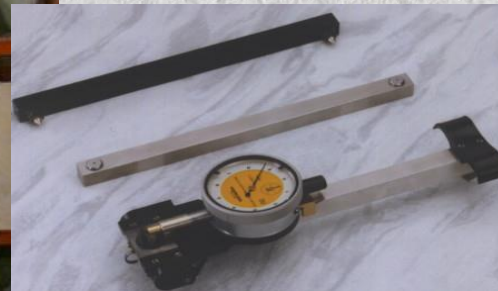
Test Set-up and Instrumentation

Midpoint flexure (selected to match fatigue testing)

concrete strains
using DEMEC
points (both faces)

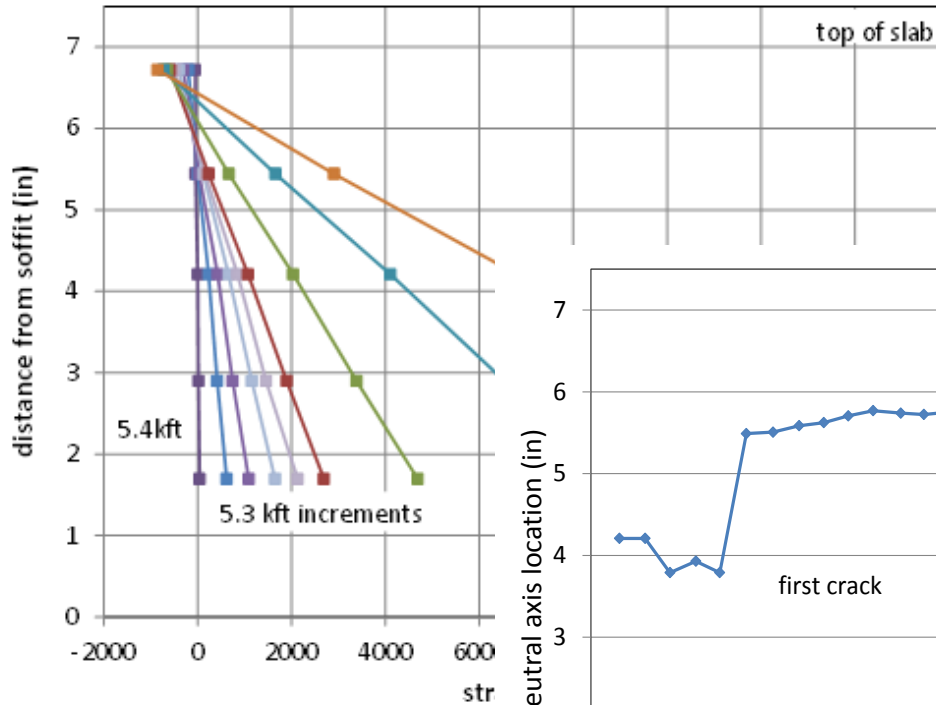
moment-curvature

strain gradients

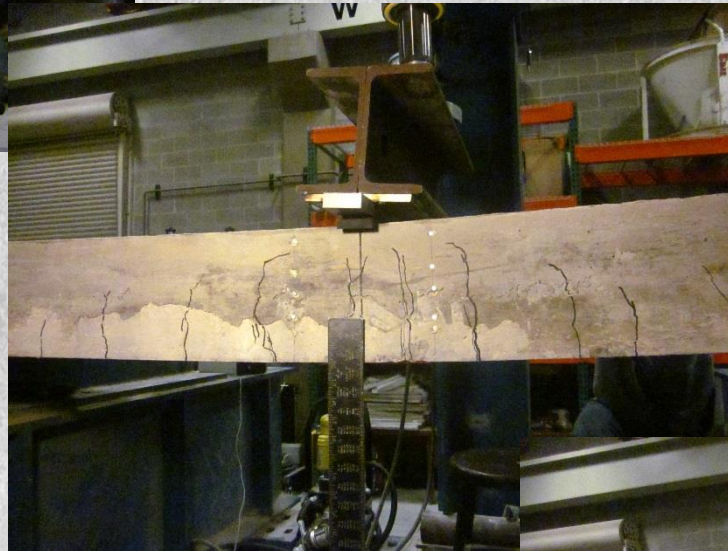
Yield of Reinforcement

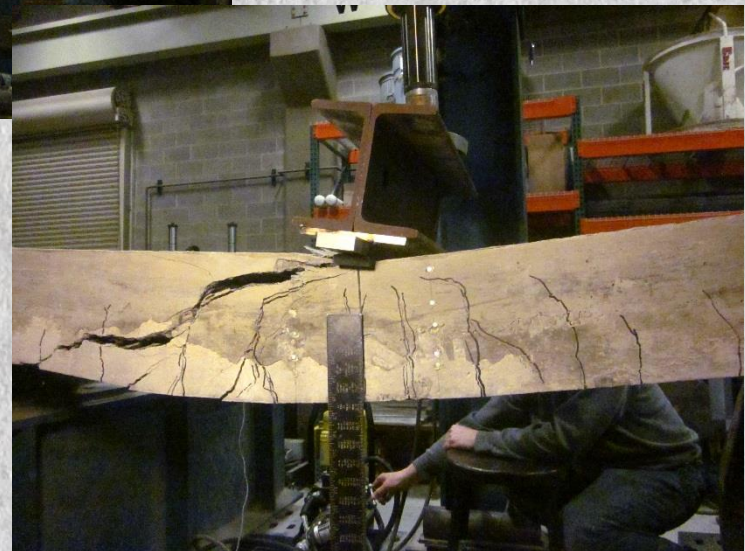
Failure

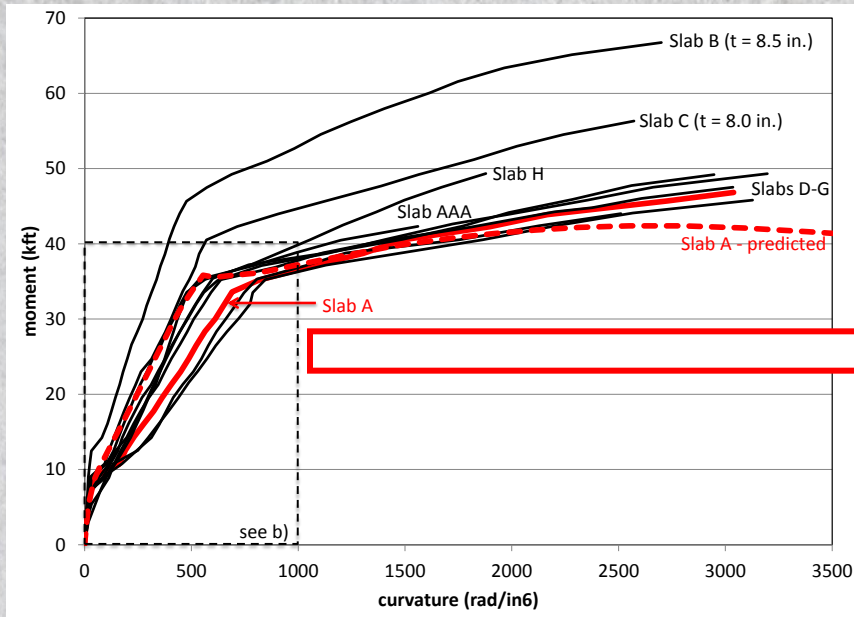
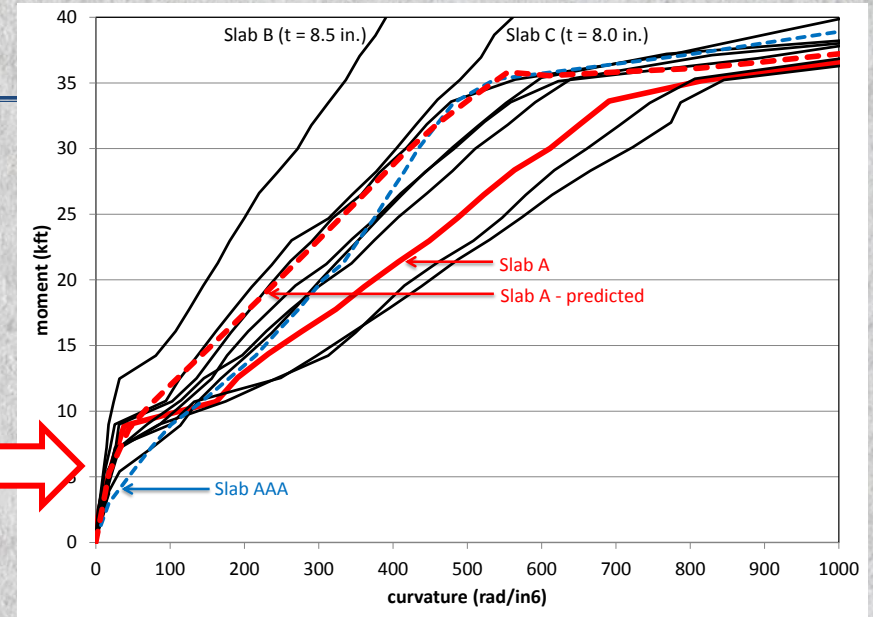
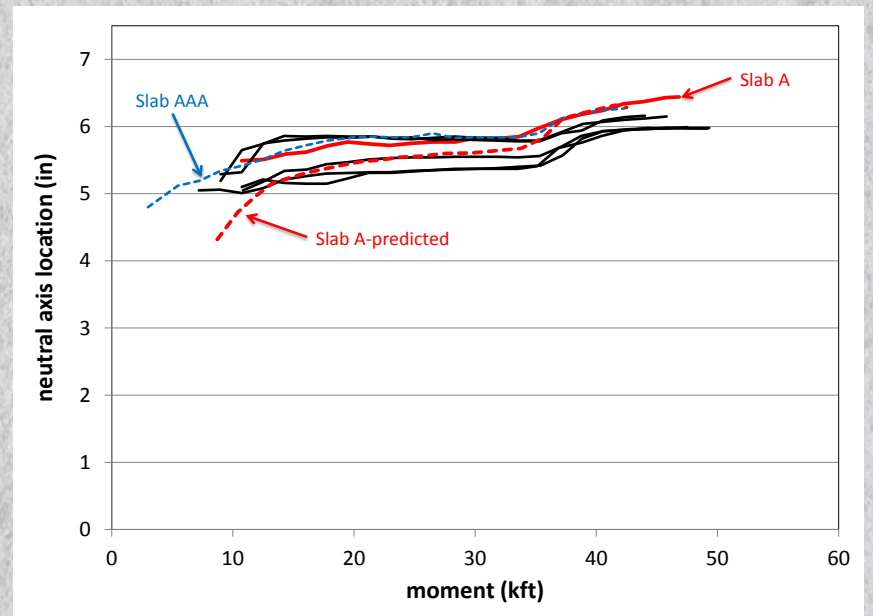
Comparison of Tests

Presence of LMC overlay had little effect on cracking, stiffness, yield, ultimate capacity, or overall flexural behaviour.

The LMC-repaired slabs acted as monolithic slabs in all cases and the capacity was uniform regardless of LMC depth.

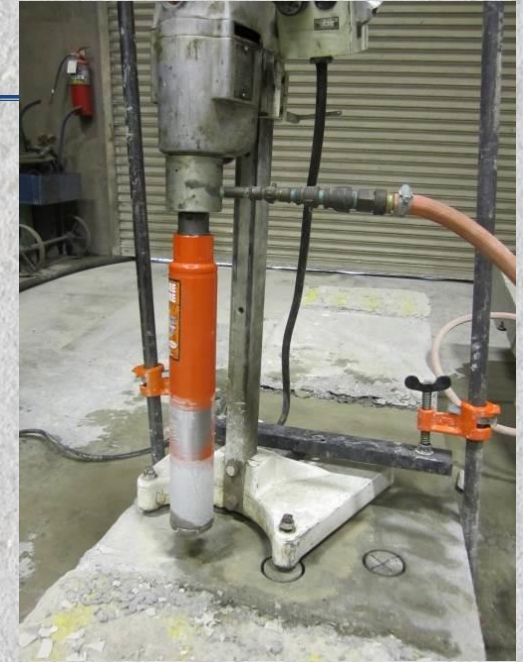
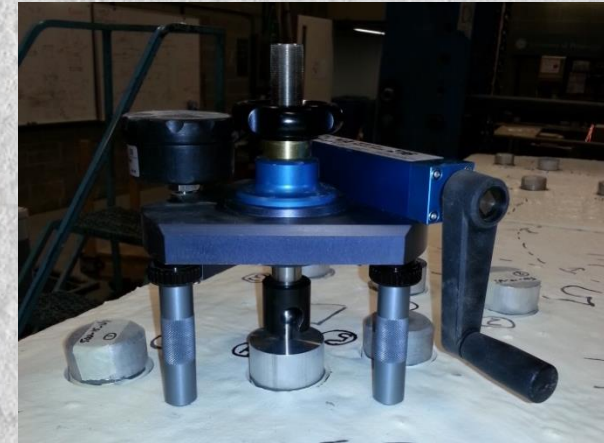
Pull-off Tests (ASTM C1583)

Investigate integrity of interface bond

92 – 2 in. cores and pull-off tests

LMC

substrate

tension failure in substrate

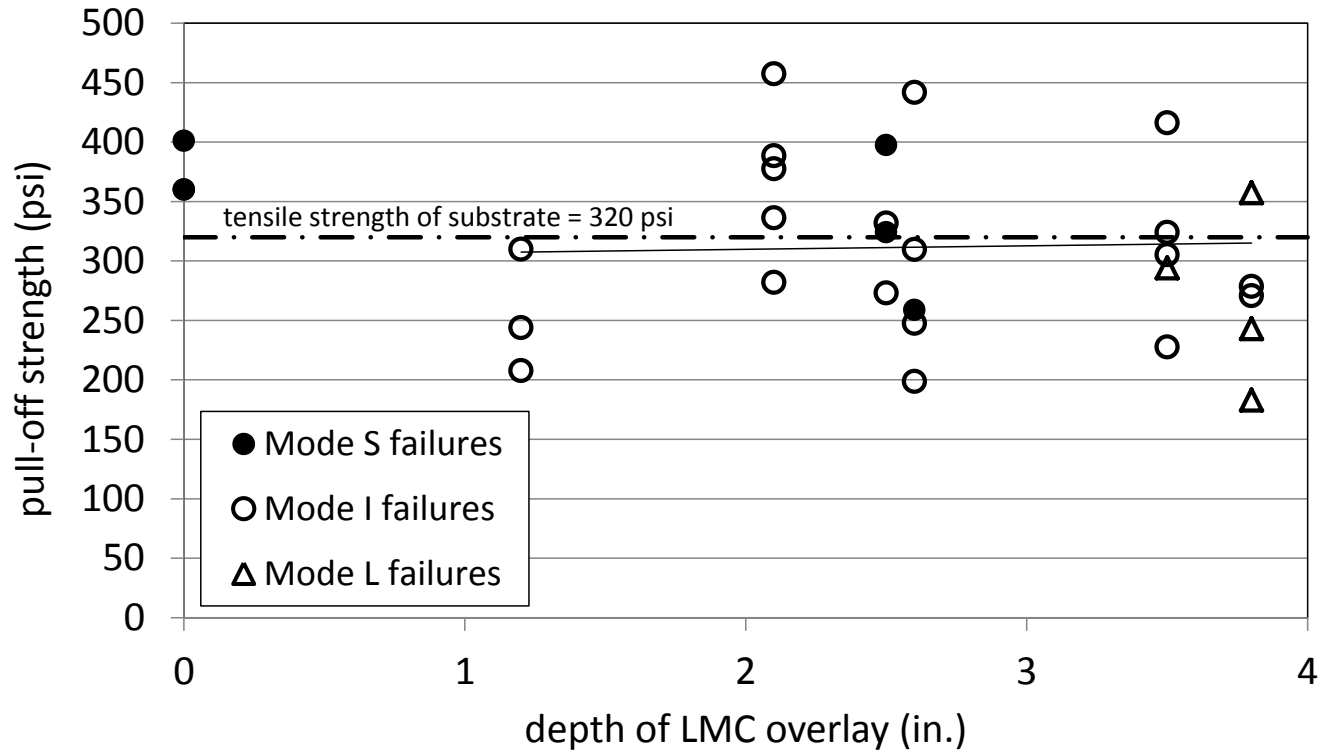
concrete age
> 132 days

LMC age
> 52 days

Assumed concrete tensile capacity = $4\sqrt{f'_c} = 320$ psi

Observed concrete tensile capacity = $4.6\sqrt{f'_c} = 373$ psi

All interface capacities exceeded 200 psi

Direct tension pull-off tests all exceeded 200 psi.

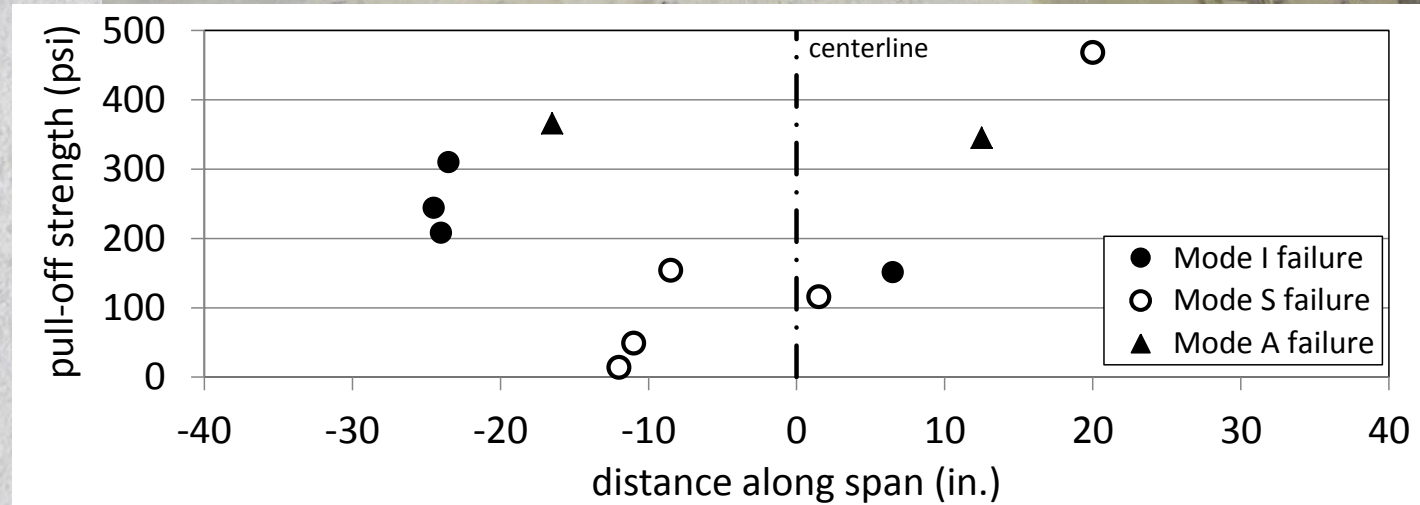
Post failure tests of overlay (Slab B; HD depth = 1.2 in.)
