# Evaluation of Bridge Cleaning Methods on Steel Structures

PennDOT Project PITT002

## Project Scope

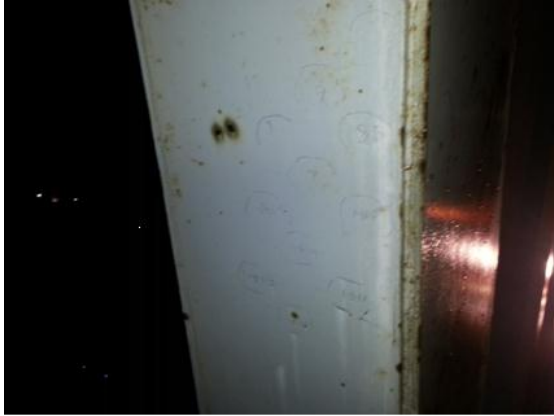
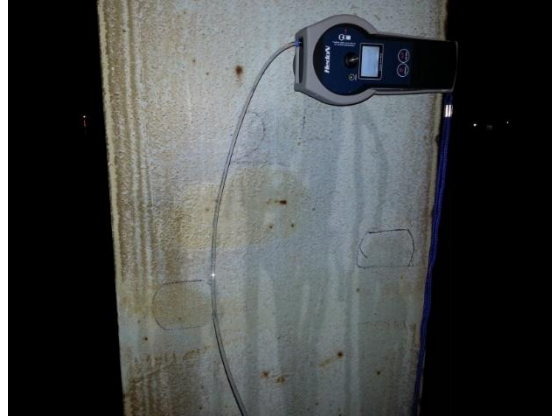
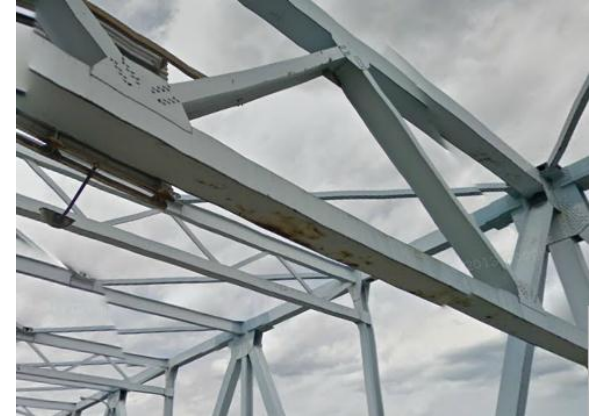
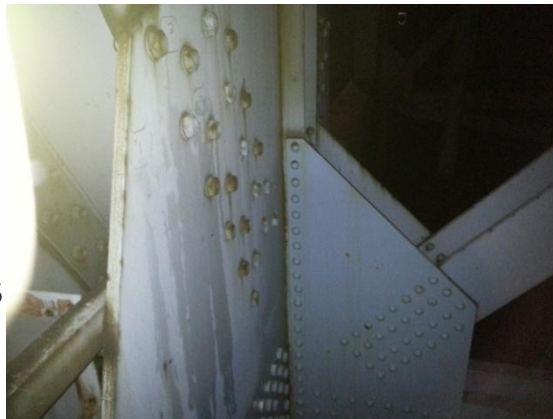
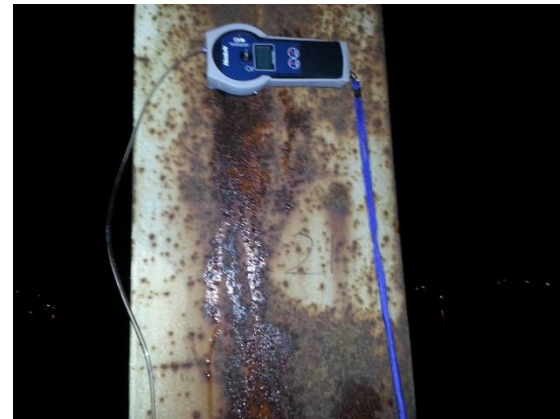
# Testing Locations

Location 1

Location 2

Location 3

Location 4

Location 5

Vanport Bridge Pre-Wash Surface Salt Concentrations		
Location	Mean SSC (mg/m <sup>2</sup> )	Statistically Similar Location
3	31	5
5	27	2,3
2	21	5,4
4	14	2,1
1	13	4

Post-wash surface salt concentrations were significantly lower everywhere besides locations 4 and 5.

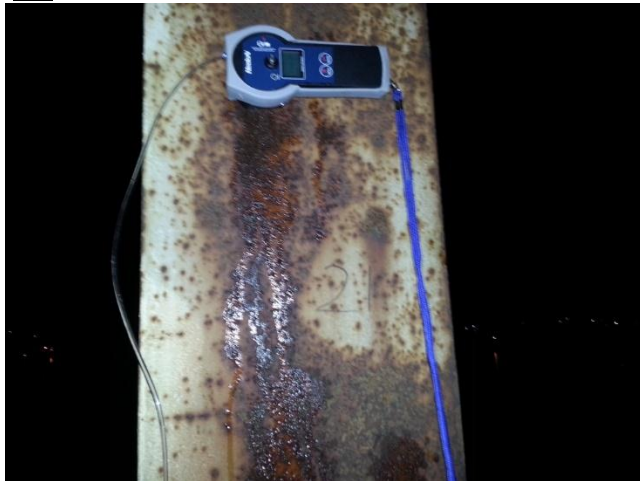
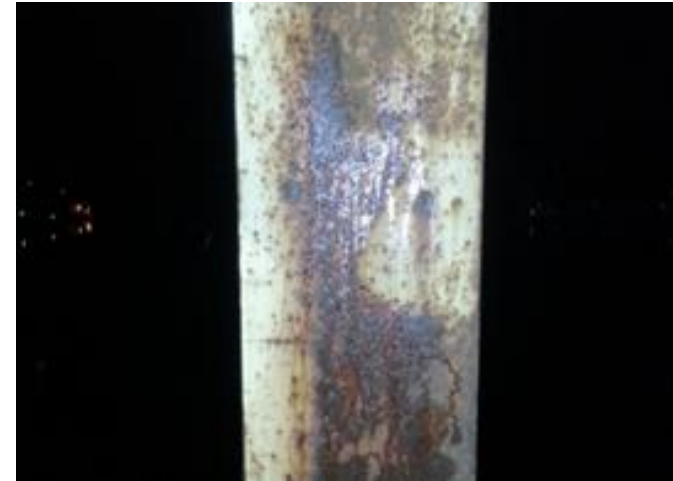
# Location 5

Before

After

Location 5 Readings (mg/m <sup>2</sup> )	
Before	After
30	37
24	278
28	44
	328

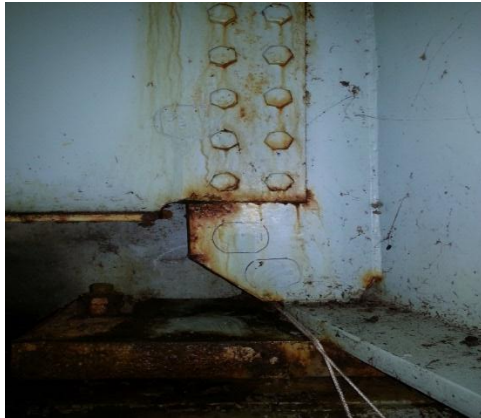
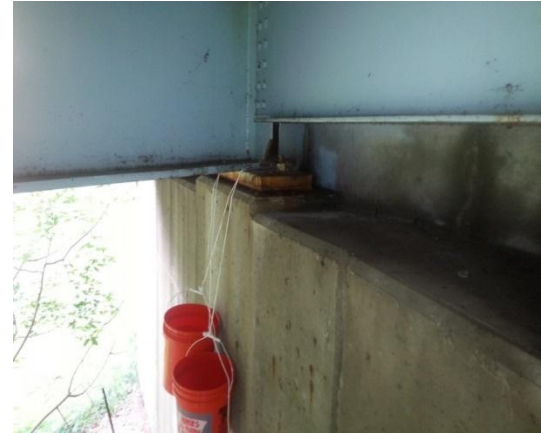
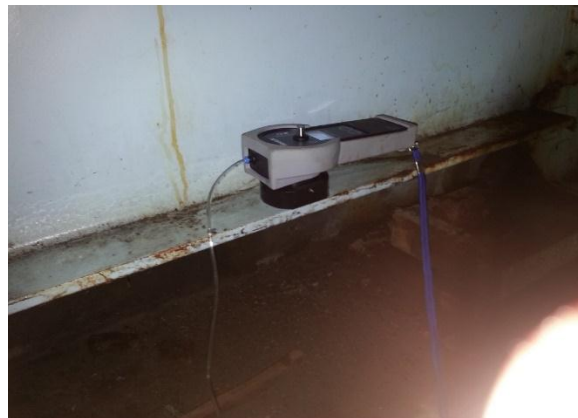
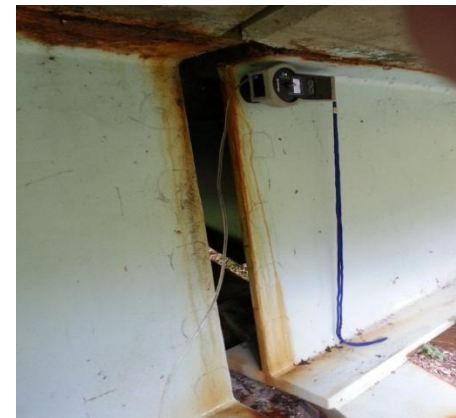
# Testing Locations

Location 1

Location 2

Location 3

Locations 4&5

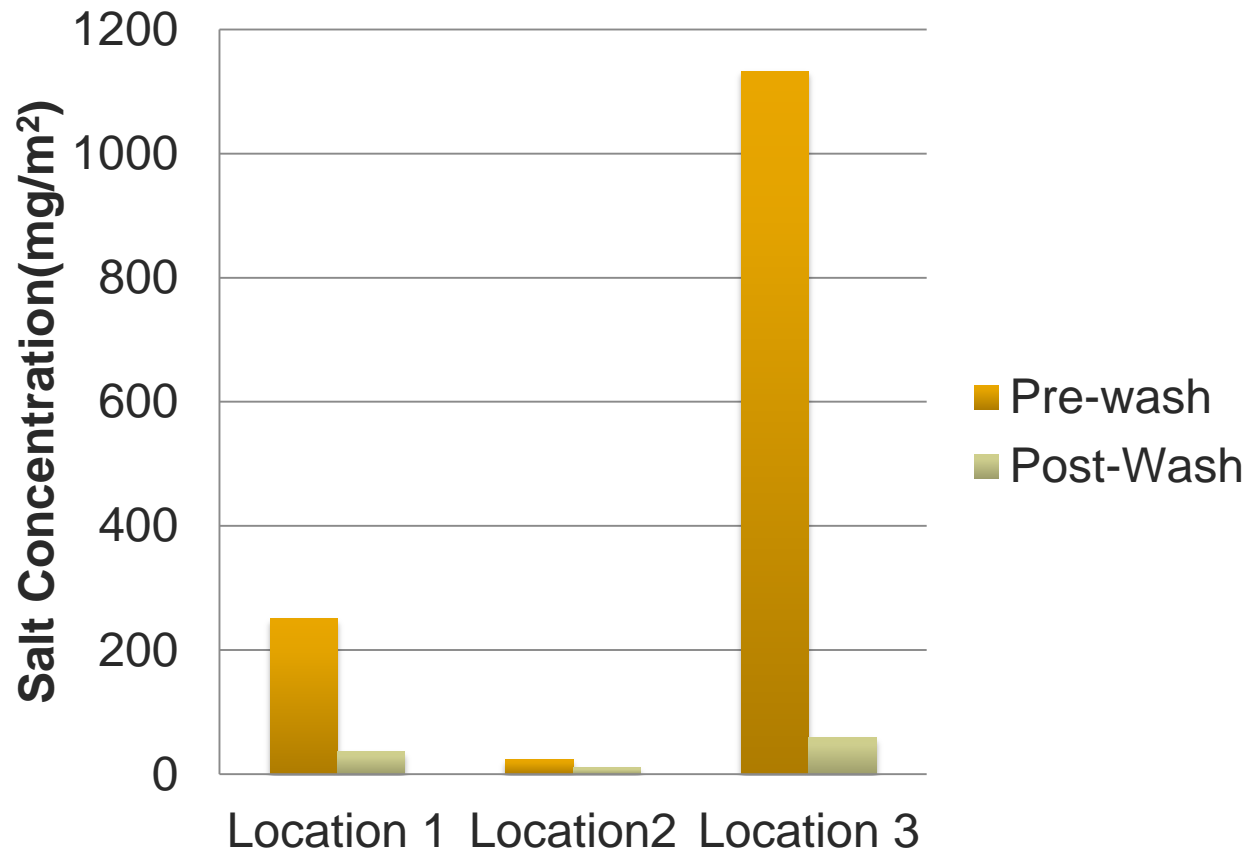
# Results Locations 1, 2 & 3

## Hassam Road Salt Concentrations

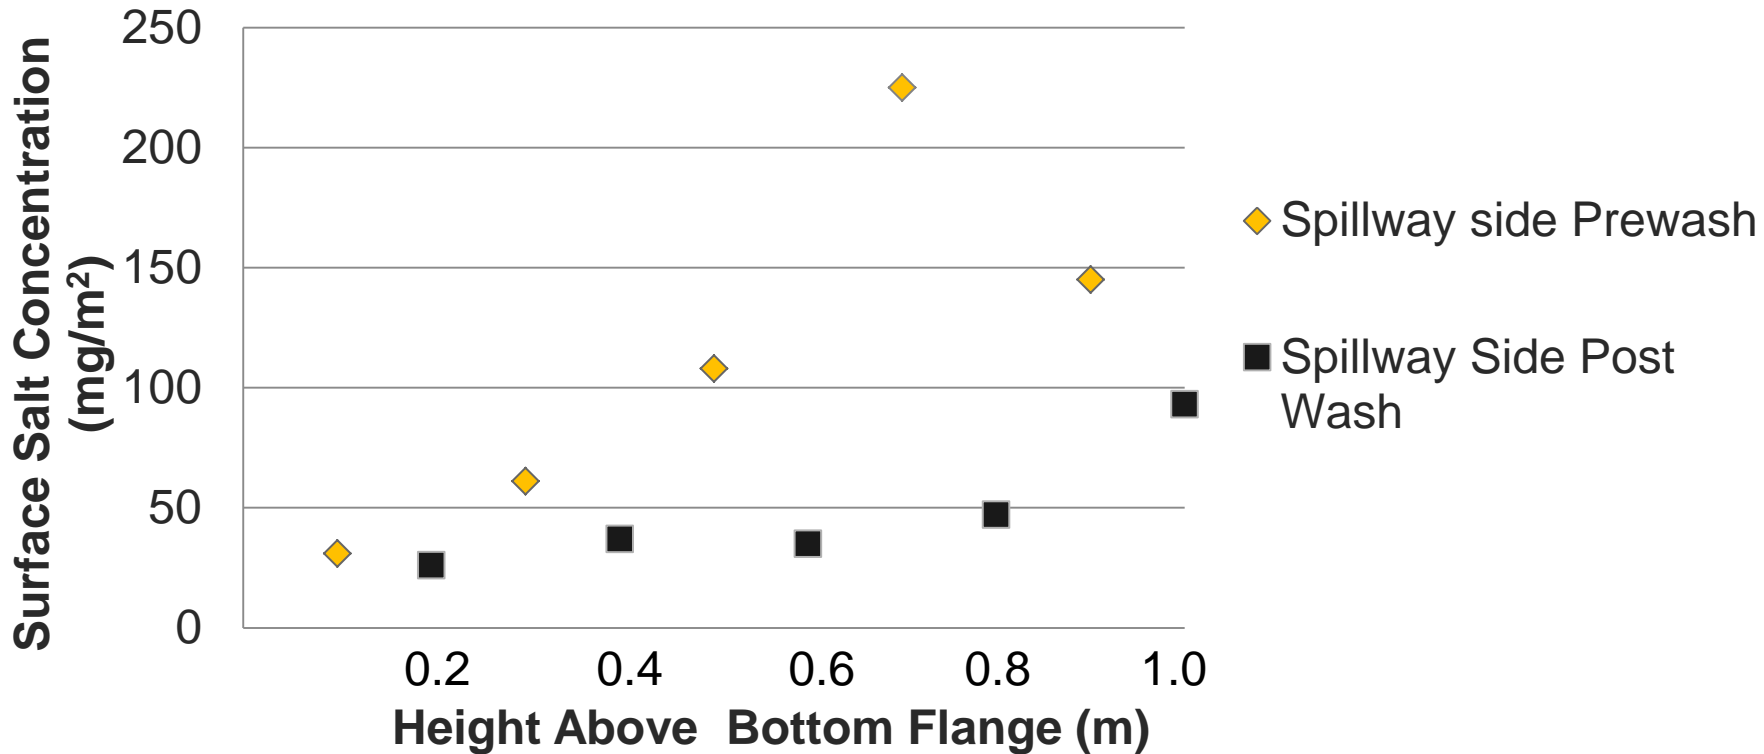
# Locations 4 & 5 (Cont.)

## Surface Salt Concentration On Spillway Side

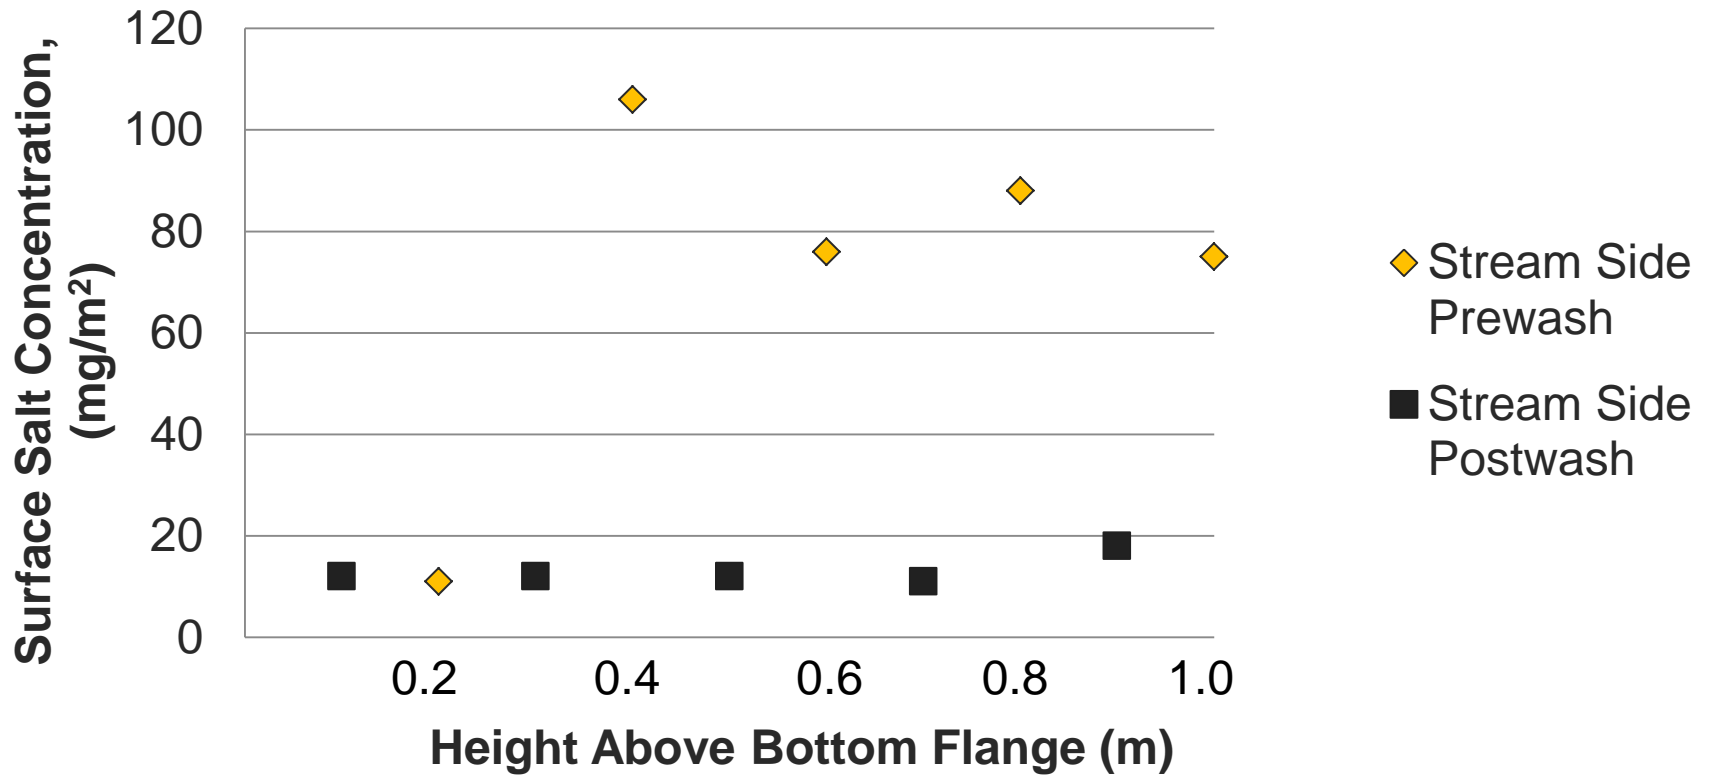
# Locations 4 & 5 (Cont.)

## Surface Salt Concentration Stream Side

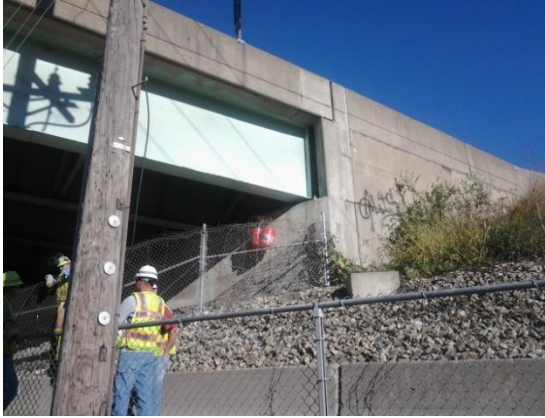
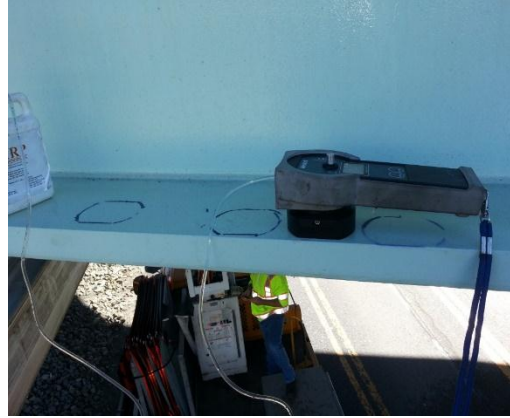
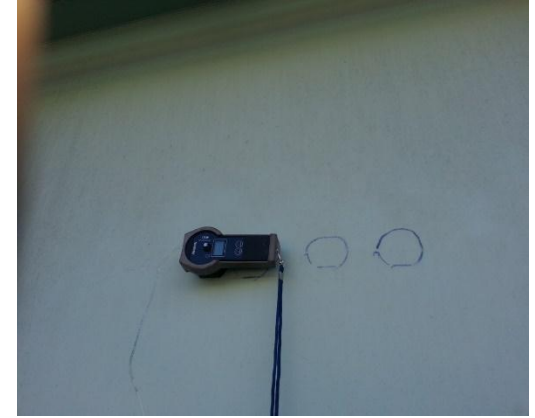
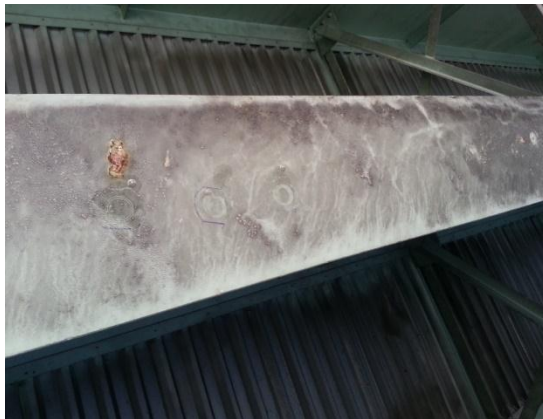
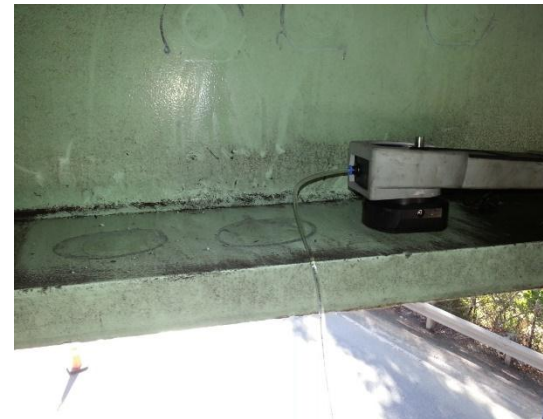
# Testing Locations (Cont.)

Location 1

Location 2

Location 3

Location 4

Location 5 and 6

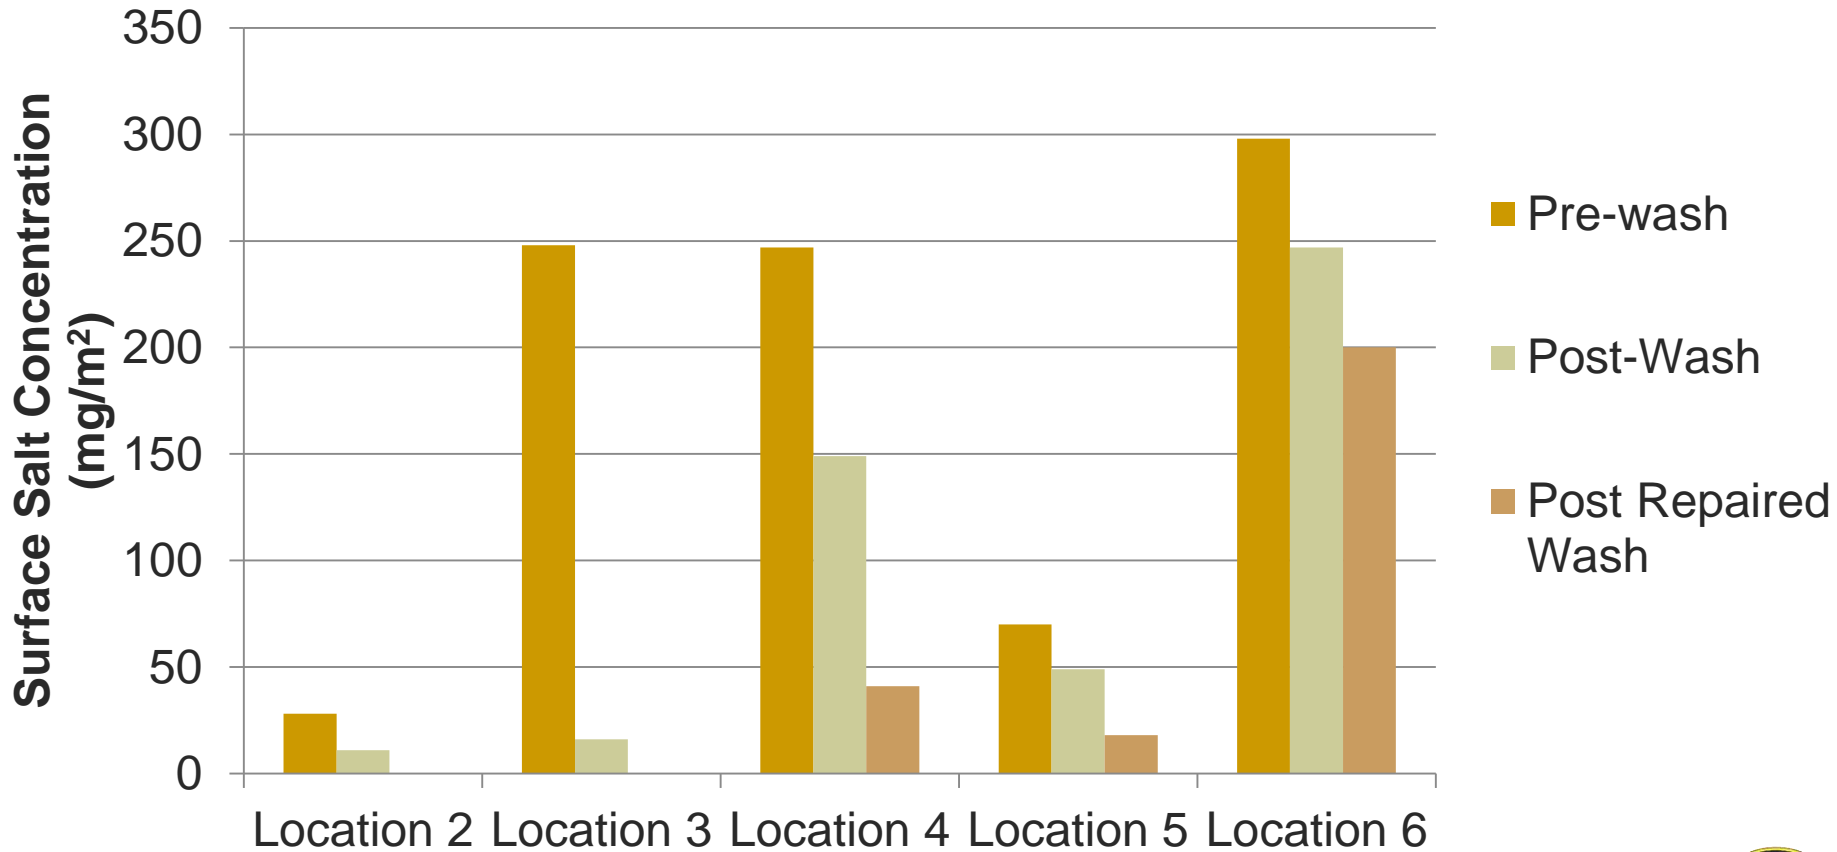
# Location 2-6

## 179 Salt Concentrations

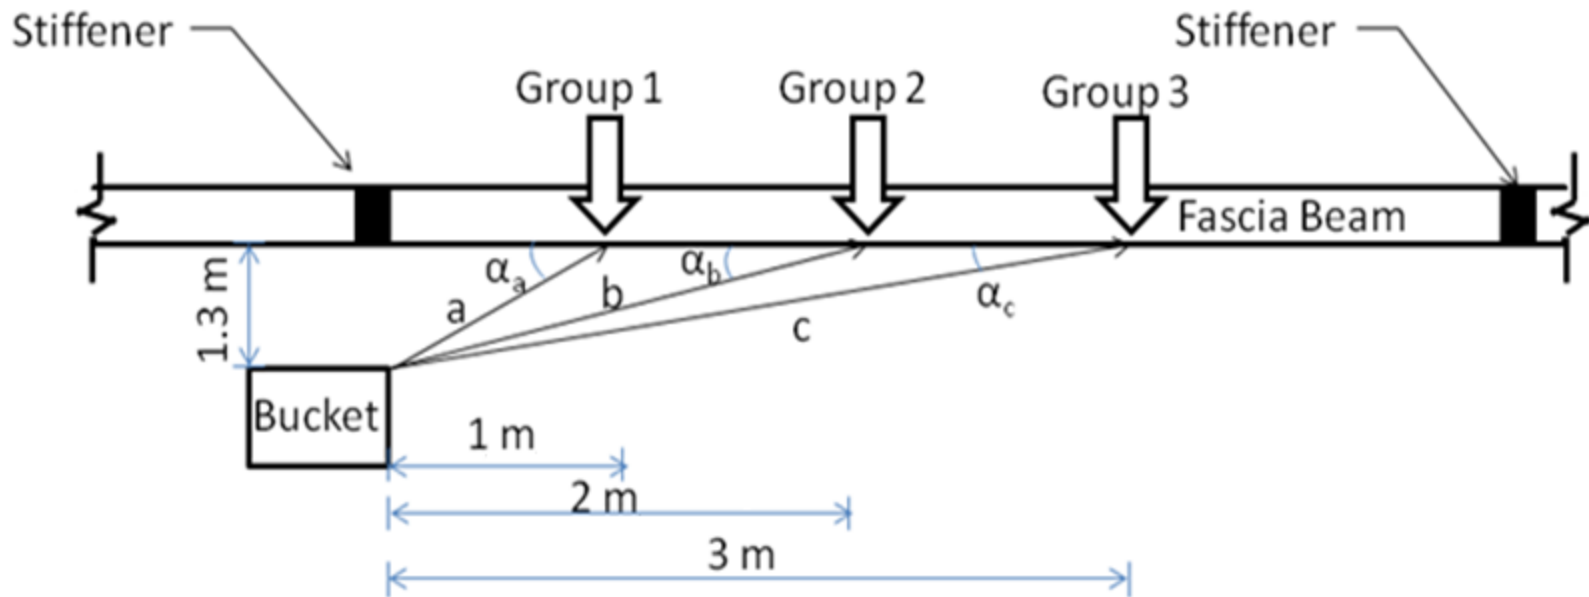
# Experiment A

a: 1.7 Meters

$\alpha_a=53.5$  Degrees

b: 2.4 Meters

$\alpha_b=34$  Degrees

c: 3.3 Meters

$\alpha_c=24$  Degrees

- Evaluate the effect of horizontal washing distance and stream angle on washing efficiency.
- Evaluate the effect of vertical distance below the target area on wash efficiency.

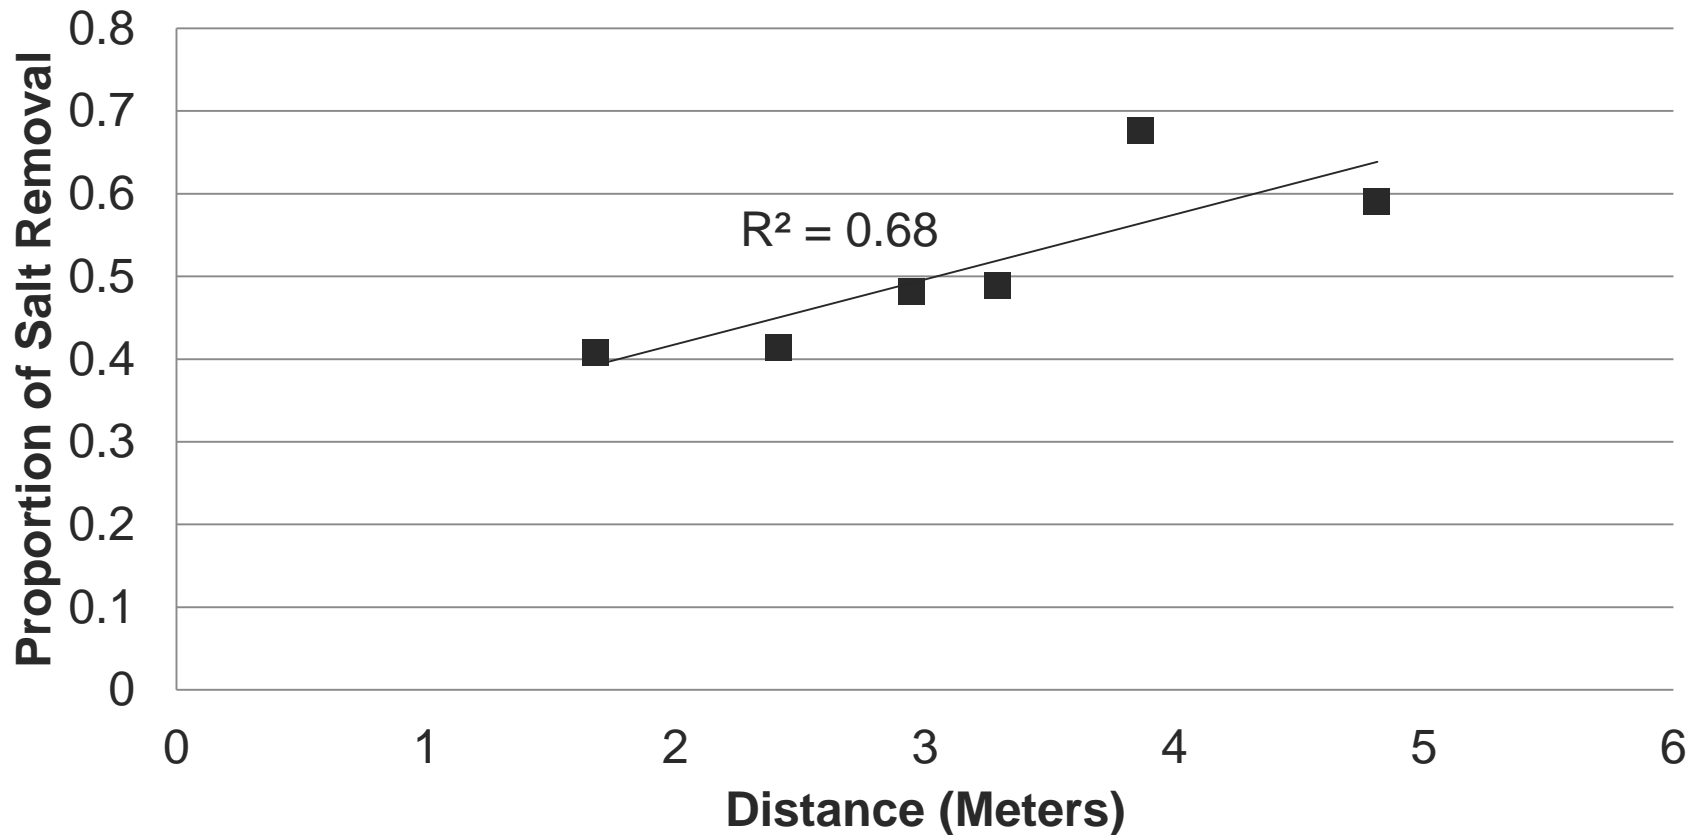
# Experiment A (Cont.)

Salt Removal vs. Distance

- Supplementing current procedure with chemicals is not necessary for most locations.
- A pressure gage should be installed to ensure wash stream is within specifications.
- Washing appears to be most effective when the upward vertical distance is limited.

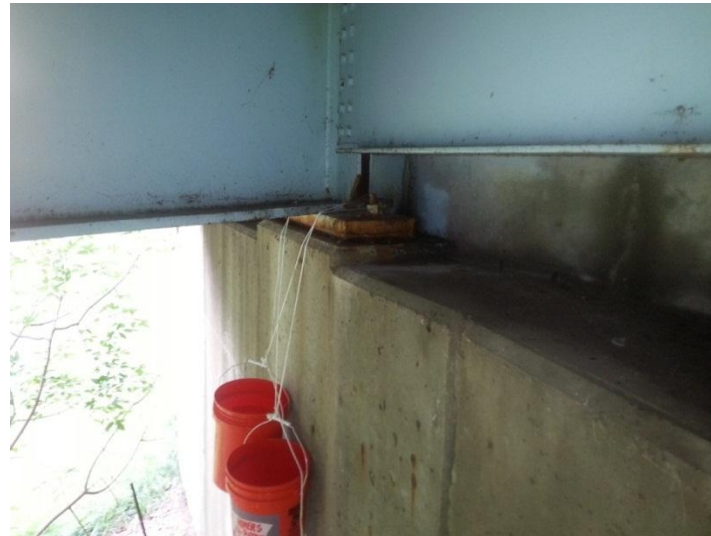
# Water Quality Testing

- Insignificant amount of hazardous materials was measured in the runoff water
