University of Pittsburgh

pennsylvania
DEPARTMENT OF TRANSPORTATION

Bridge Waterproofing Details

Presenters: Qiang Yu, Renwick L. D'Souza

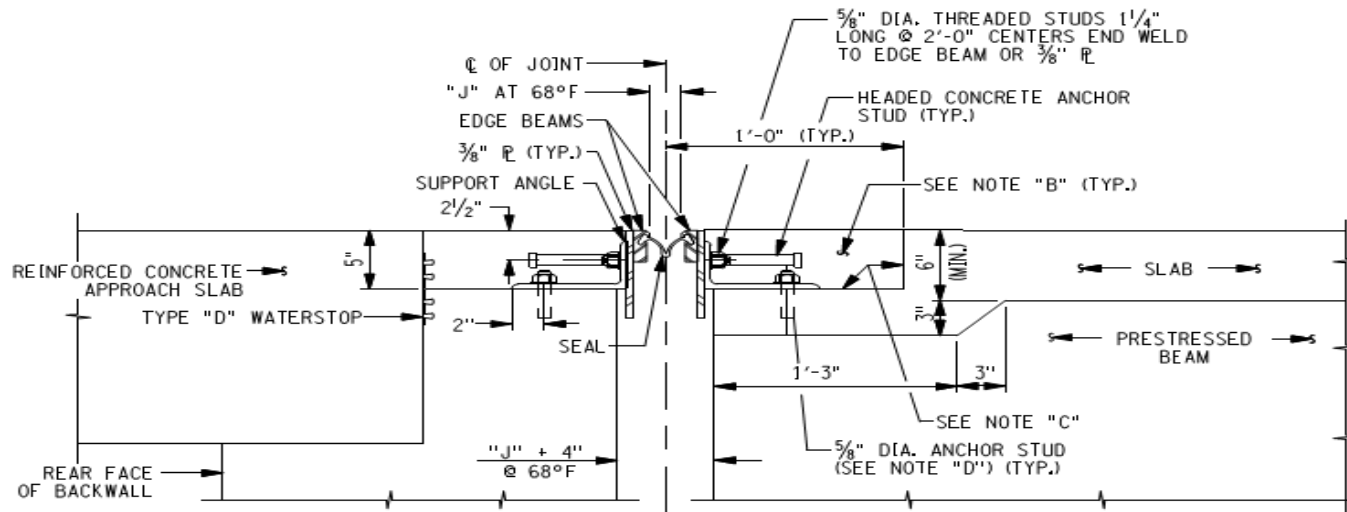
Strip Seal Joint - NYSDOT

- No armor on block-out
- Fabricator to provide opening size and strip seal design
- Span of deck restricted based on skew angle

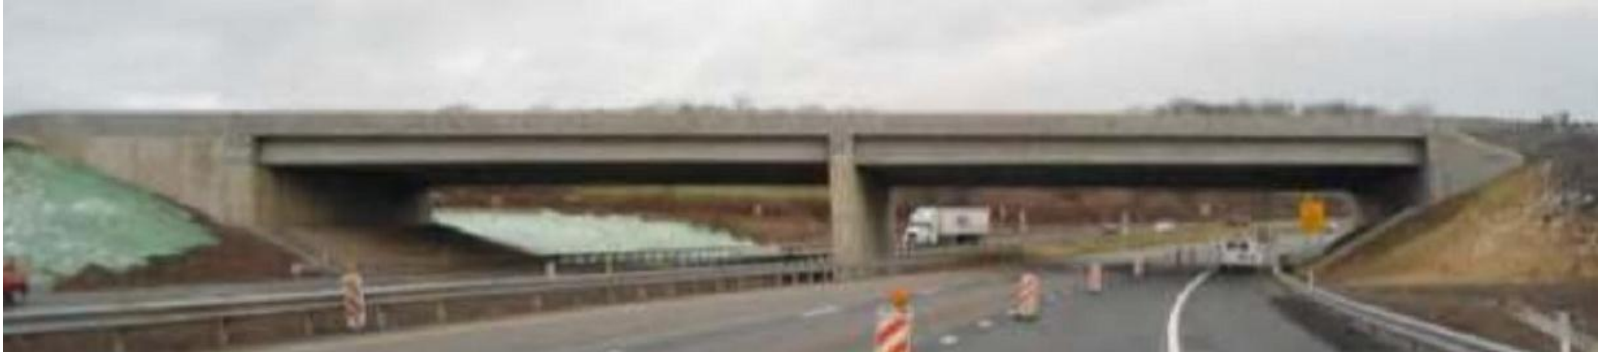
Little Creek Road Bridge

- Built 2010
- Skew angle: 70°
- Deck: 2 spans – 105 ft. & 120 ft.
- Compression seal: 0.5 in. movement

- Cracking & Erosion of joint edges
- Damage of silicone sealant at surface
- Leakage at construction joint at beam – deck interface

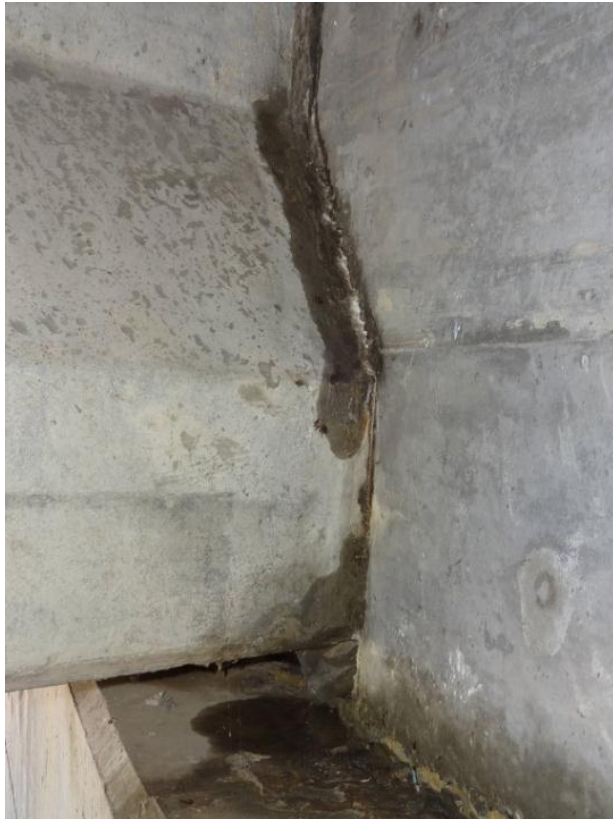
Little Creek Road Bridge

- Vegetation in joints
- Water seeping through joints
- Main cause of leakage – Expansion joint
- Leakage due to abutment possible as well

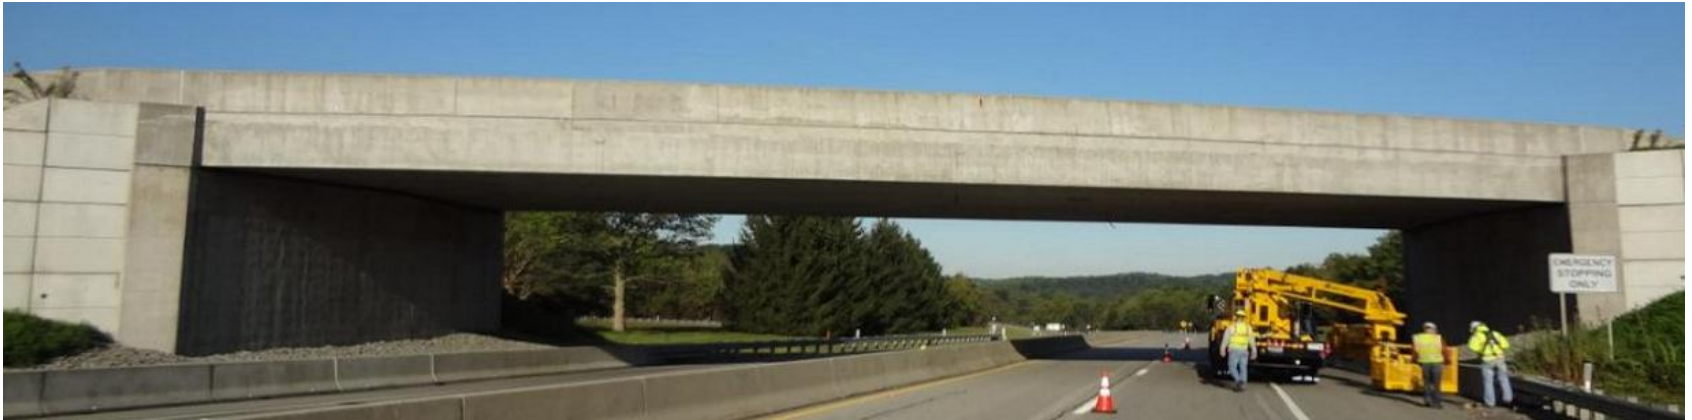
Prospect #1 Bridge

- Built 2009
- Skew angle: 70°
- Deck span: 104 ft.
- Compression seal: 1 in. movement (different from Little Creek Bridge)

- Debris accumulation on compression seal joint –
Due to recent road maintenance work –
Hinders drainage of water on deck
- Water staining on abutment – more severe near edges

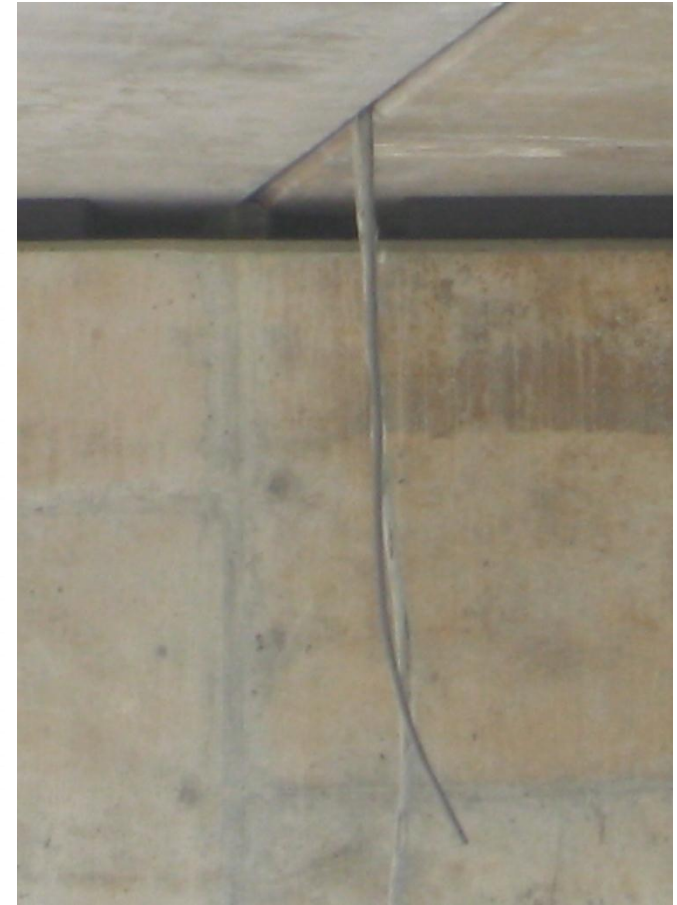
Prospect #1 Bridge

- Main cause:
 - Failure of concrete block-out – evident through leakage on edges
 - Leakage through box girder – both from expansion joint and backfill
- Debris accumulation exacerbates leakage issue
- Possible leakage of water through backwall
 - from sloped backfill – evident through weep hole leakage

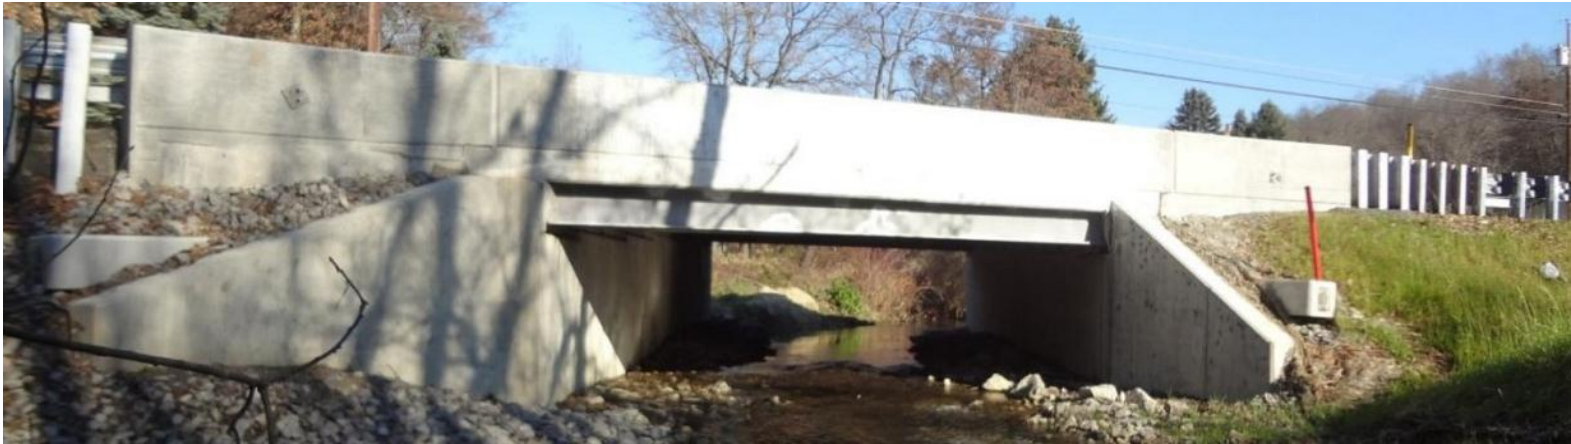
SW of Boydstown Bridge

- Built 2012 – Rehab
- Skew angle: 60°
- Deck span: 25 ft.
- Compression Seal: 0.5 in. movement

- Initial signs of deterioration of silicone sealant in joint observed
- Leakage observed in old-new concrete interface on abutment
- Leakage at construction joint on abutment
- Deck slope insufficient to drain silt
- Silt found in weep holes

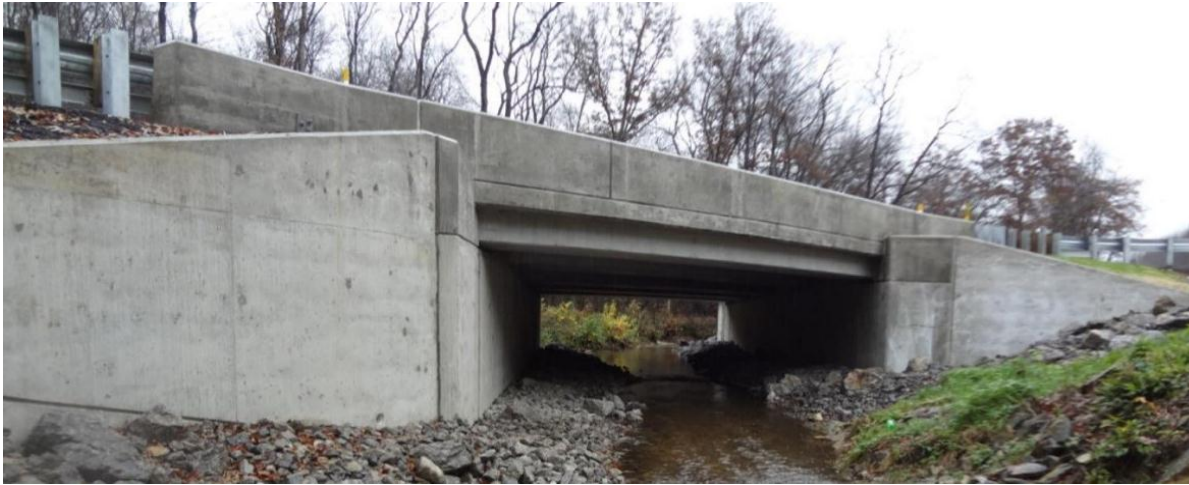
Little Connoquenessing Bridge

- Built 2012
- Skew angle: 45°
- Deck Span: 34 ft.
- Compression Seal: 0.5 in. movement

- Bridge still new; However showing initial signs of edge chipping
- Water staining on abutment stem more so on the east side

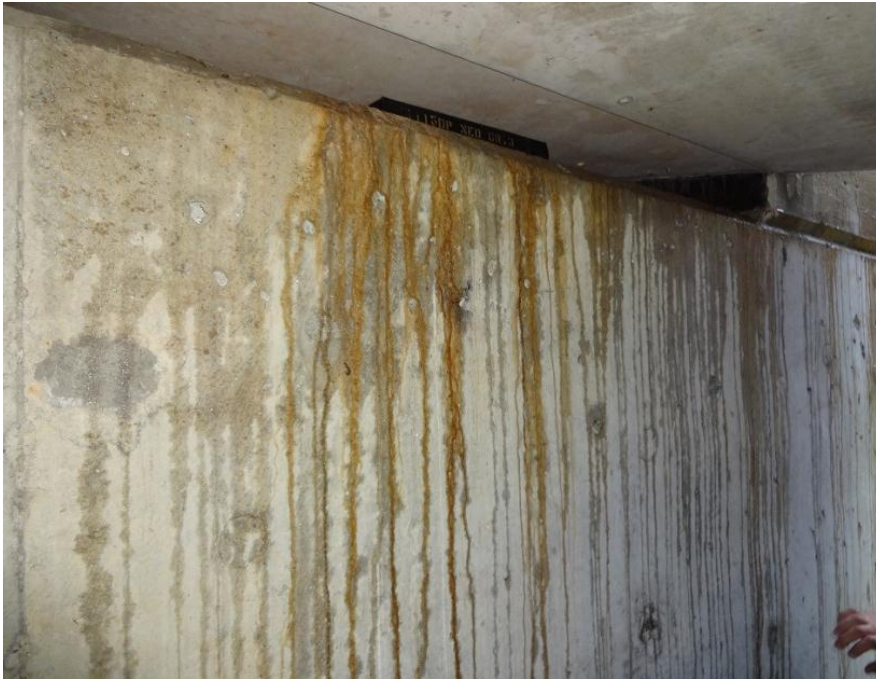
Little Connoquenessing Bridge

- Main Cause: Backfill through abutment seat
- Possible role of surrounding terrain
- Possible waterstop failure

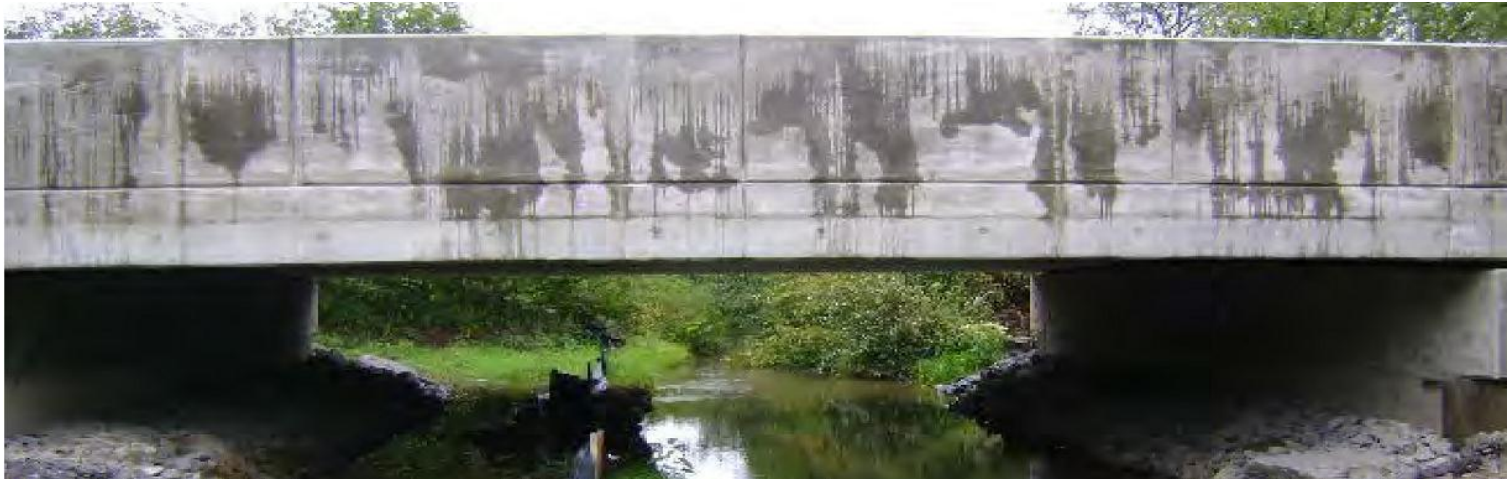
Beechton Bridge

- Built 2011 – Rehab
- Skew angle: 90°
- Deck Span: 31 ft.
- Rubberized joint sealing material

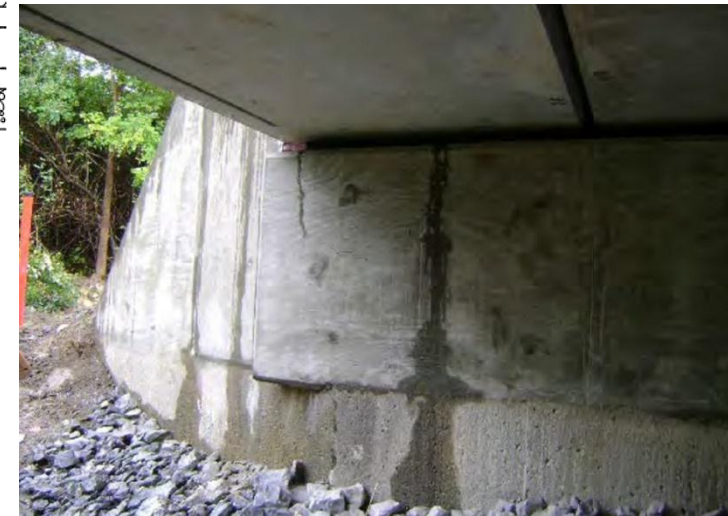
Beechton Bridge

- Severe leakage at old-new concrete interface on abutment
- Leakage at cracks propagating from the interface

- Main cause: Backfill through old-new concrete interface
- Waterproofing membrane bent – mostly failed
- Crack in new concrete due to differential shrinkage
- Only drainage at old-new concrete interface – not at bearing (explain observation of leakage at bearing seat)

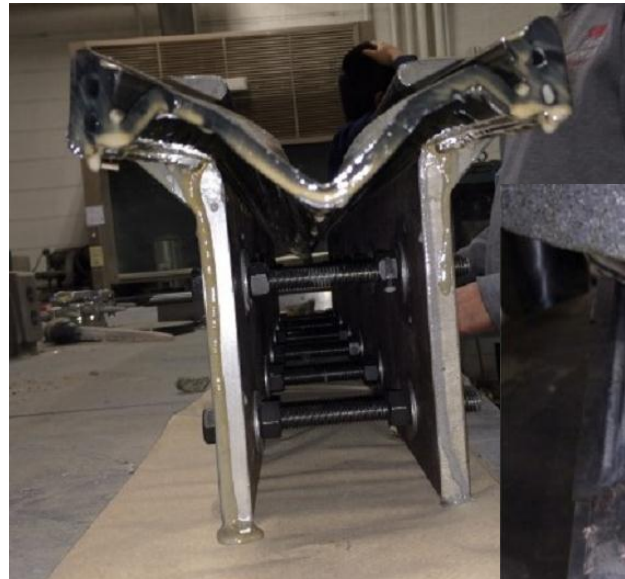
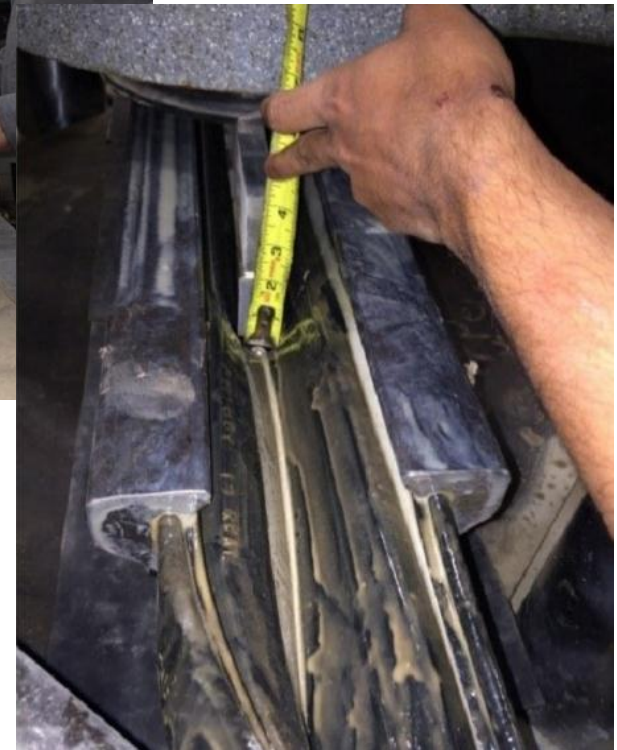
Seal Push out test of Strip seal

- Sample from PennDOT approved manufacturer
- 3 ft. specimen; Spacing of 3 in. at top of the specimen
- Reaches around 4 in. of deflection and 2700 lb. of loading (1600 lb. reqd.)
- Great ductility and thus great tolerance to debris compared to compression seal

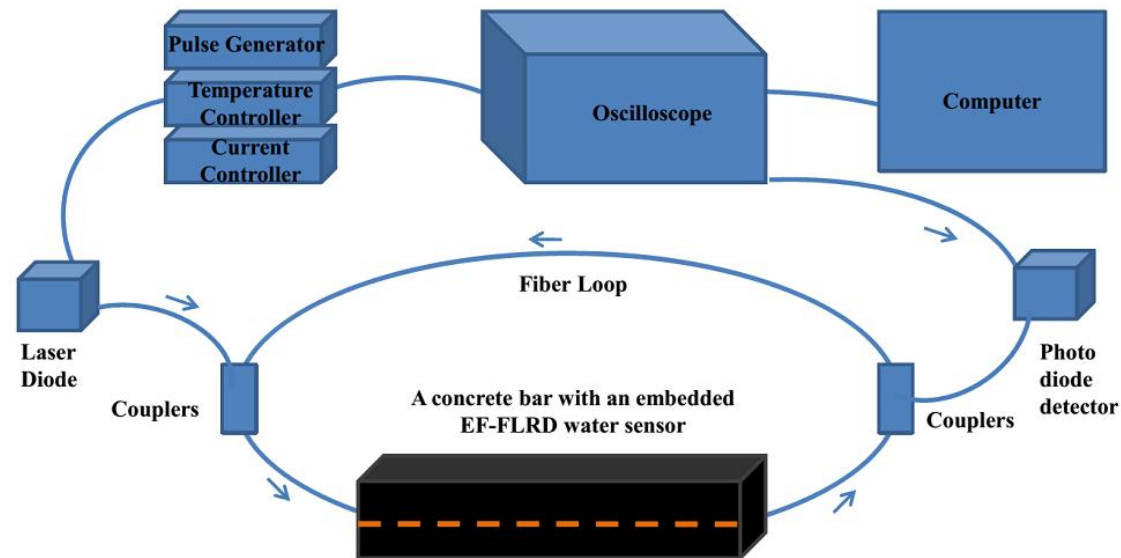
Evanescent Field Fiber Loop Ringdown (EF-FLRD)

- Change in water content will affect optical refractive index of fiber loop
- Reusable and thus can be used for monitoring – needs timely attention in collection of data
