International Journal of Pavement Engineering

Quantifying built-in construction gradients and early-age slab deformation caused by environmental loads in a jointed plain concrete pavement

Steven A. Wells^a; Brian M. Phillips^a; Julie M. Vandenbossche^a

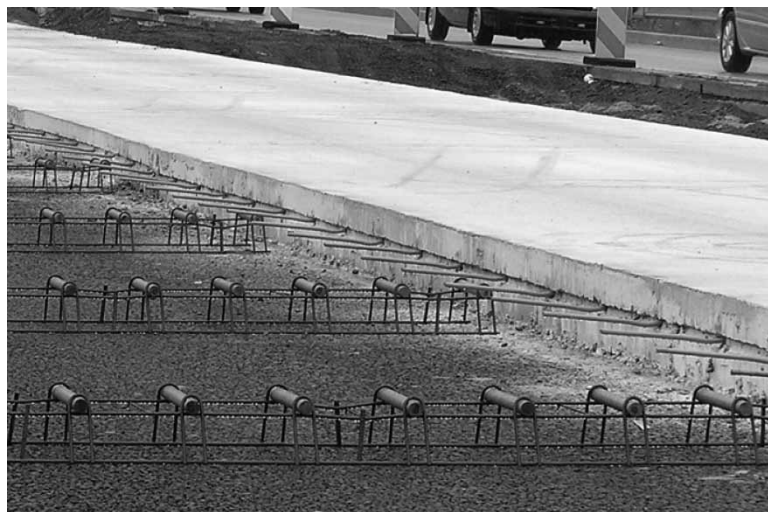
Figure 2. Dowel and tie bar configuration on SR-22.

The new JPCP is a four-lane divided highway with 4.6 m (15 ft) transverse joints, 3.7 m (12 ft) lanes, and 0.8 m (2.6 ft) wide concrete curb-and-gutter shoulders. The pavement contained 3.8 cm (1.5 in.) diameter dowels along the transverse joints and 1.6 cm (0.625 in.) diameter tie bars spaced 3 ft on center along the centerline joint, as shown in figure 2.

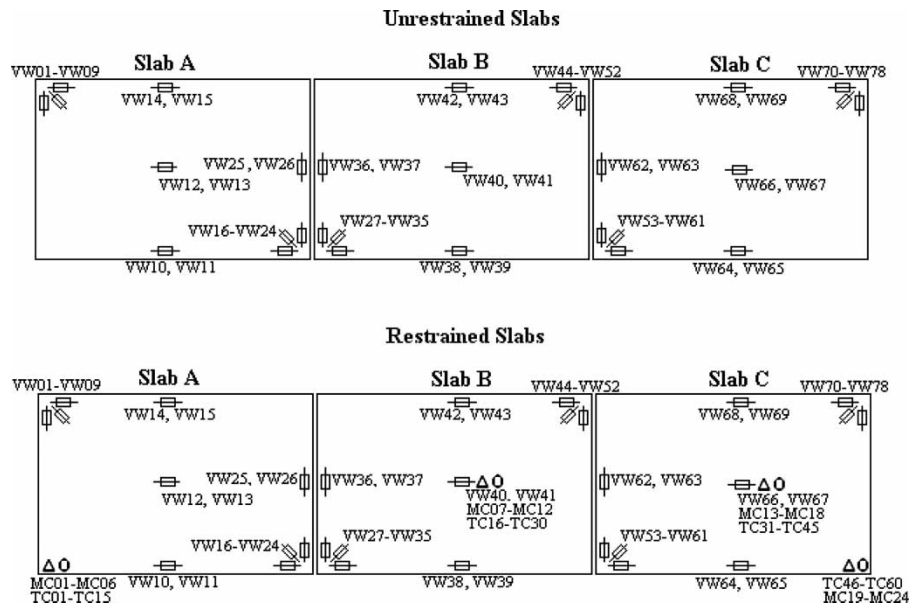
Figure 4. Instrumentation layout of test section.

Figures 4 and 5 show the instrumentation layout for both the restrained and unrestrained slabs. The instrumented slabs contained Geokon 4200 vibrating wire static strain gages. In order to directly compare strain response

in restrained versus unrestrained slabs, the layout of the gages was replicated for both sets of slabs, as shown in figure 4. The slabs were also instrumented with temperature and moisture sensors. Type T thermocouples were installed at various depths throughout the concrete and throughout the pavement structure to accurately quantify thermal gradients. The thermocouples were installed in the restrained slabs at midpanel and at the corner of the slab in two replicate locations. Sensirion SHT75 relative humidity and temperature sensors were also installed throughout the restrained slabs at midpanel and at the corner of the slab in two replicate locations. Procedures developed at the University of Illinois at Urbana-Champaign for the use of these sensors in concrete applications were followed (Grasley *et al.* 2003). Wind speed, temperature and relative humidity were measured in the field using an on-site weather.

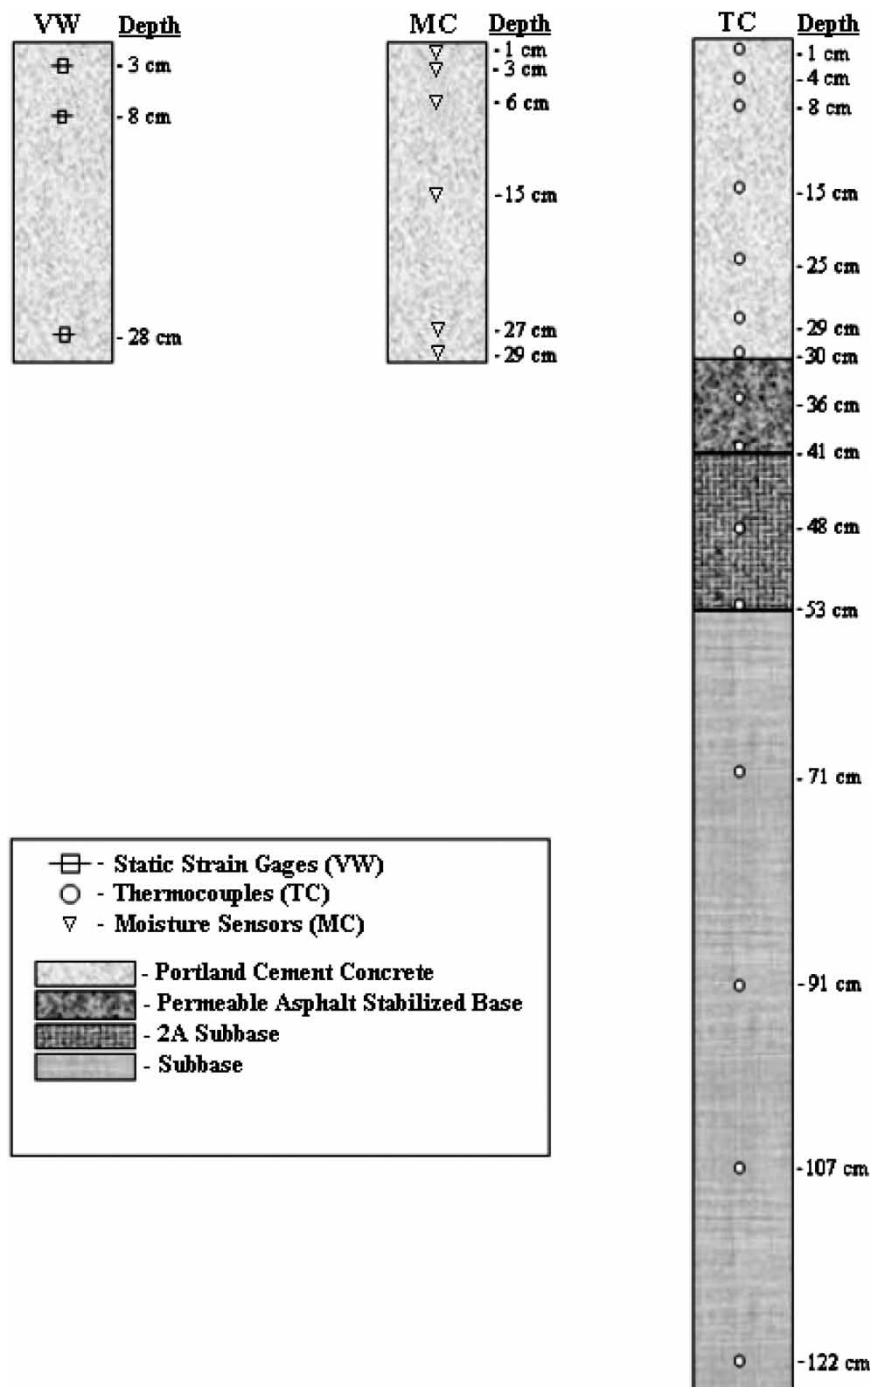
Figure 5. Instrumentation depths throughout pavement structure.

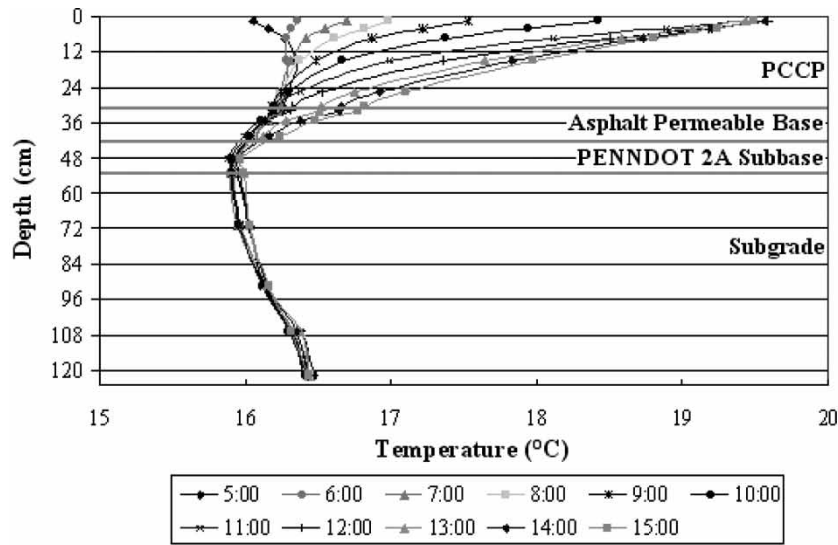
Figure 10. Temperature gradient in the slab during a 10h period on October 31, 2005.

Figure 10 shows more clearly the difference between gradients at midpanel and at the edge. It is apparent that the midpanel is subject to more dramatic temperature swings during the day. These larger swings result in the development of larger gradients at the midpanel. As shown in figure 10, even adding on the curb and cutter does not completely negate the effect between the temperatures at the edge of the slab and at midpanel.

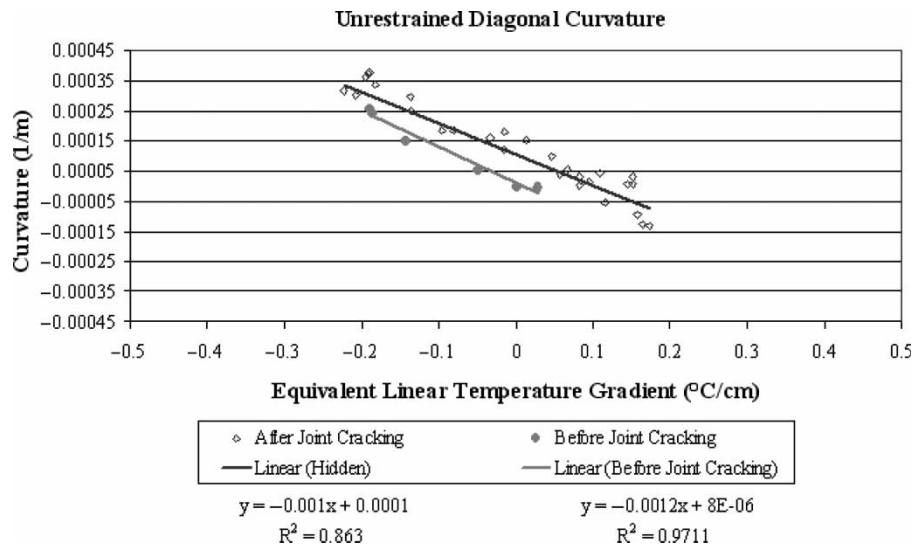
Figure 17. Illustration of the relationship between equivalent linear temperature gradient and curvature before and after joint cracking for the diagonal profiles of the unrestrained cell.

The response of the slab to temperature gradients before and after the joints crack is quite different, as would be expected since the effective slab length is substantially longer. Figure 17 shows the curvature calculated for profiles measured before and after the joints cracked for slab A (figure 4) in the unrestrained cell. The curvature calculated before the joints cracked (shown as solid circles) are well below the best-fit line of all of the data points. In all cases except when the equivalent linear gradient is quite high, curvature calculated before cracking will be less than curvature calculated after cracking by a factor of two.

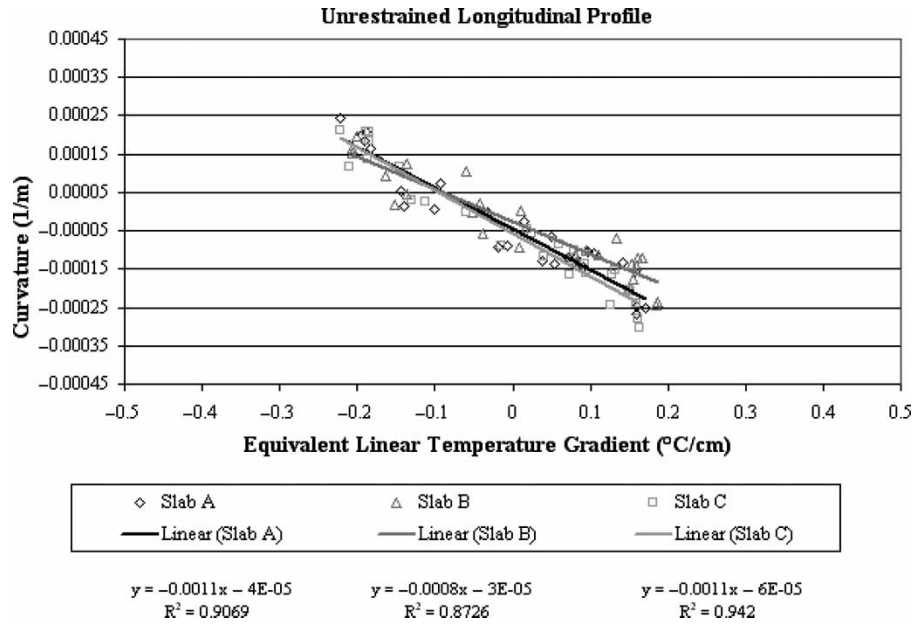
Figure 20. Equivalent linear temperature gradient versus curvature for longitudinal profiles at unrestrained slabs.

Figures 18–23 illustrate the relationship between curvature and equivalent linear temperature gradient. The curvatures for the diagonal profiles measured for the unrestrained and restrained slabs are provided in figures 18 and 19, respectively. Curvatures calculated for the transverse and longitudinal profiles are summarized in figures 20–23, respectively. Only the curvatures calculated for the profiles measured after the slab cracked were used to generate the plots.
