**Bonded Whitetopping Overlay Design Considerations with Regard to the
Prevention of Reflection Cracking, Joint Sealing and the use of Dowel Bars**

A Paper Accepted by the Transportation Research Board for Publication

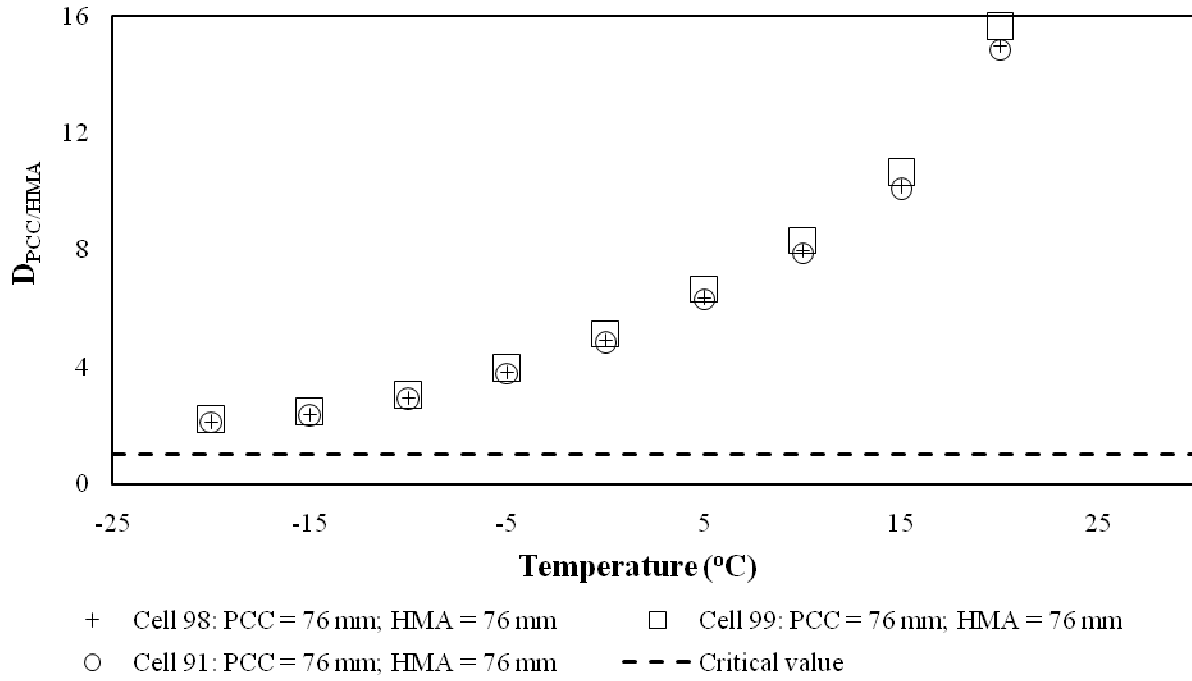
FIGURE 5 Relative stiffness of PCC and HMA layer for US-169 test sections.

To further evaluate the previously established critical flexural stiffness ratio of 1, the relative stiffness of the PCC and HMA layer, $D_{PCC/HMA}$ for the US-169 test sections was determined. The stiffness of the HMA was conservatively assumed to be the same as that measured at Mn/ROAD even though it was of poorer quality and hence would have a lower stiffness. The flexural stiffness ratio was found to be greater than 1 for the range of possible HMA temperatures that could develop at the project site (Figure 5). This supports the fact that no reflection cracks should have developed. A summary of the $D_{PCC/HMA}$ determined for each of

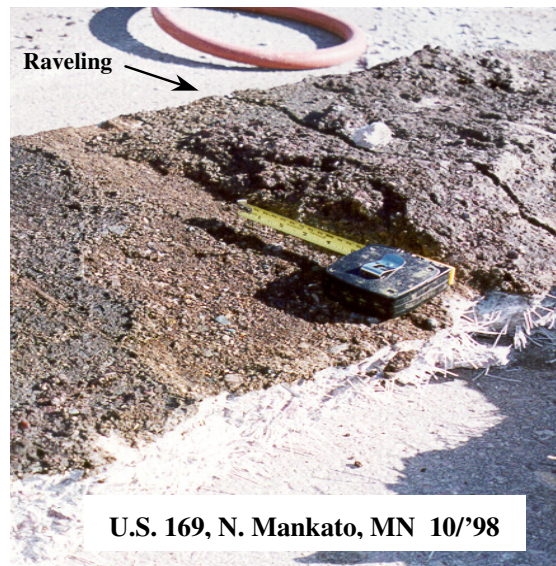
FIGURE 6 Three different modes of debonding between the HMA and concrete overlay.

These thin bonded overlays rely on the underlying HMA to carry a portion of the load. The strain measurements made at these test sections just discussed emphasize the importance of the support provided by the HMA layer (6). A reduction in this support can occur when the temperature of the HMA is increased or when the HMA begins to ravel. The results from the strain measurements and the cores pulled from the test sections indicate the HMA raveling at a faster rate along the joints where there is greater access for water to enter the pavement structure. The lane shoulder joint is the most difficult to keep sealed and therefore the HMA along this joint was found to be more susceptible to stripping/raveling. Figure 6 shows raveling of the HMA layer supporting the bonded whitetopping. It is essential that water be kept out of the pavement structure to maintain the bond strength at the overlay/HMA interface and to prevent the loss of the structural support provided by the HMA due to stripping/raveling.

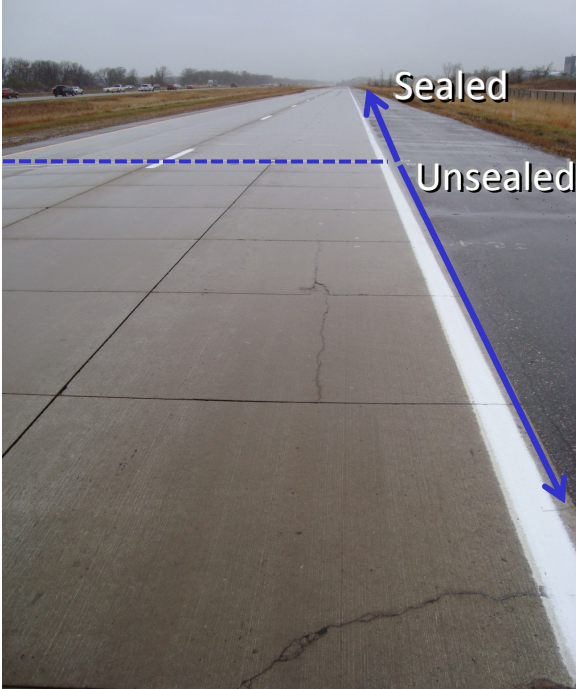
FIGURE 7 Companion test sections with sealed and unsealed joints.

To further evaluate the effects of sealing on the performance of the bonded whitetopping, companion test sections were constructed for a 102-mm (4-in) overlay with 1.5-m x 1.8-m (5-ft x 6-ft) panels and a 127-mm (5-in) overlay with 1.5-m x 1.8-m (5-ft x 6-ft) panels with one section sealed and one section unsealed. Both transverse cracking and corner cracking can be the result of, or exacerbated by, water entering into the joints. This is because these distresses initiate at the edge of the panel where water can infiltrate due to unsealed or poorly sealed joints. Therefore, the transverse and corner cracking for these sections after just 4 years of service have been summarized in Table 2. The preliminary results indicate that even after just a short period of time, the benefits of joint sealing are starting to be revealed. The reason for this is evident by the photos taken shortly after it rained. See Figure 7. The photos clearly reveal the water on the pavement near the joints has drained into the joint while water puddles across the joints in the section that is sealed.

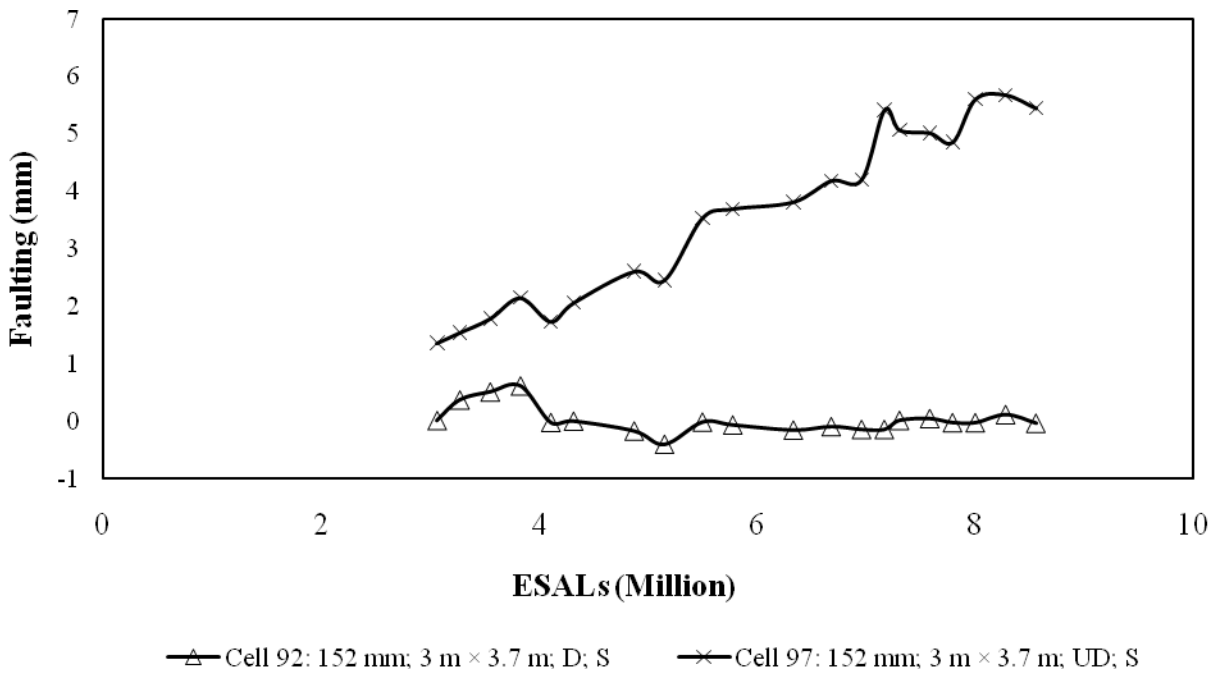
FIGURE 8 Faulting history for Cells 92 and 97.

The benefit dowel bars provided in the performance of the bonded whitetopping sections at Mn/ROAD was also observed. In the Mn/ROAD whitetopping sections, only Cell 92 contained doweled joints. Cell 92 and Cell 97 are companion sections in that the designs are exactly the same but Cell 92 contains 25 mm (1-in) dowels. The faulting history for Cell 92 and 97, shown in Figure 8, indicates that the presence of dowel bars helps to reduce faulting in Cell 92. Whereas very little faulting is visible in Cell 92, Figure 9 clearly shows the presence of faulting in Cell 97. It should be noted that Cell 97 accumulated over 5 million ESALs before exhibiting faulting greater than 6 mm (0.25 in). For typical bonded whitetopping applications, this would meet or exceed a 20- or even 30-year design life. It does show the potential for using thin bonded whitetopping for high volume roadways to extend the performance of an HMA pavement 10 to 15 years and that only a small 25-mm (1-in) diameter dowel could drastically increase the performance of this overlay.

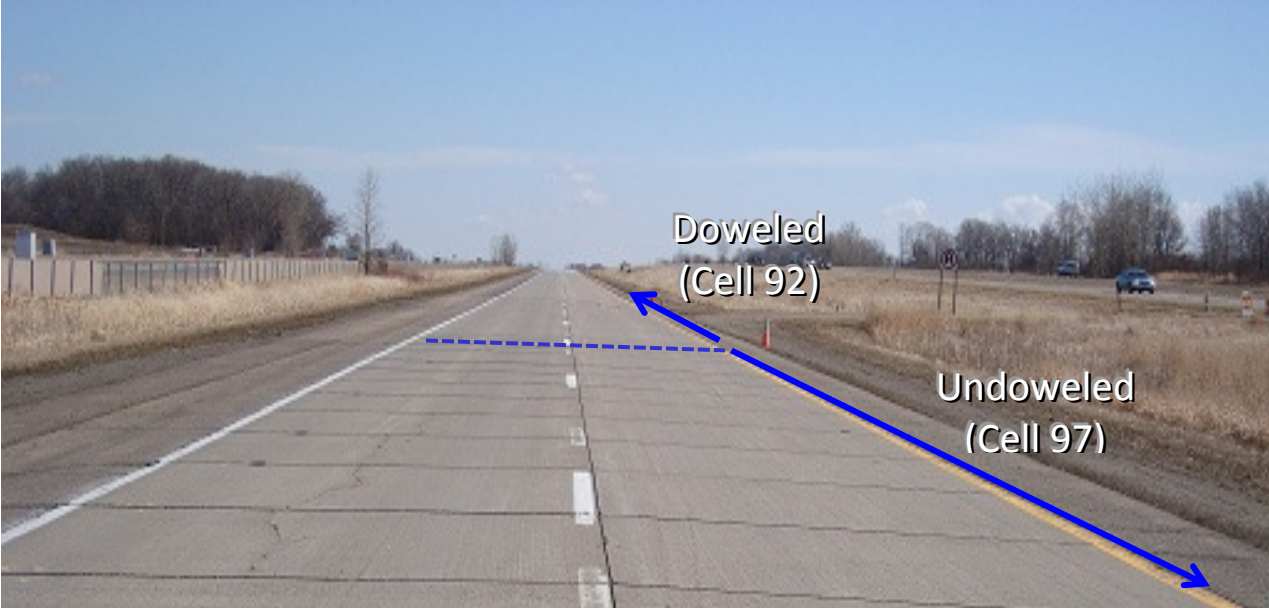
FIGURE 9 Visible faulting for the undoweled Cell 97.
