Improving Bridge Assessment through the Integration of Conventional Visual Inspection, Non-Destructive Evaluation, and Structural Health Monitoring Data

University of Pittsburgh – IRISE (Dr. Amir Alavi)

Rutgers University – CAIT (Dr. Frank Moon)

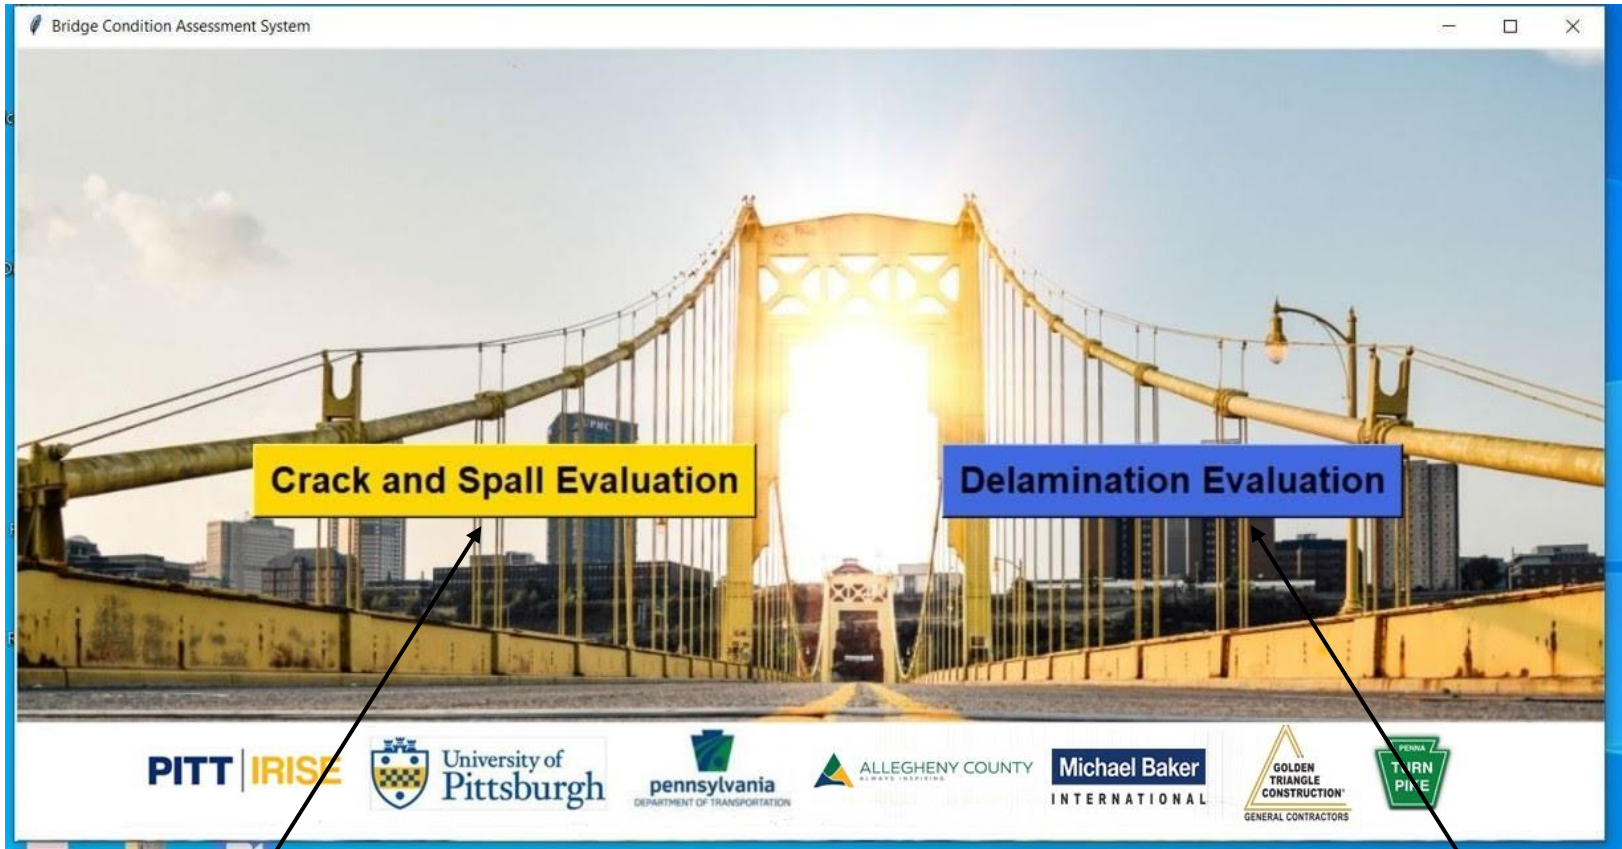
Pitt Bridge Condition Assessment System (PittBCAS)

Click to open the interface for
Crack and Spall Evaluation

Click to open the interface for
Delamination Evaluation

- ❑ Pitt Bridge Condition Assessment System (PittBCAS): Automated detection and quantification of cracks, spalls and delamination in concrete structures using deep learning
- ❑ Spalling and delamination densities are the two main parameters in the current PennDOT rating system for concrete bridge decks
- ❑ The crack density is also most useful for the prediction of useful life of bridge decks
- ❑ Images taken manually by the PennDOT personnel or via their UAVs can readily be fed into the PittBCAS software to calculate the densities of the cracked, spalled and delaminated areas
- ❑ The calculation speed is about 5 seconds per square foot of the deck

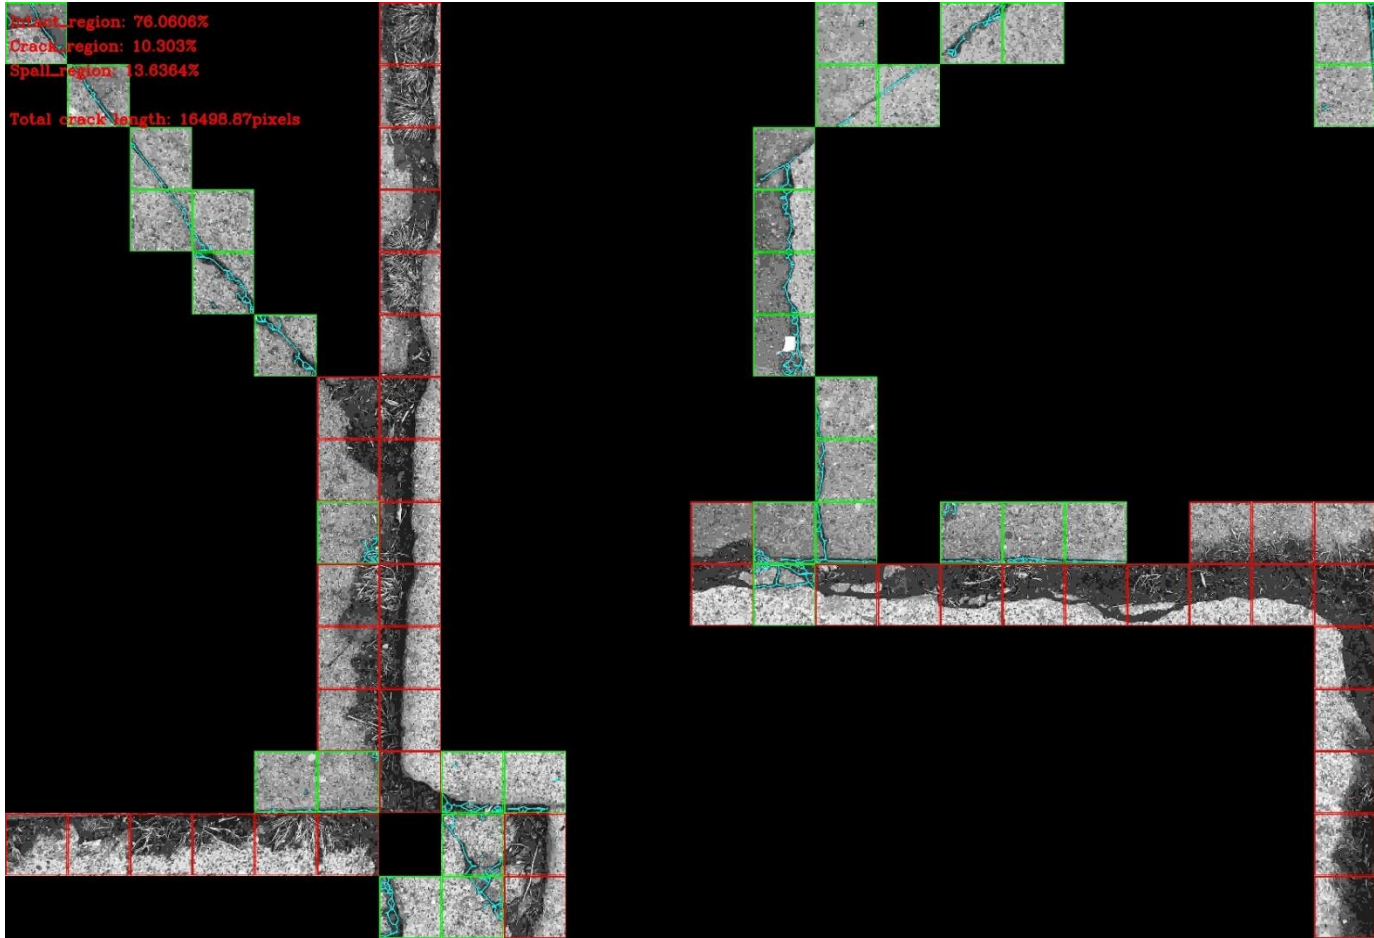
Output Example

Spalling Region

Crack Region

Crack
