University of
Pittsburgh

Effect of Extreme Superloads on Pavements in Pennsylvania

Julie Vandebossche, PE, PhD

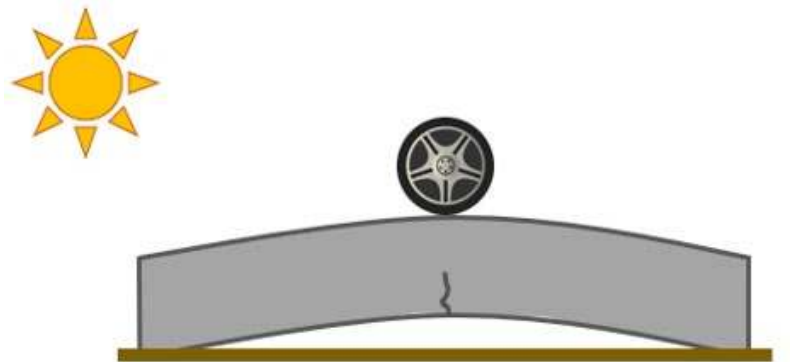
Positive Temperature Gradient

- Caused by repeated vehicle and environmental loading
- Location of crack development dependent on load application, temperature gradient

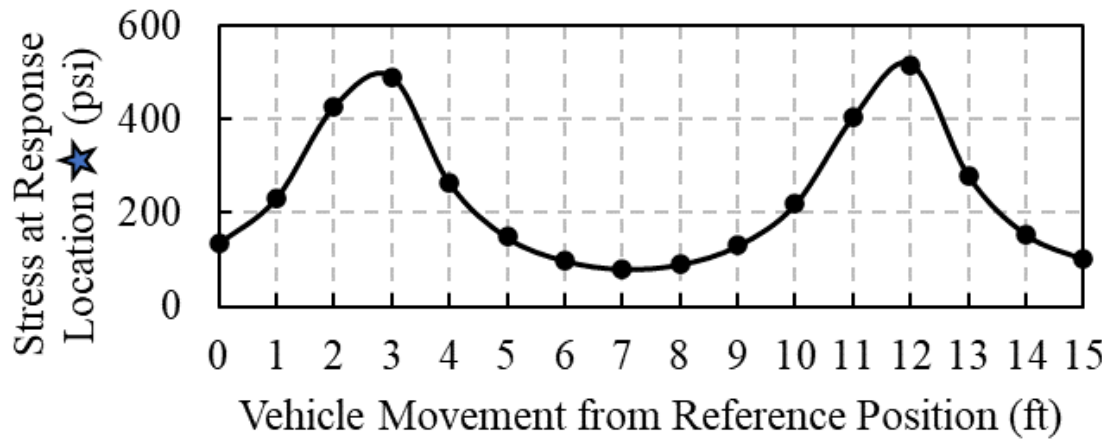
ELTG = +3 °F/in

Significant damage with high positive ELTG

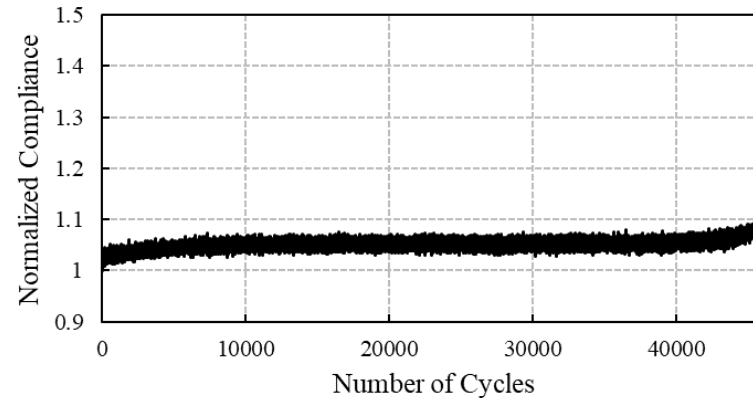
SR = 0.7, Single axle

Damage accumulates non-linearly!

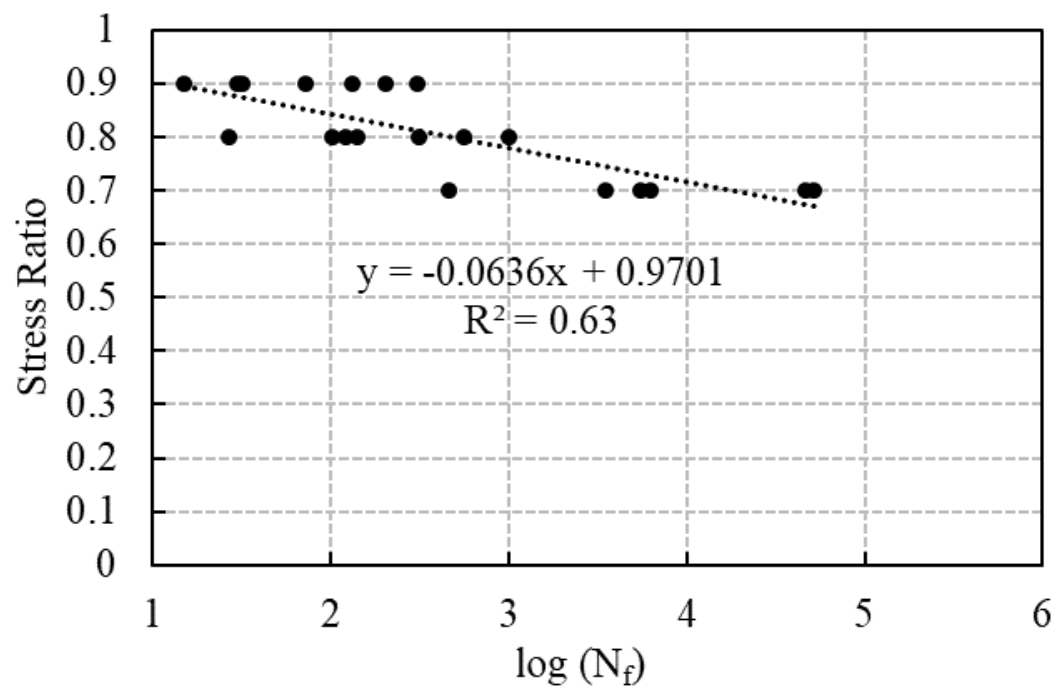
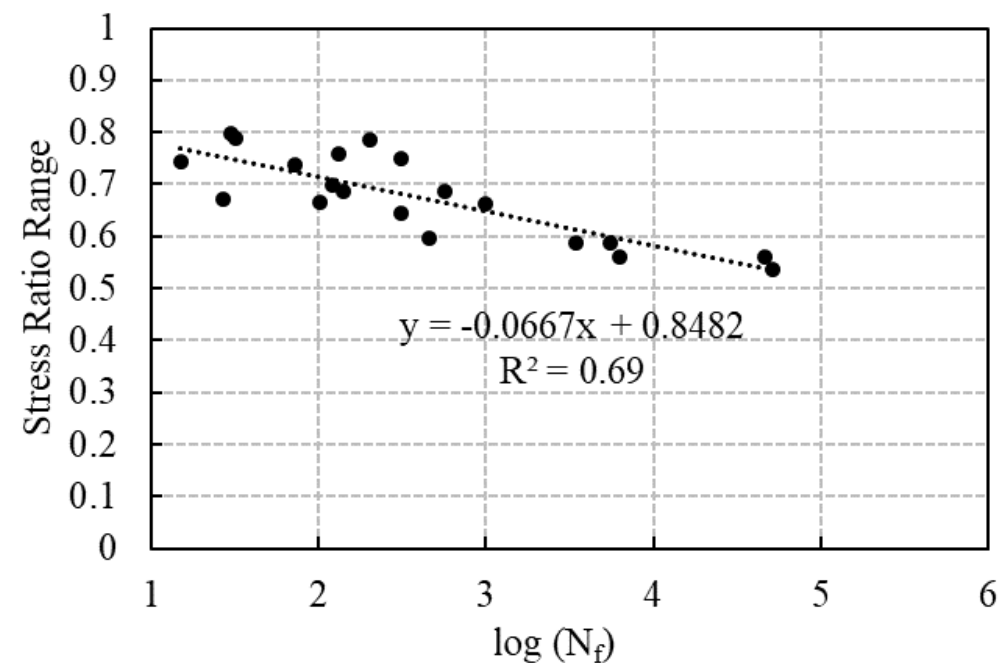
Effect of stress ratio

Higher stress ratios results in fewer loads to failure

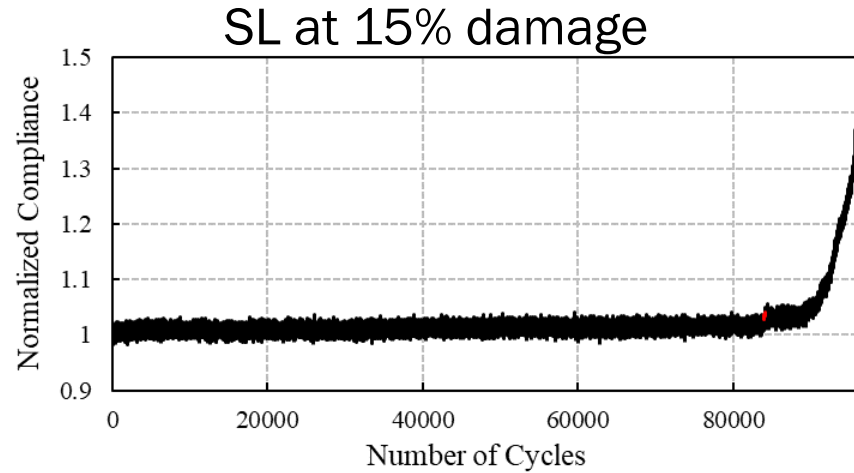
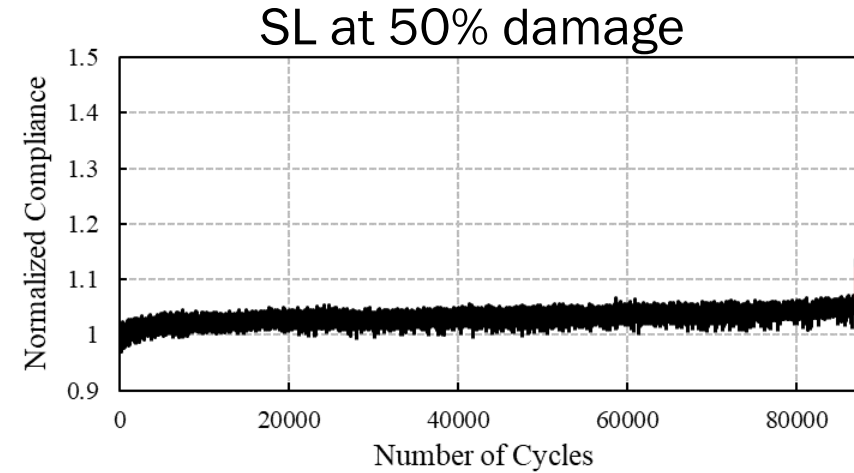
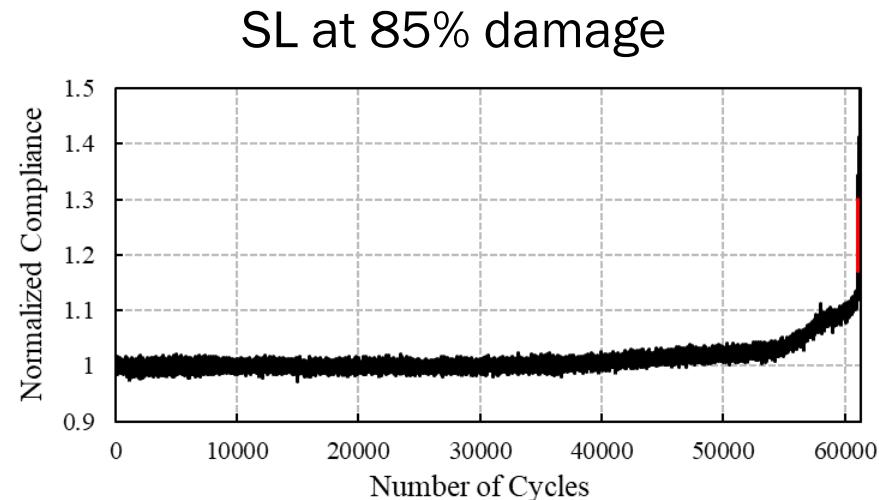
Effect of pavement condition

Damage caused by SL is larger when applied to pavements with more damage (older pavements)

- Non-linear increase in the fatigue damage
- Increase in damage caused by single SL pass depends on the existing damage state
- Traditional S-N curve and linear damage hypothesis approach to predict fatigue damage for an overload stress can underestimate the damage caused by a SL

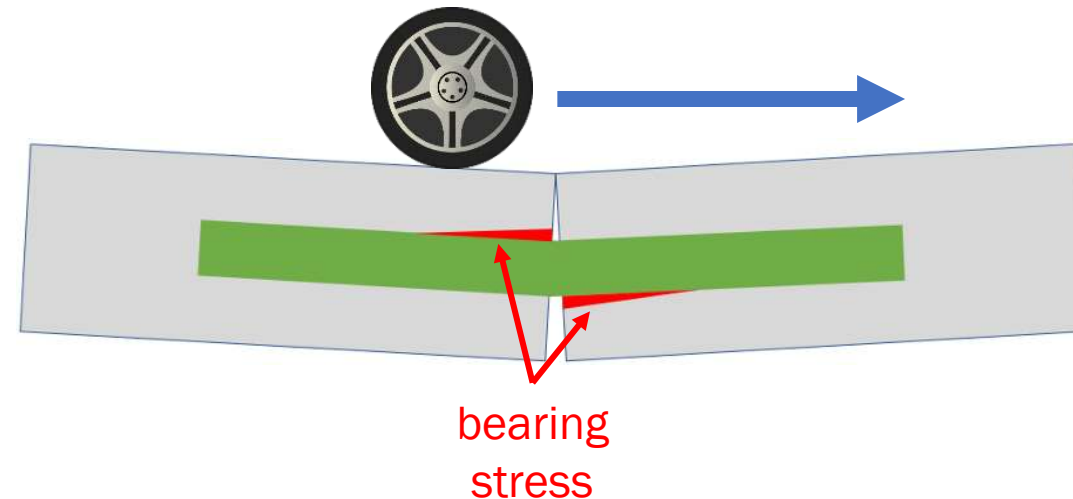
Vehicle loads induce **bearing stresses** in concrete surrounding the dowel

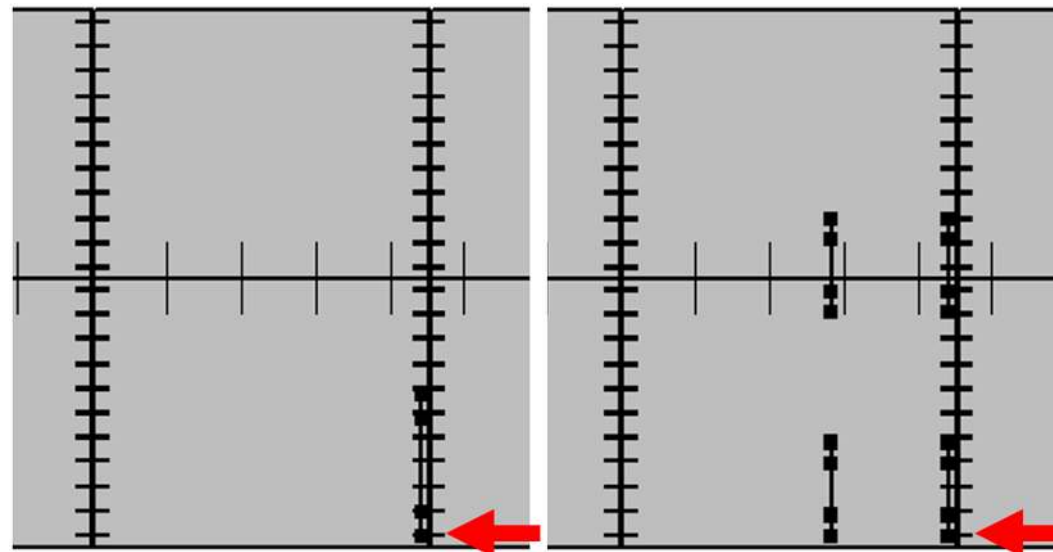
- Typ. SL axle configurations modeled using EverFE

Single and tandem axles placed in critical position relative to indicated dowels

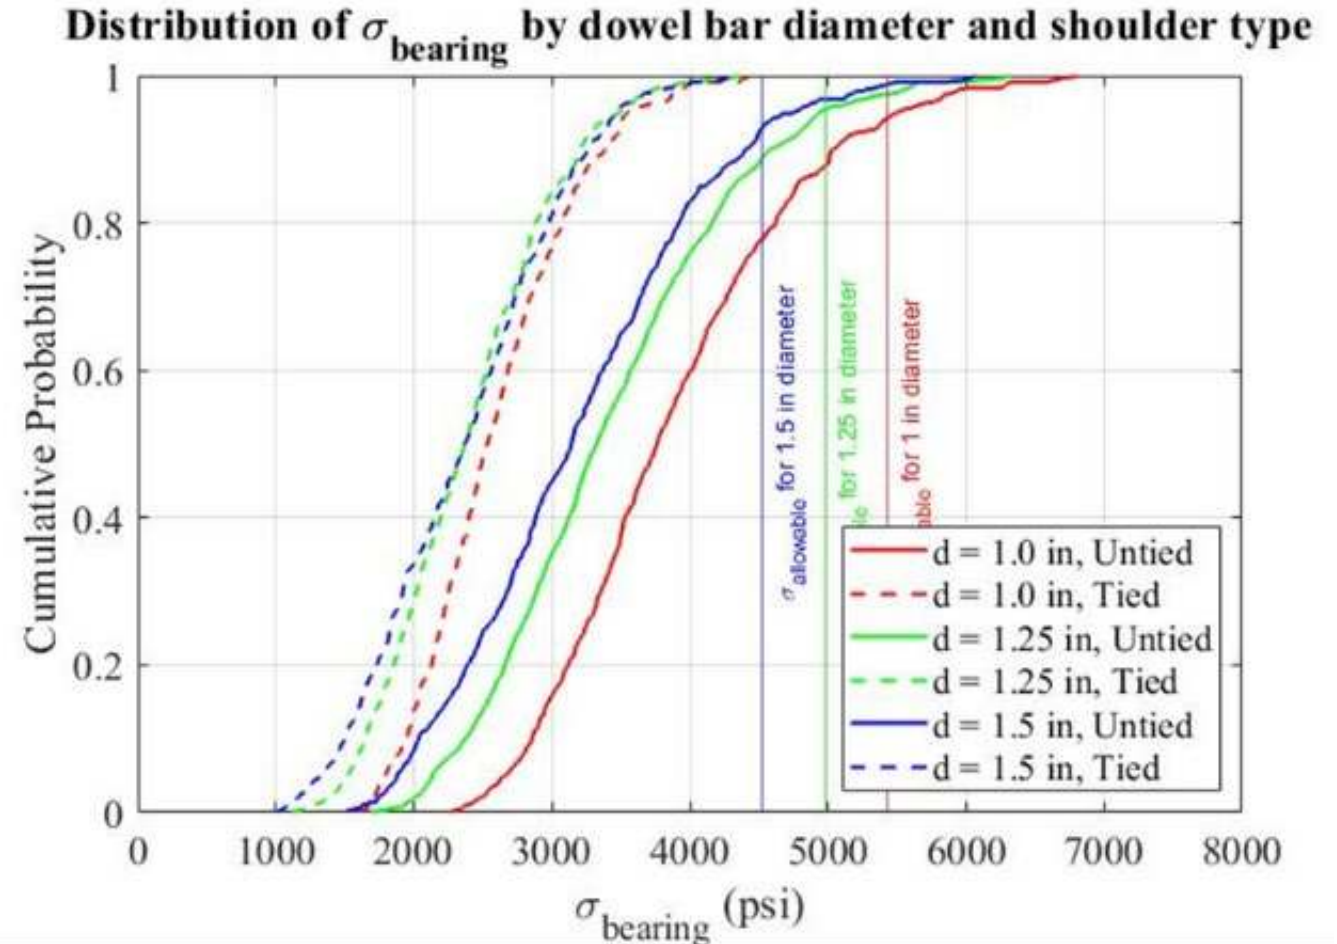
Critical bearing stress

$\kappa = 1500$ ksi/in; w/o aggregate interlock; $f'_c = 5,000$ psi

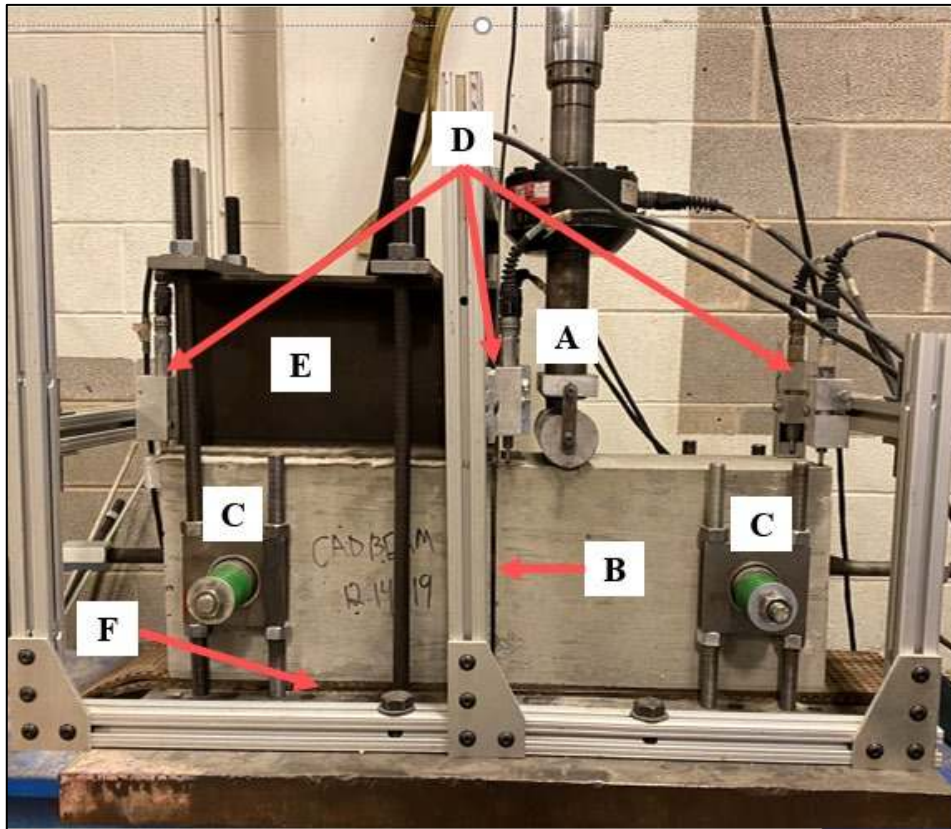
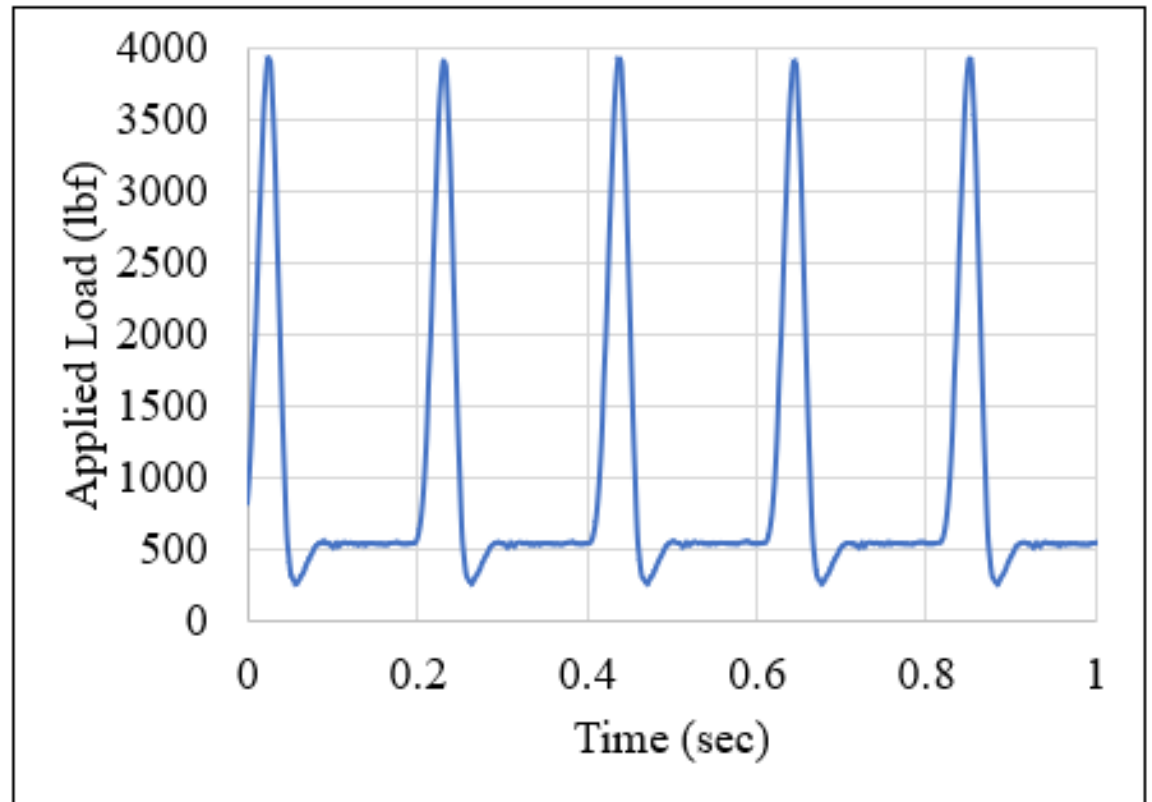
Laboratory investigation

- A – load head
- B – joint
- C – bearings
- D – sensors
- E – clamp
- F – simulated base

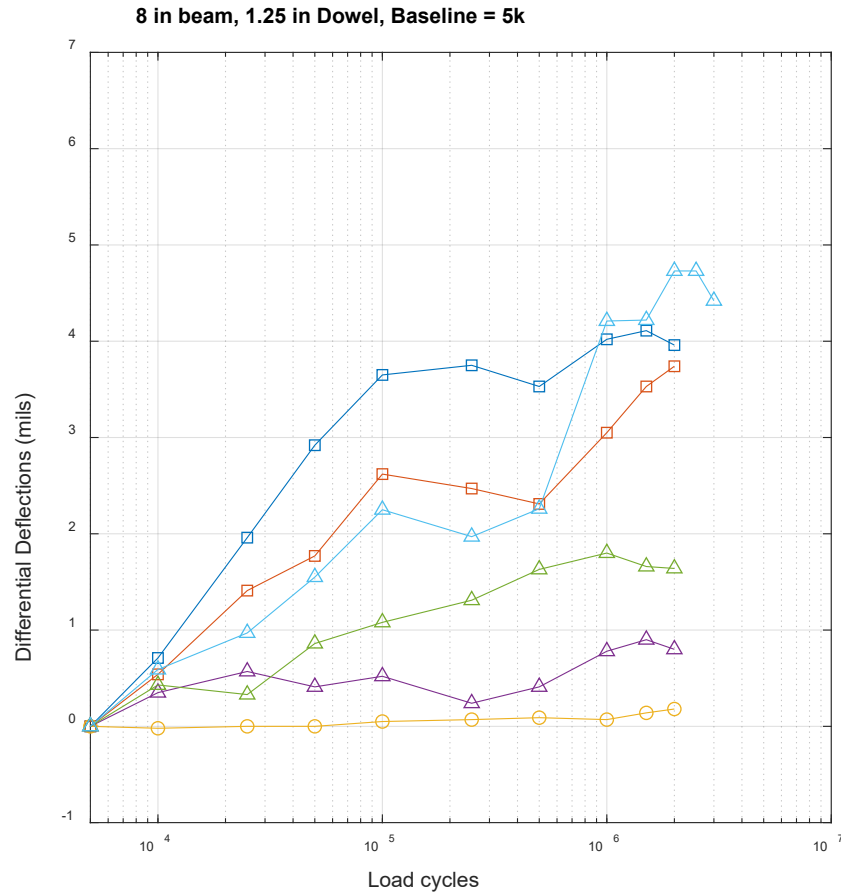
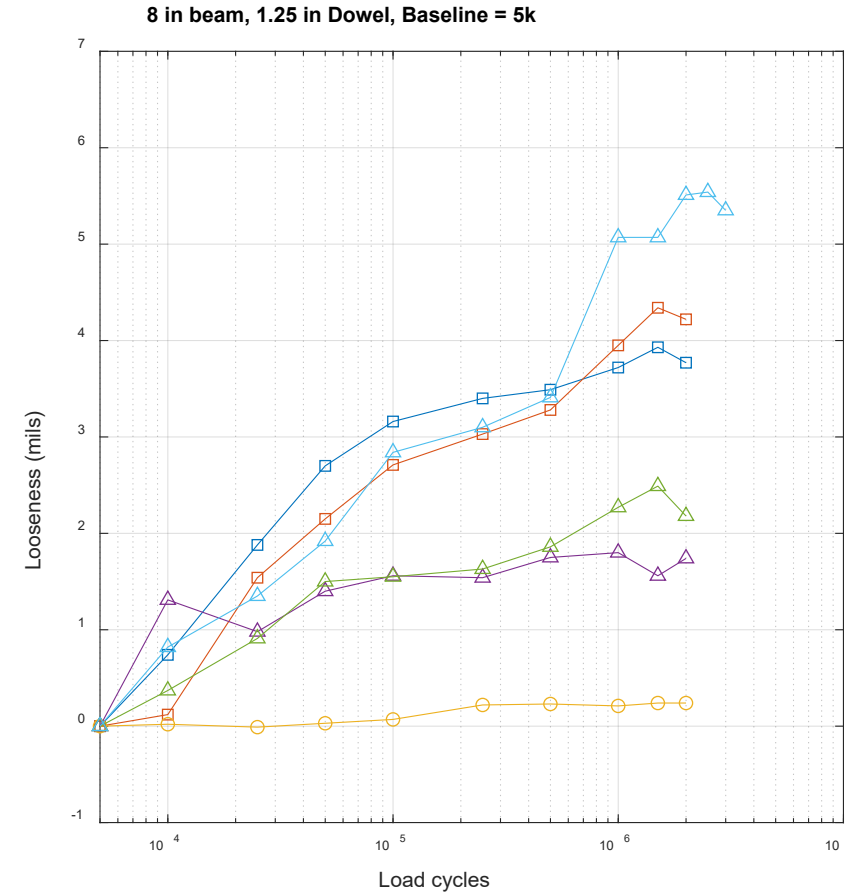
Effect of load

Note: 125 8B ML e had large void around dowel which caused large deflections

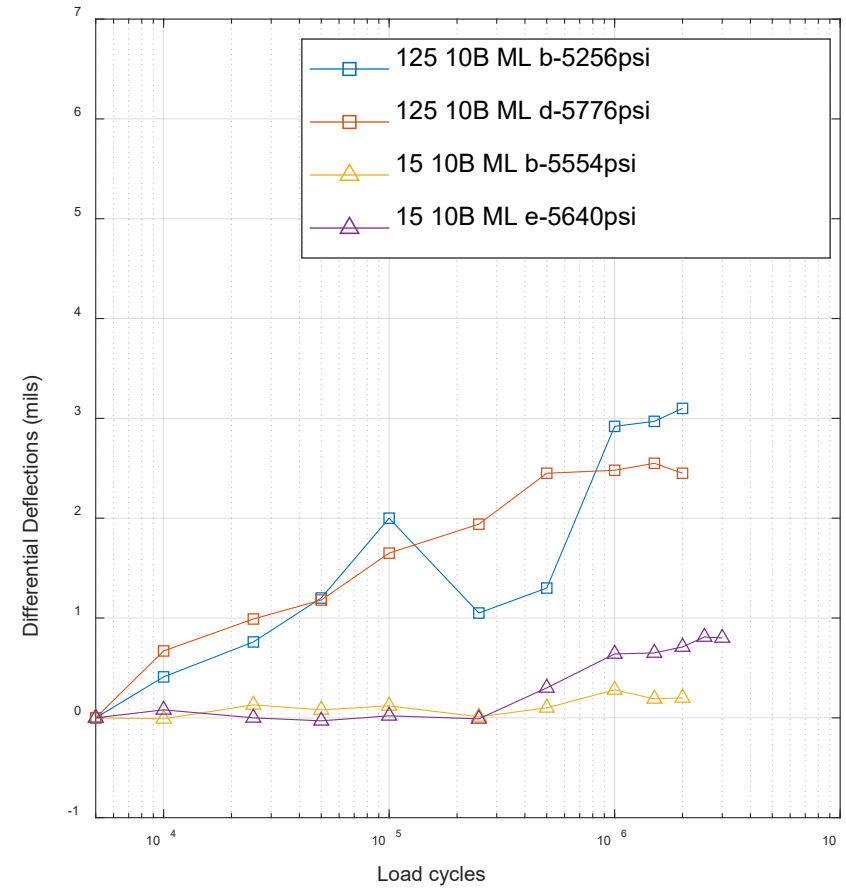
10 in beam, 1.25 and 1.5 Dowel HL, Baseline = 5k

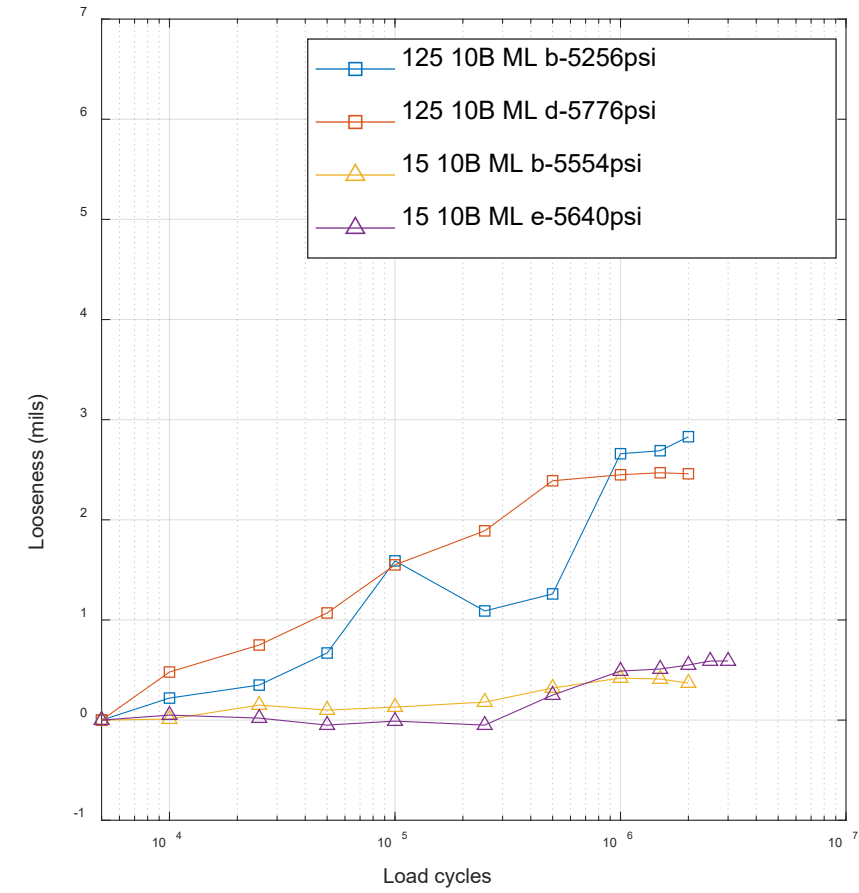
10 in beam, 1.25 and 1.5 Dowel HL, Baseline = 5k

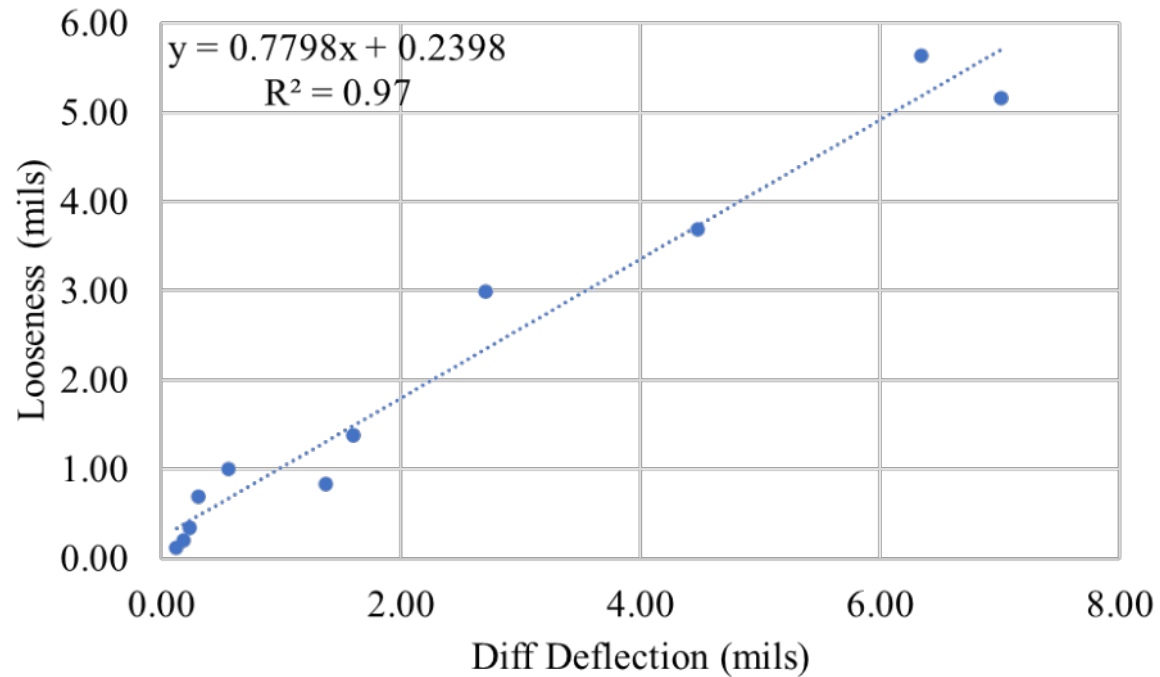
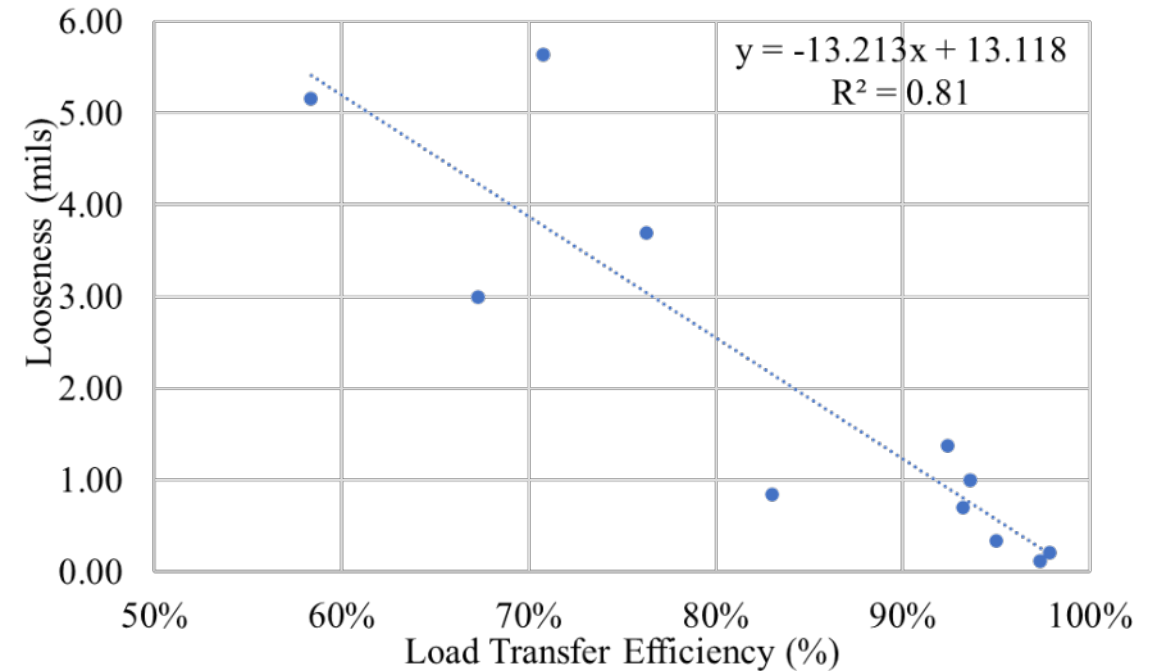
DD correlates better to looseness than LTE

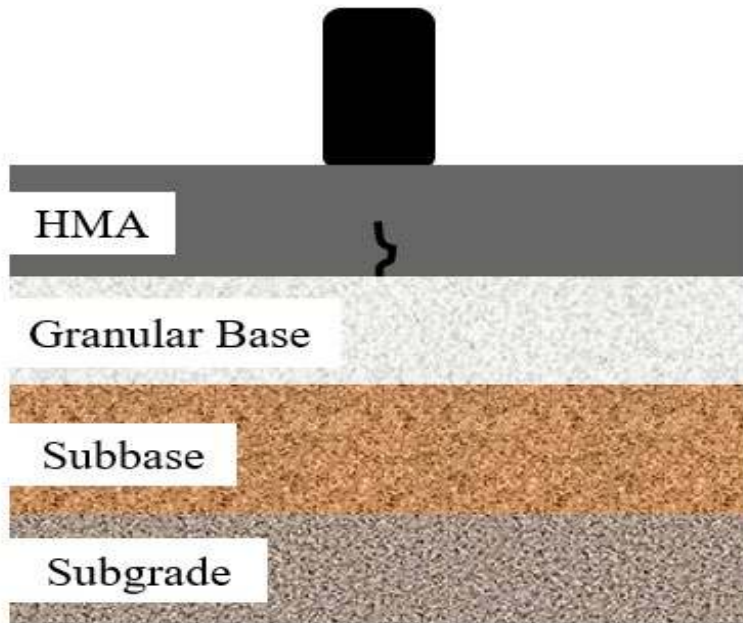
- Rutting
 - Caused by accumulated plastic deformation in each layer
- Shear failure at subgrade
 - Related to compressive strain in the subgrade
- Bottom-up fatigue cracking
 - Caused by horizontal tensile strains at the bottom of the HMA layer

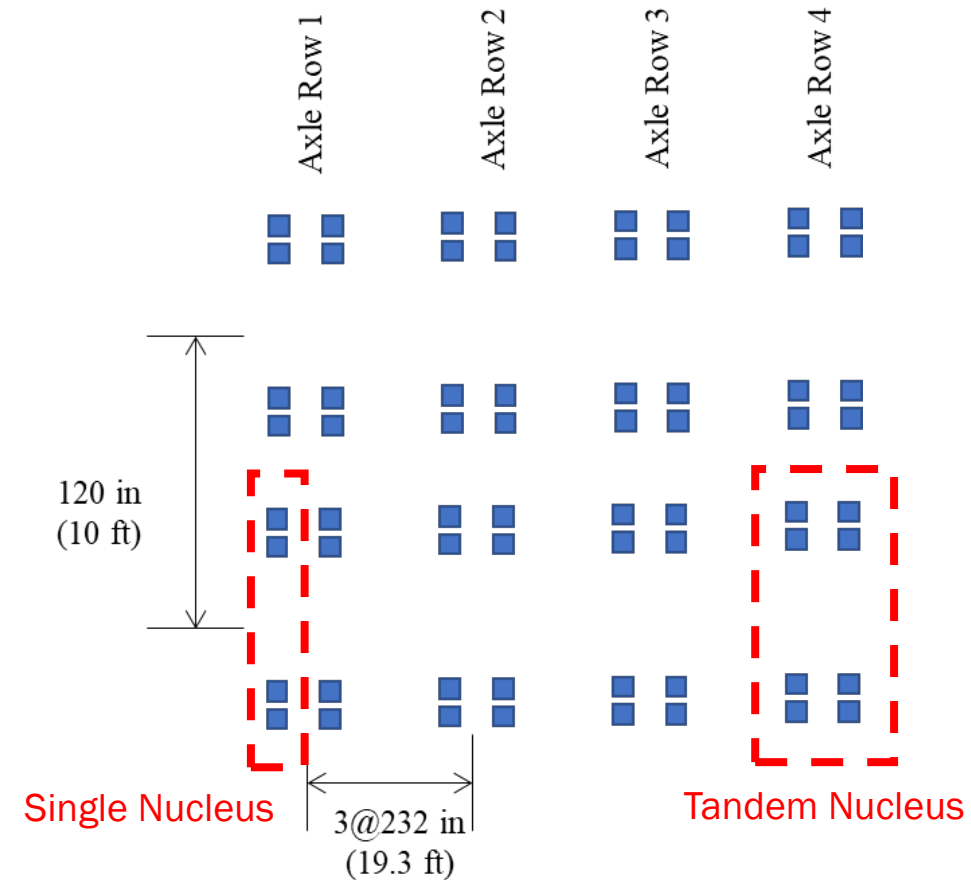
- Layered Elastic Analysis (LEA) to evaluate stresses and strains – **computationally intensive**
- SLs divided into repeating units (“nucleus”) that create the same response each from the pavement – only the nucleus was modeled

Observation: Single nucleus is adequate for typical SLs in PA

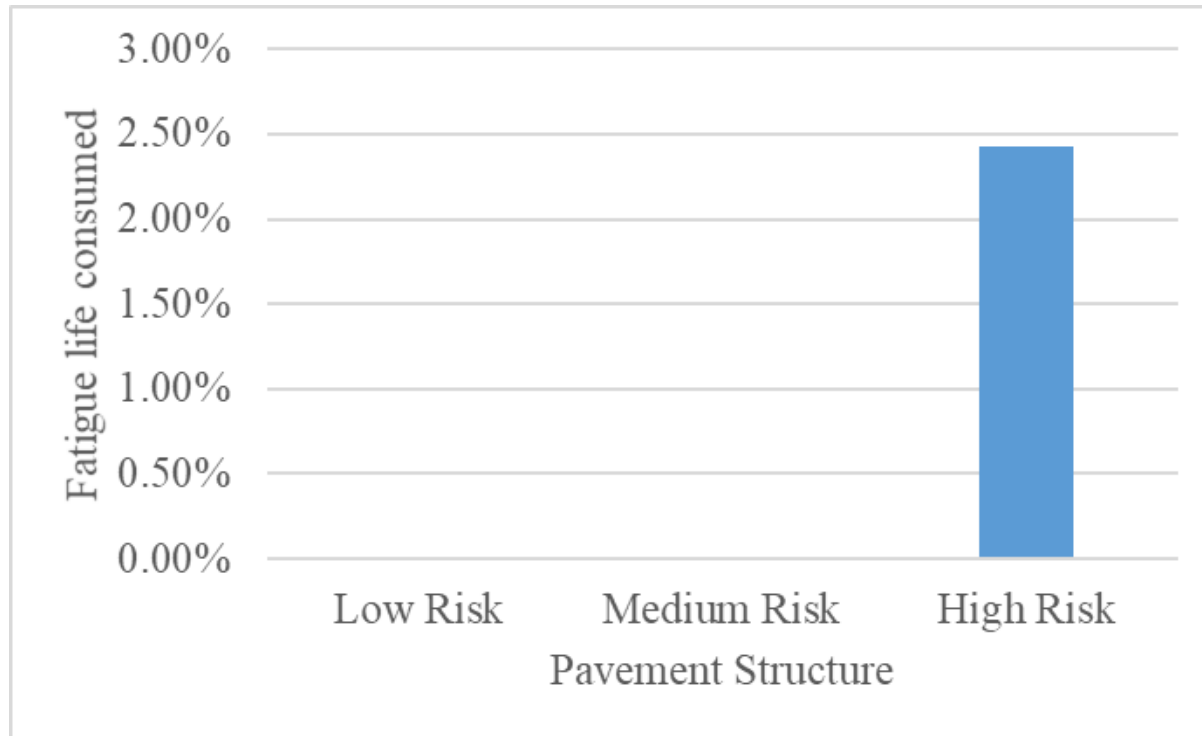
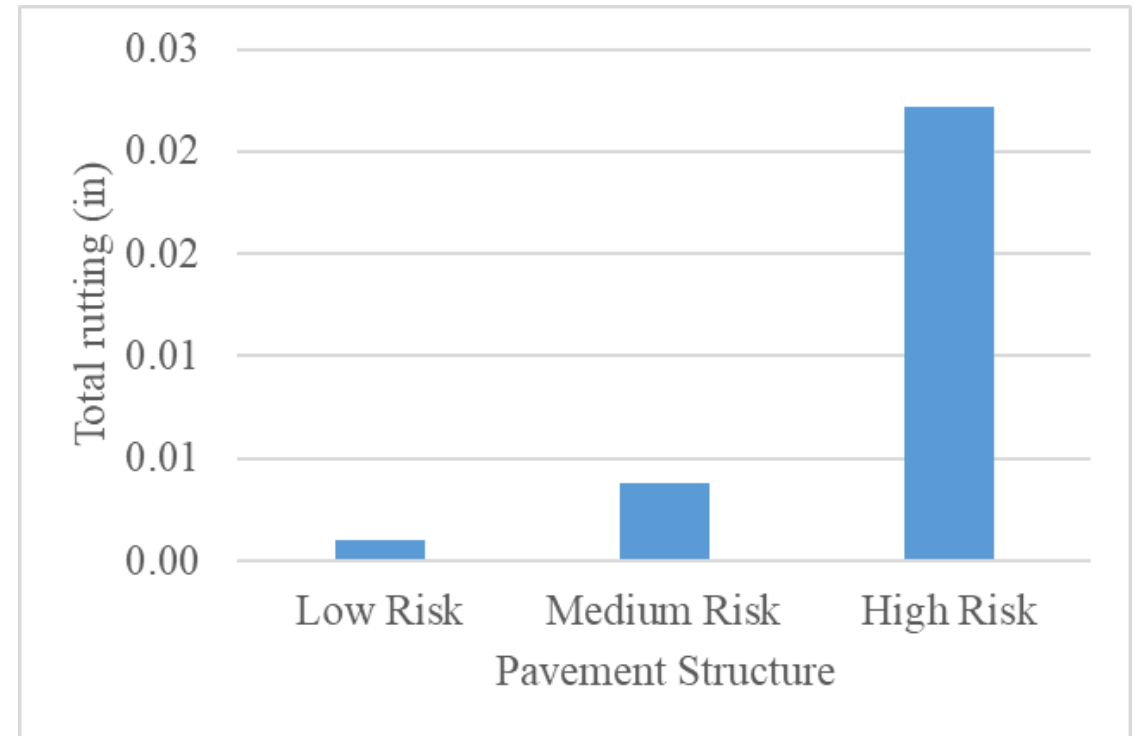
Example distresses

- Low, medium, and high risk structures based on thickness and stiffness of pavement layers
- Low risk = thick AC layer (18 in), stiff binder, thick base layer (24 in)
- High risk = thin AC layer (3 in), soft binder, thin base layer (7 in)

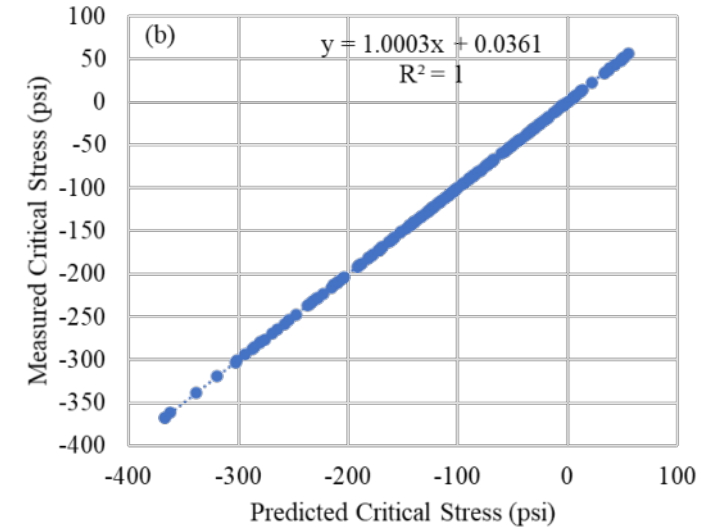
Single SL

- Only positive gradients were found to be critical previously and are modeled in the tool
- Artificial Neural Network model to predict maximum stresses

SL category	Sign of the Temperature Gradient	R^2 adj
Single	Positive	0.99
Tandem	Positive	0.99
