# New Baltimore Landslide – Evolution of Instrumentation

Suresh Gutta, Ph.D., P.E.

American Geotechnical & Environmental Services, Inc.

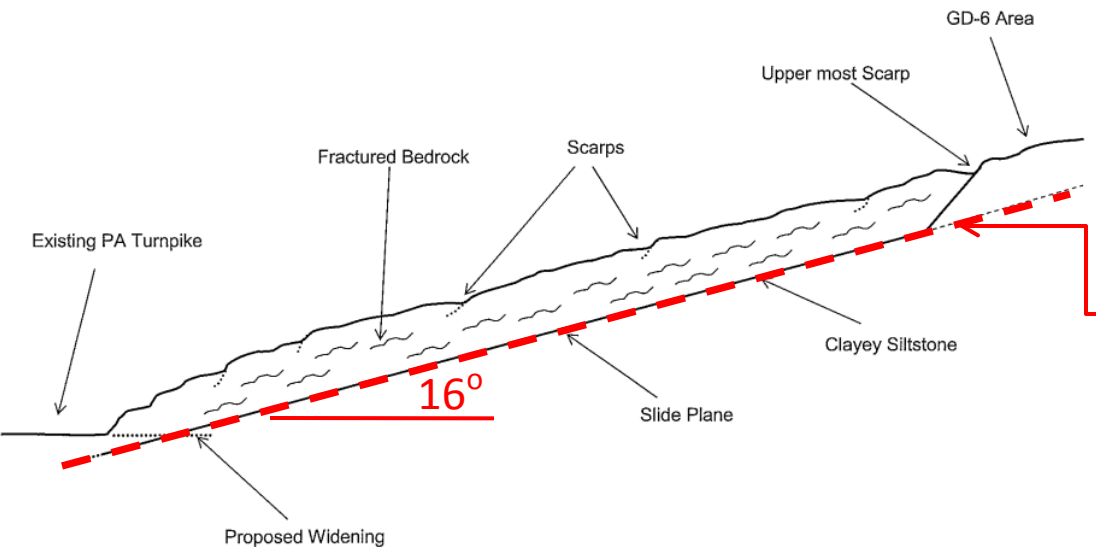
Figure ES-1: Schematic view

**Failure Plane**

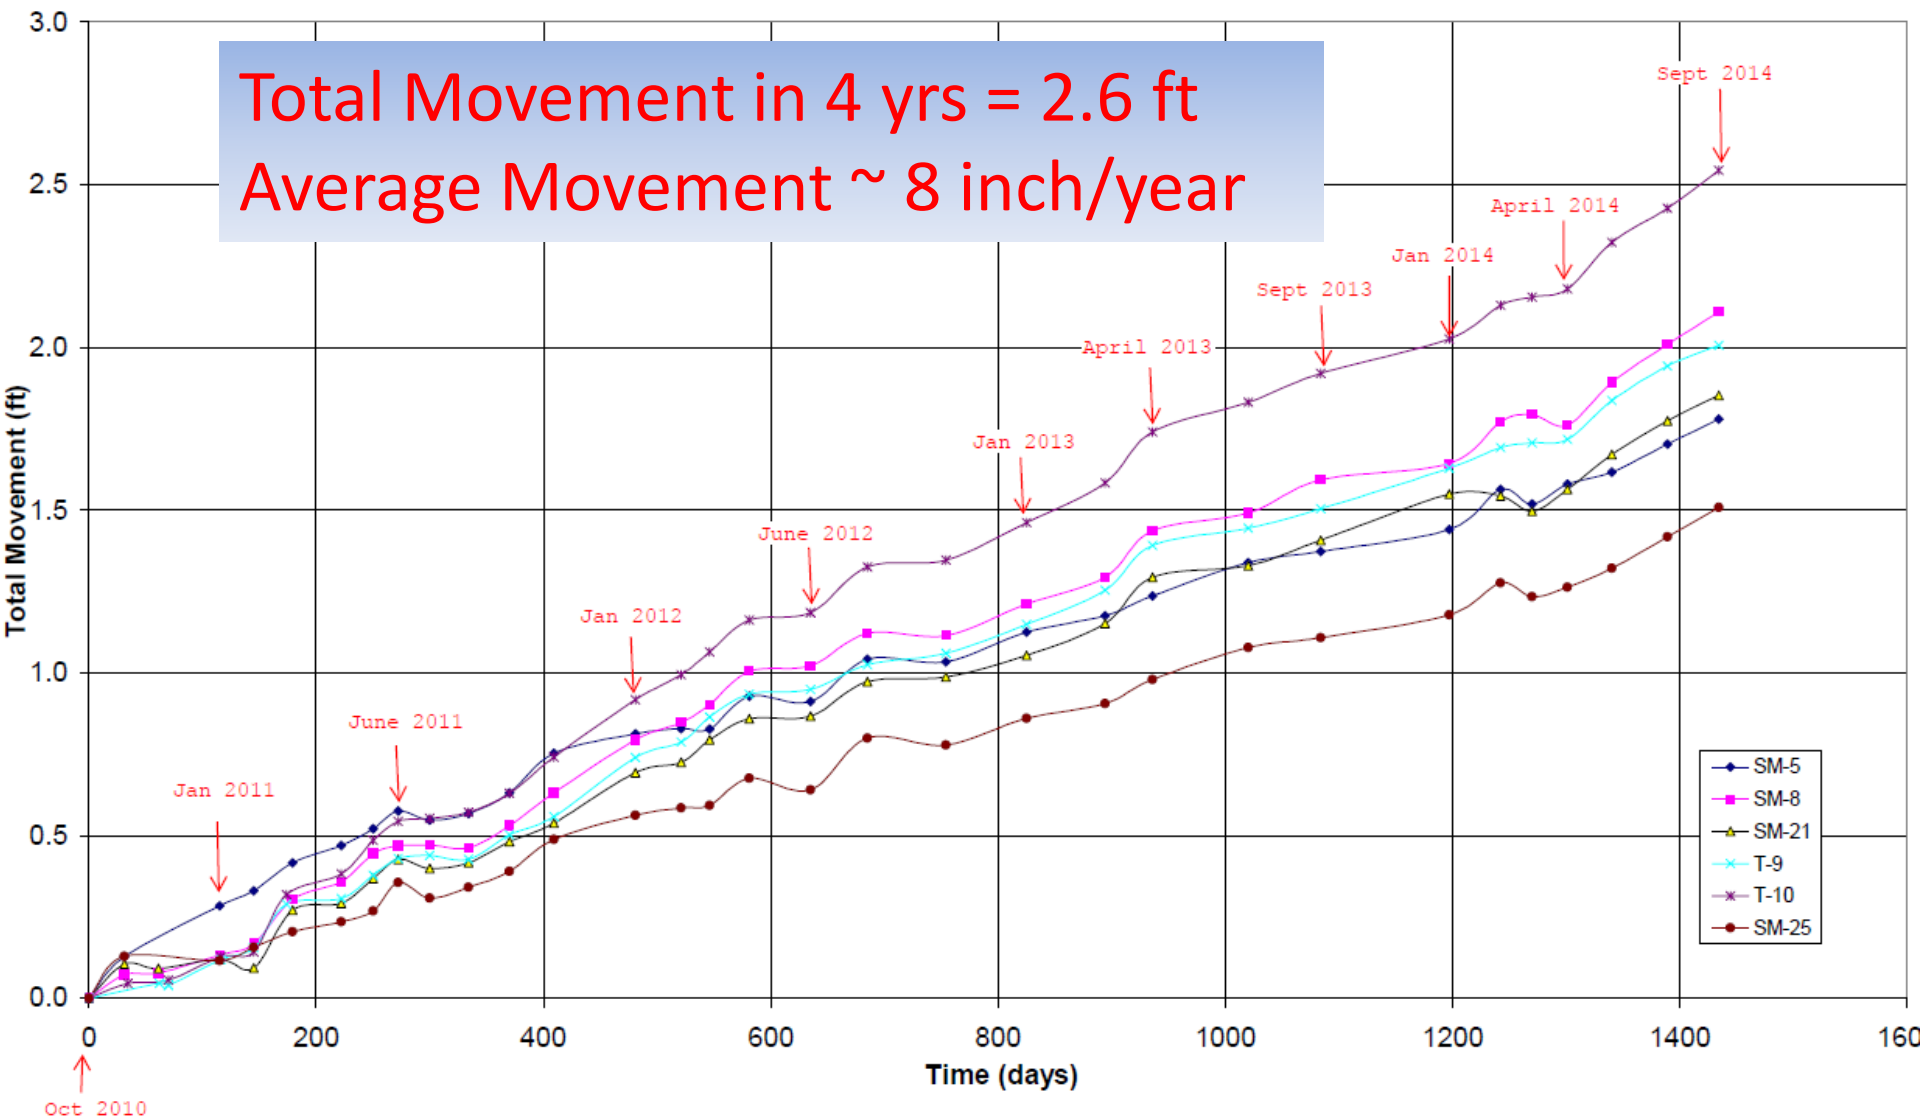
# Survey of Surface Monuments

Survey performed by JMT

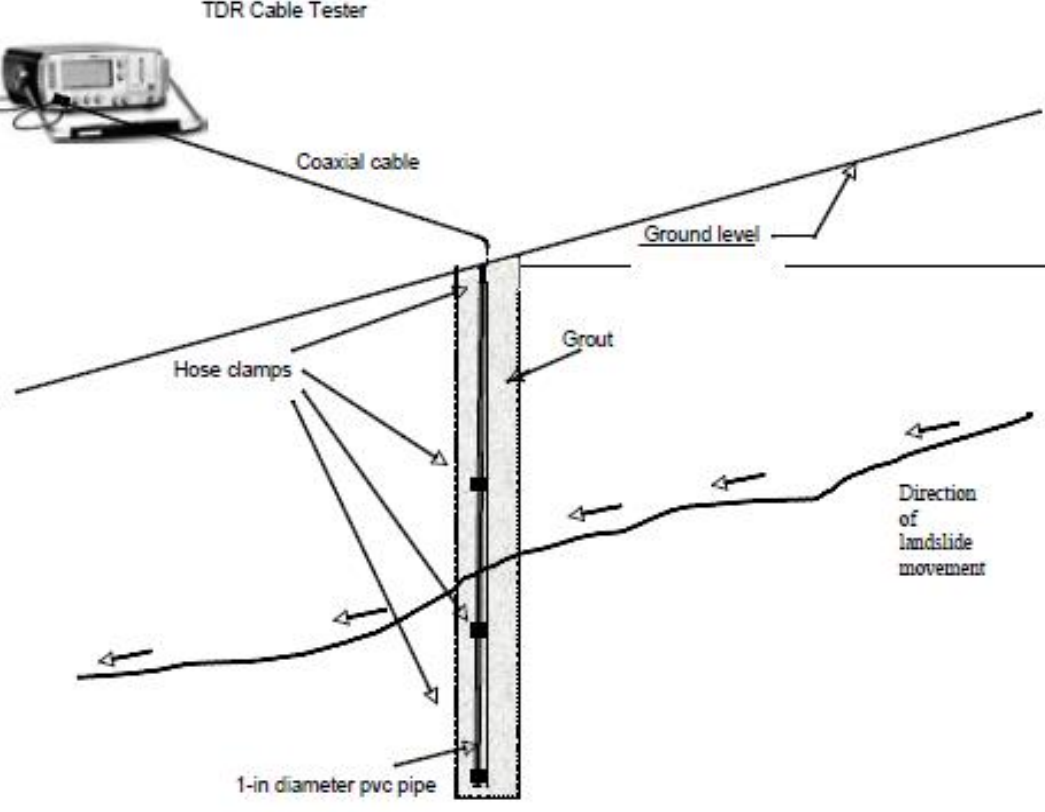
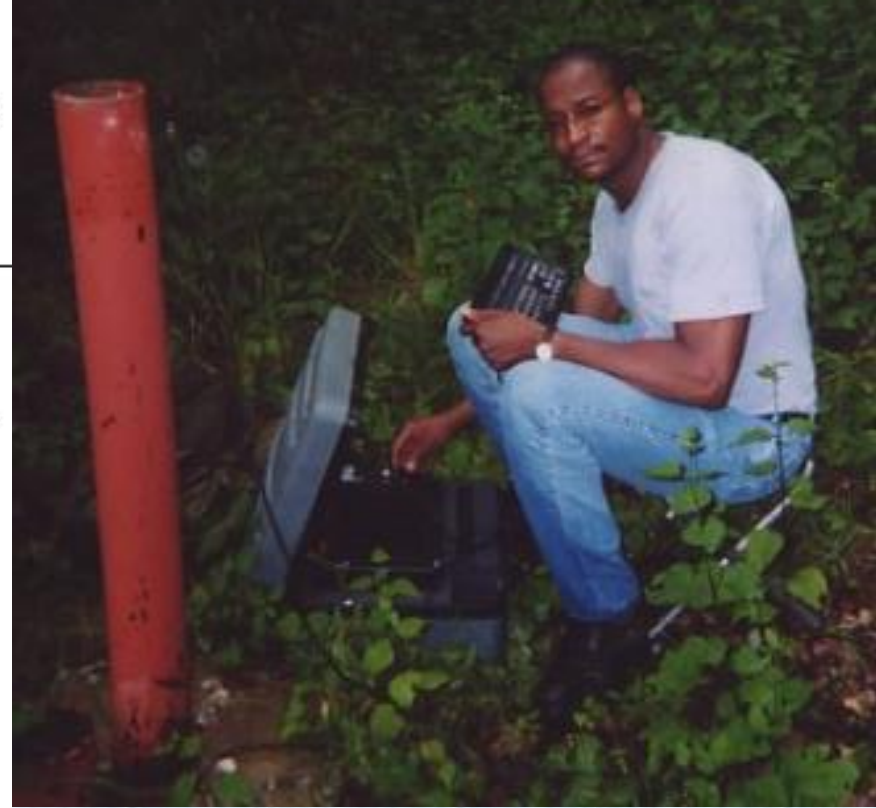
Basic components of TDRs

TDR data collection

## Time Domain Reflectometry (TDR) Monitoring 1999-2000

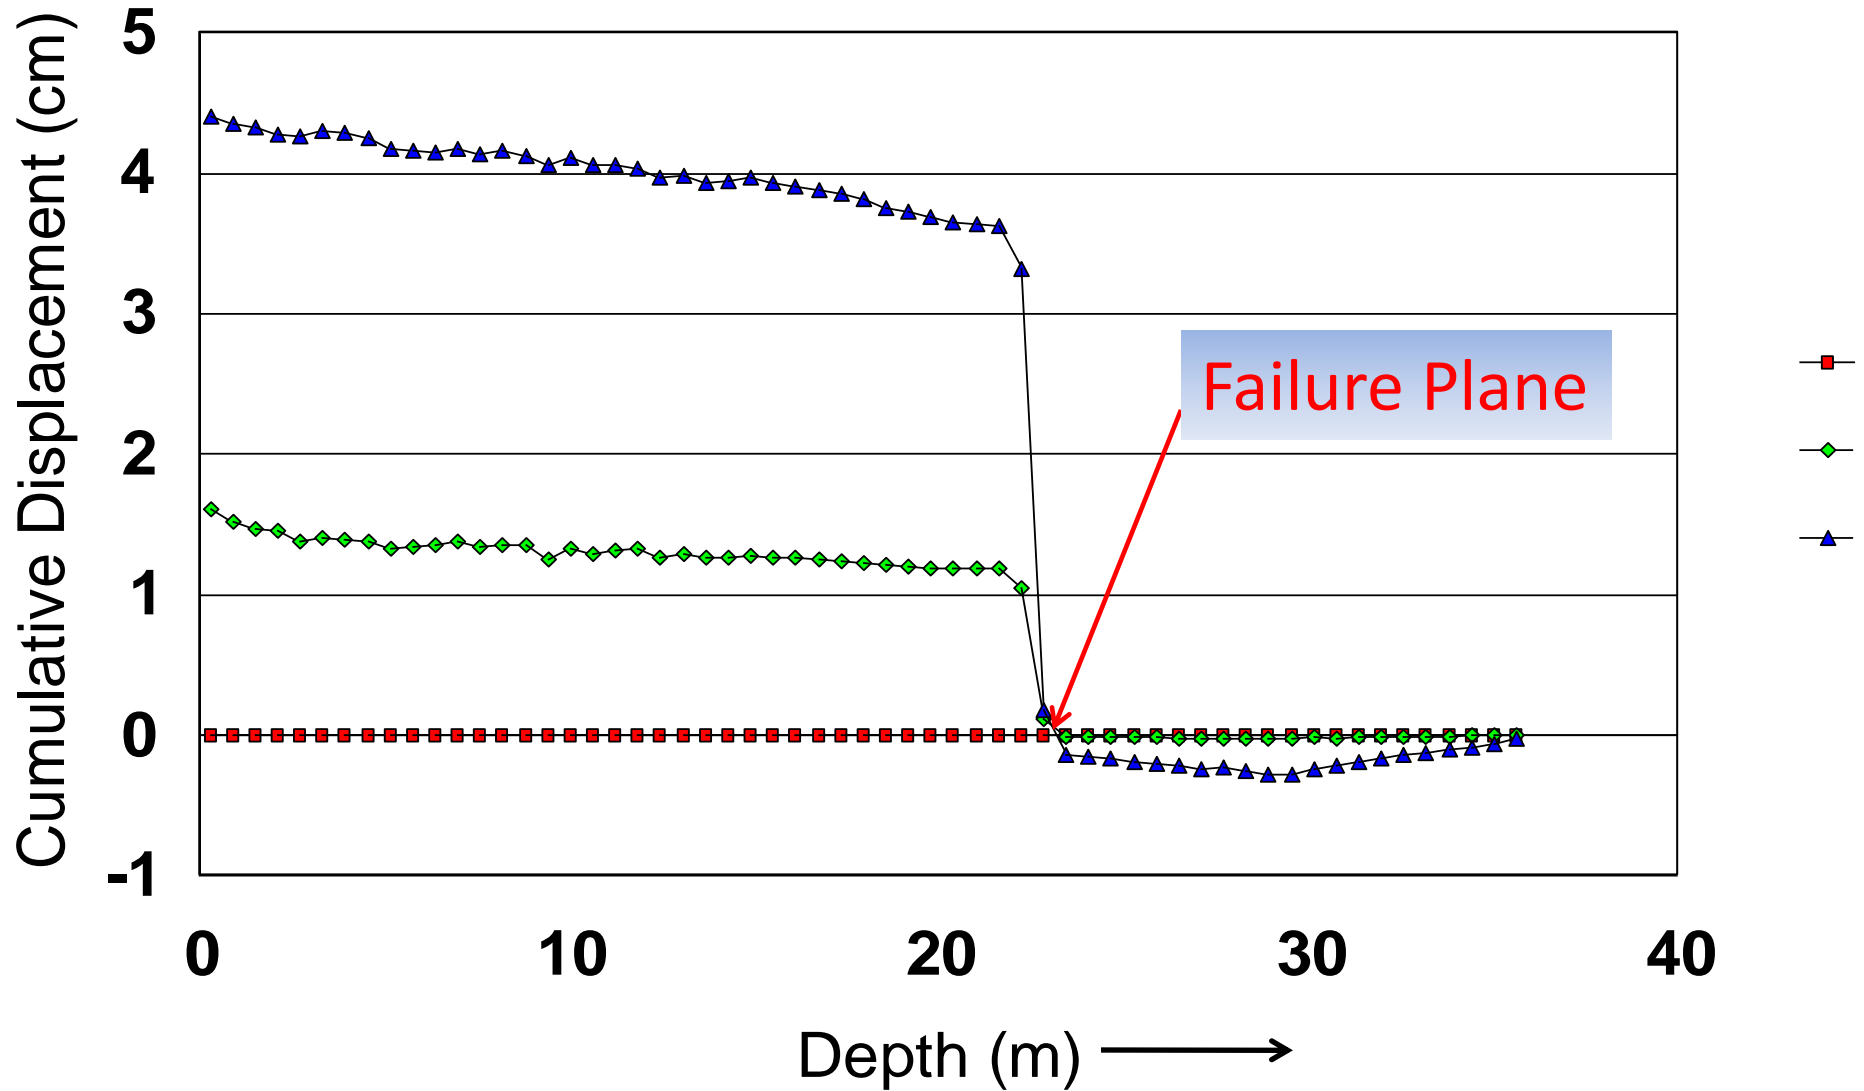
# Inclinometer T-4(TDR)

## Cumulative Displacement vs. Depth, A-Axis

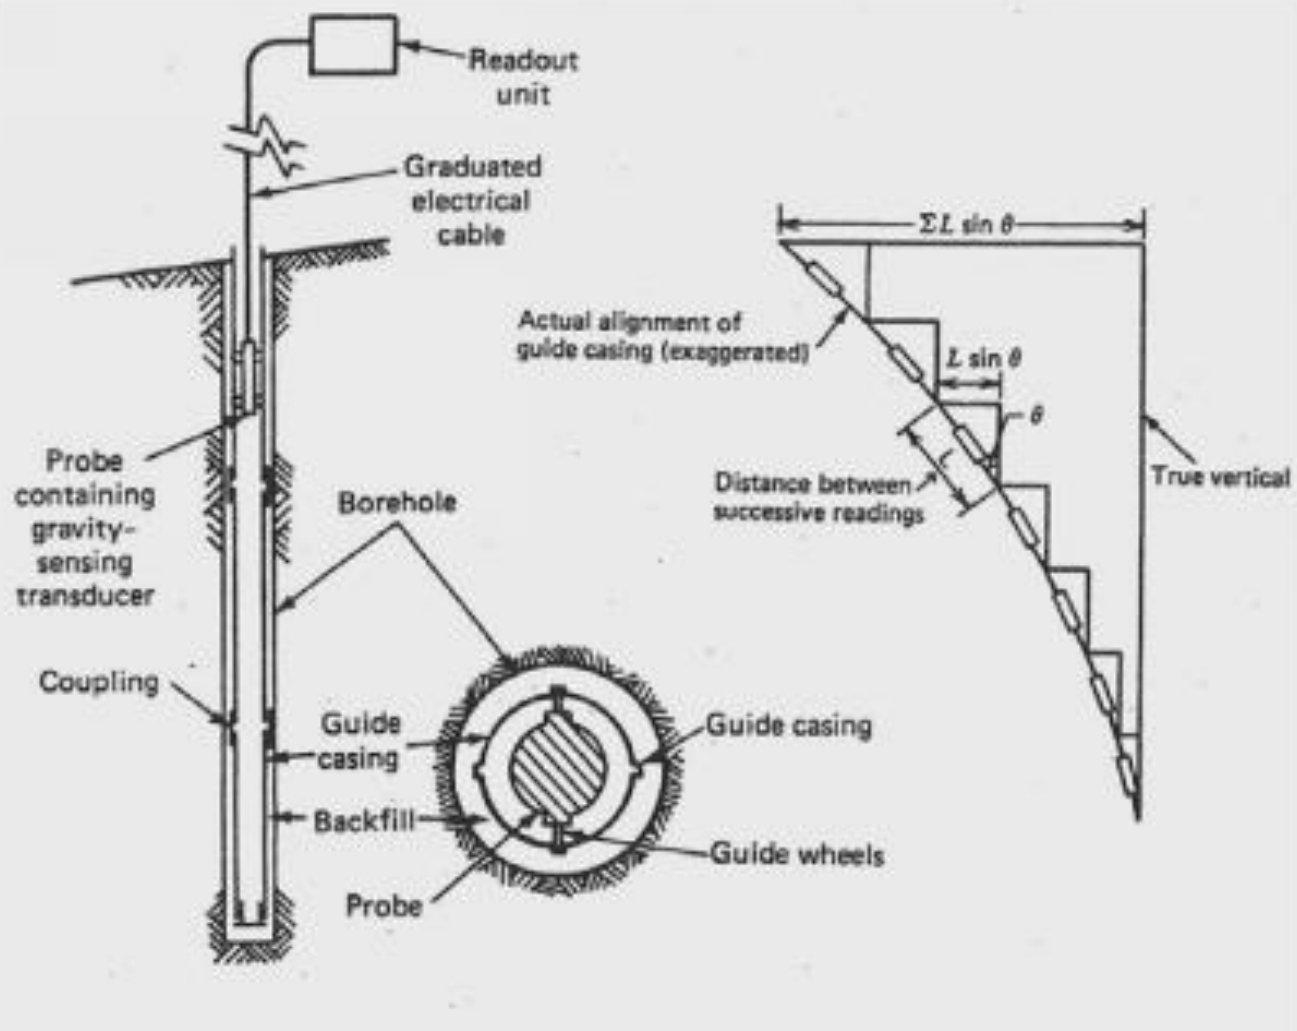
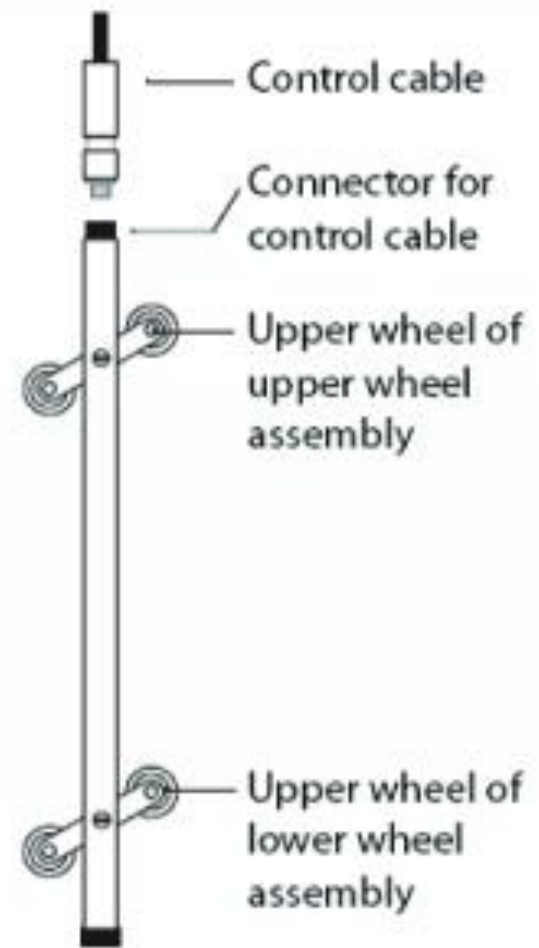
**Schematic of Inclinometer Probe inserted in Inclinometer Casing  
(Ref: TRB Circular 129)**

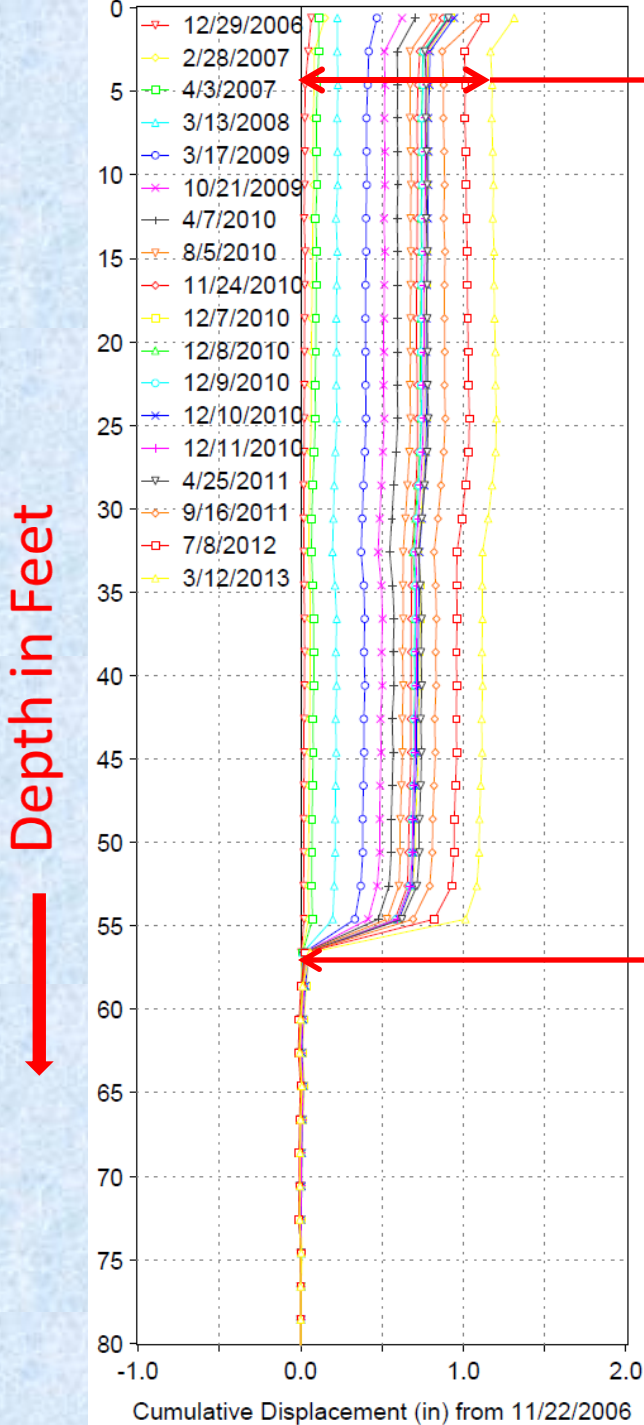
# Inclinometer (Traditional) Data

Cumulative  
Movement

Depth to Failure  
Surface

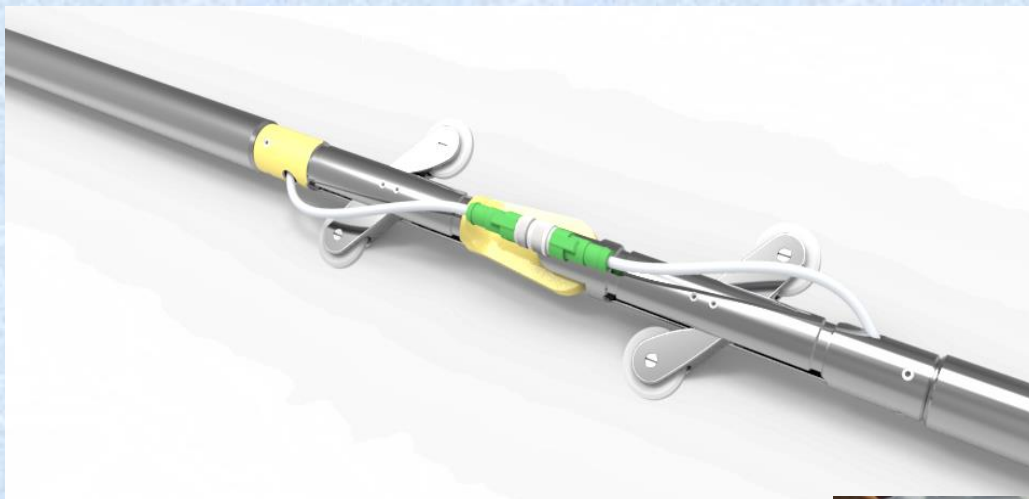
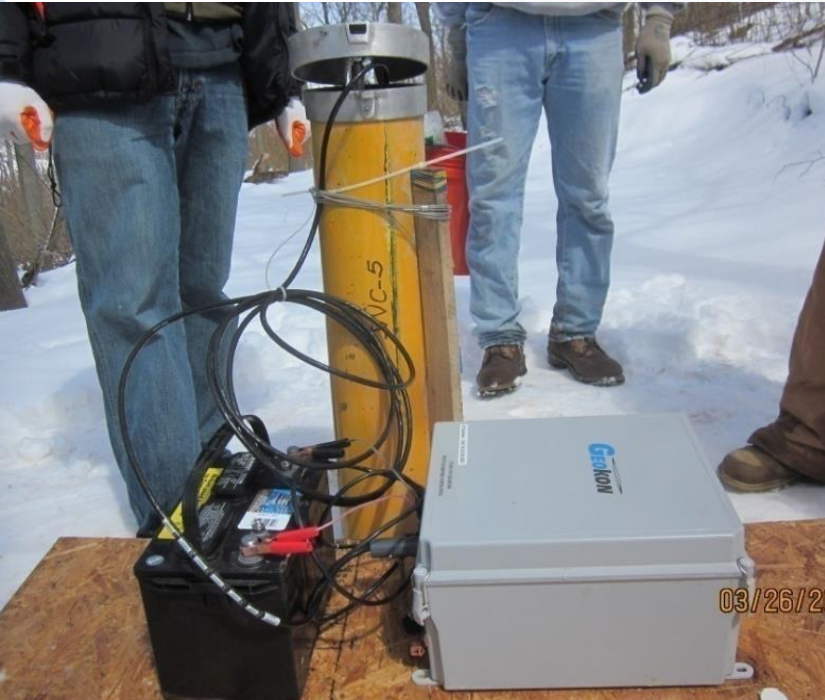
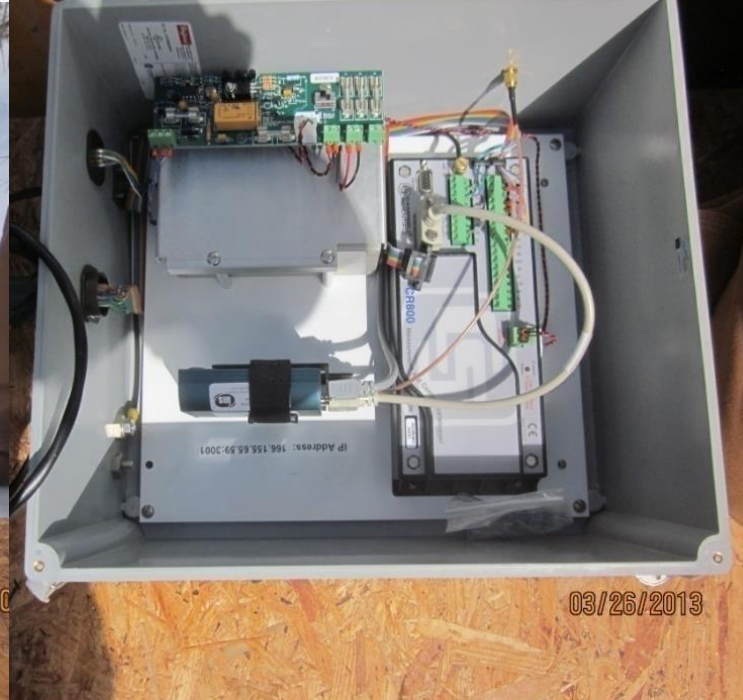
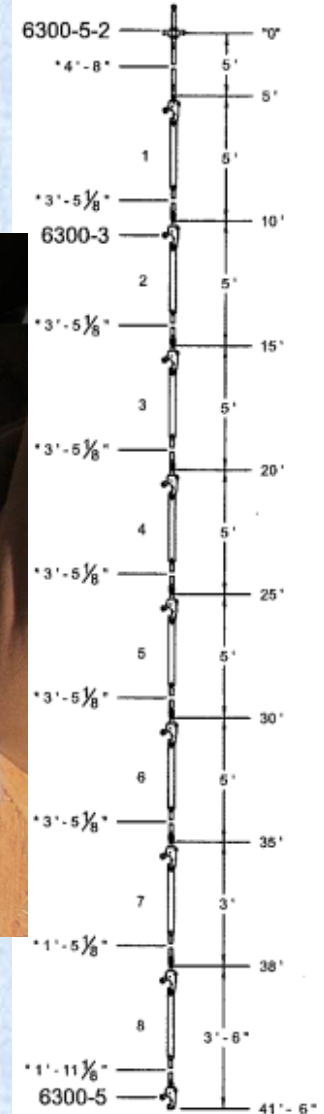
## Advantages

- Real-time monitoring
- Remote data collection
- Alarm/email

**In-Place Inclinometers**  
**2013-2016**

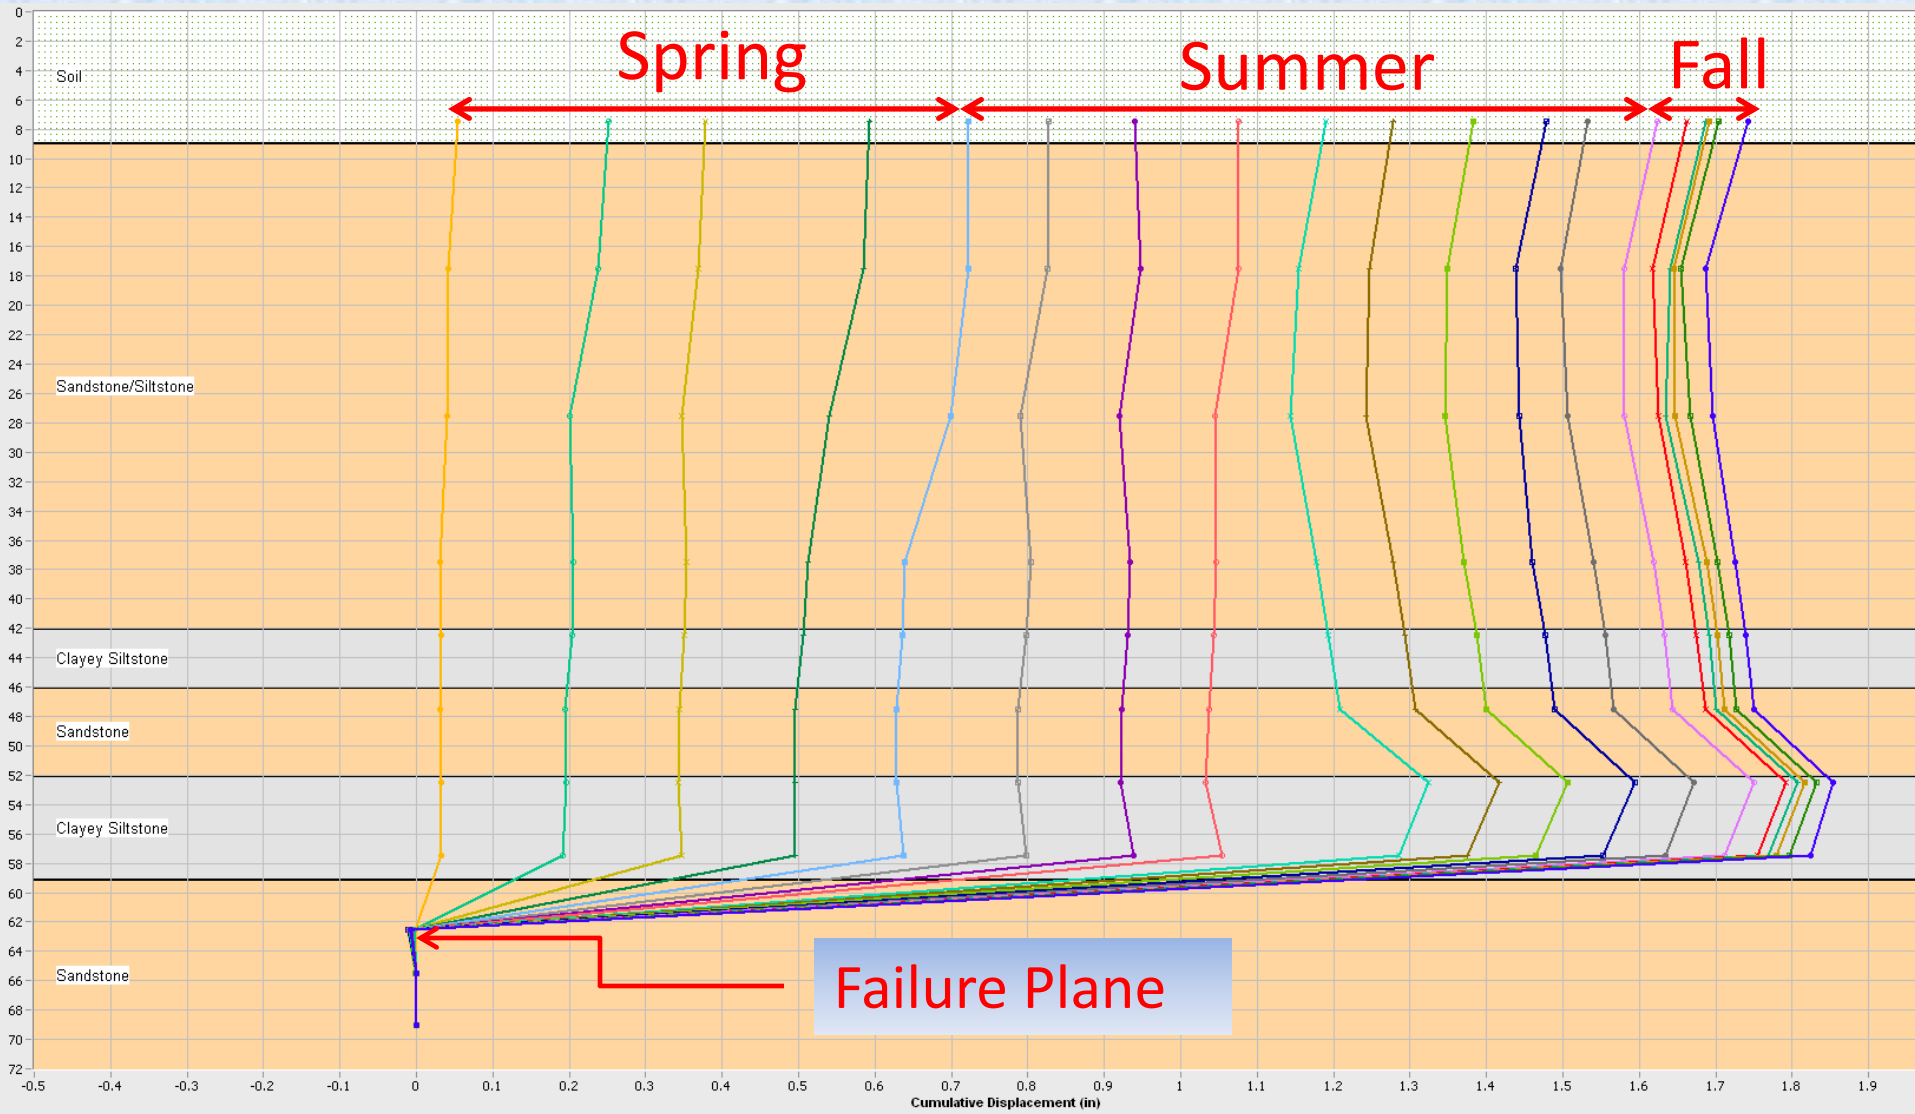
## INC-1: April, 13 – Sept, 13

# In-Place Inclinometer Data

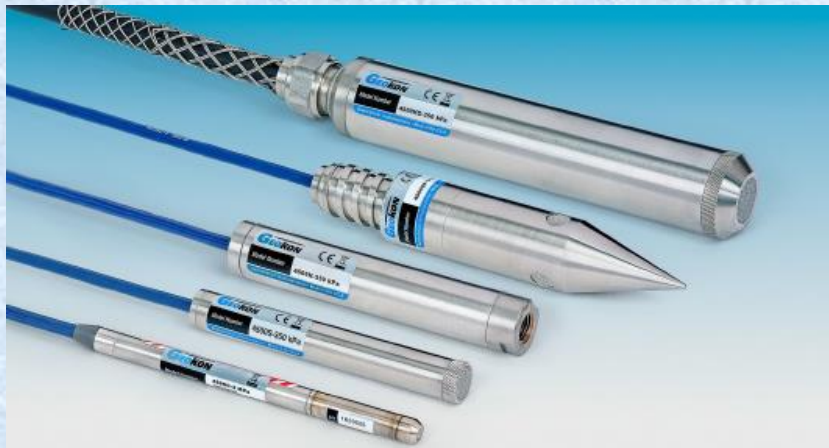
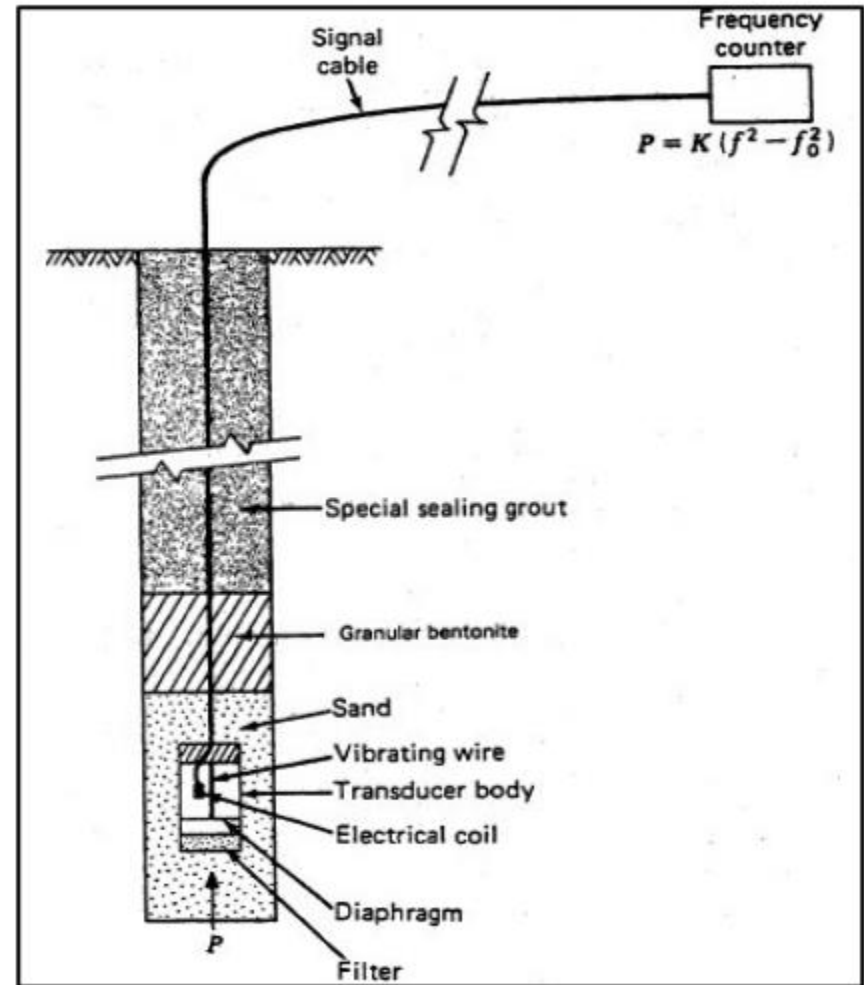
Figure 1 - Schematic of Vibrating Wire Piezometer Installed in a Borehole  
(Dunncliff, 1998 (After Dunncliff, 1988, 1993))

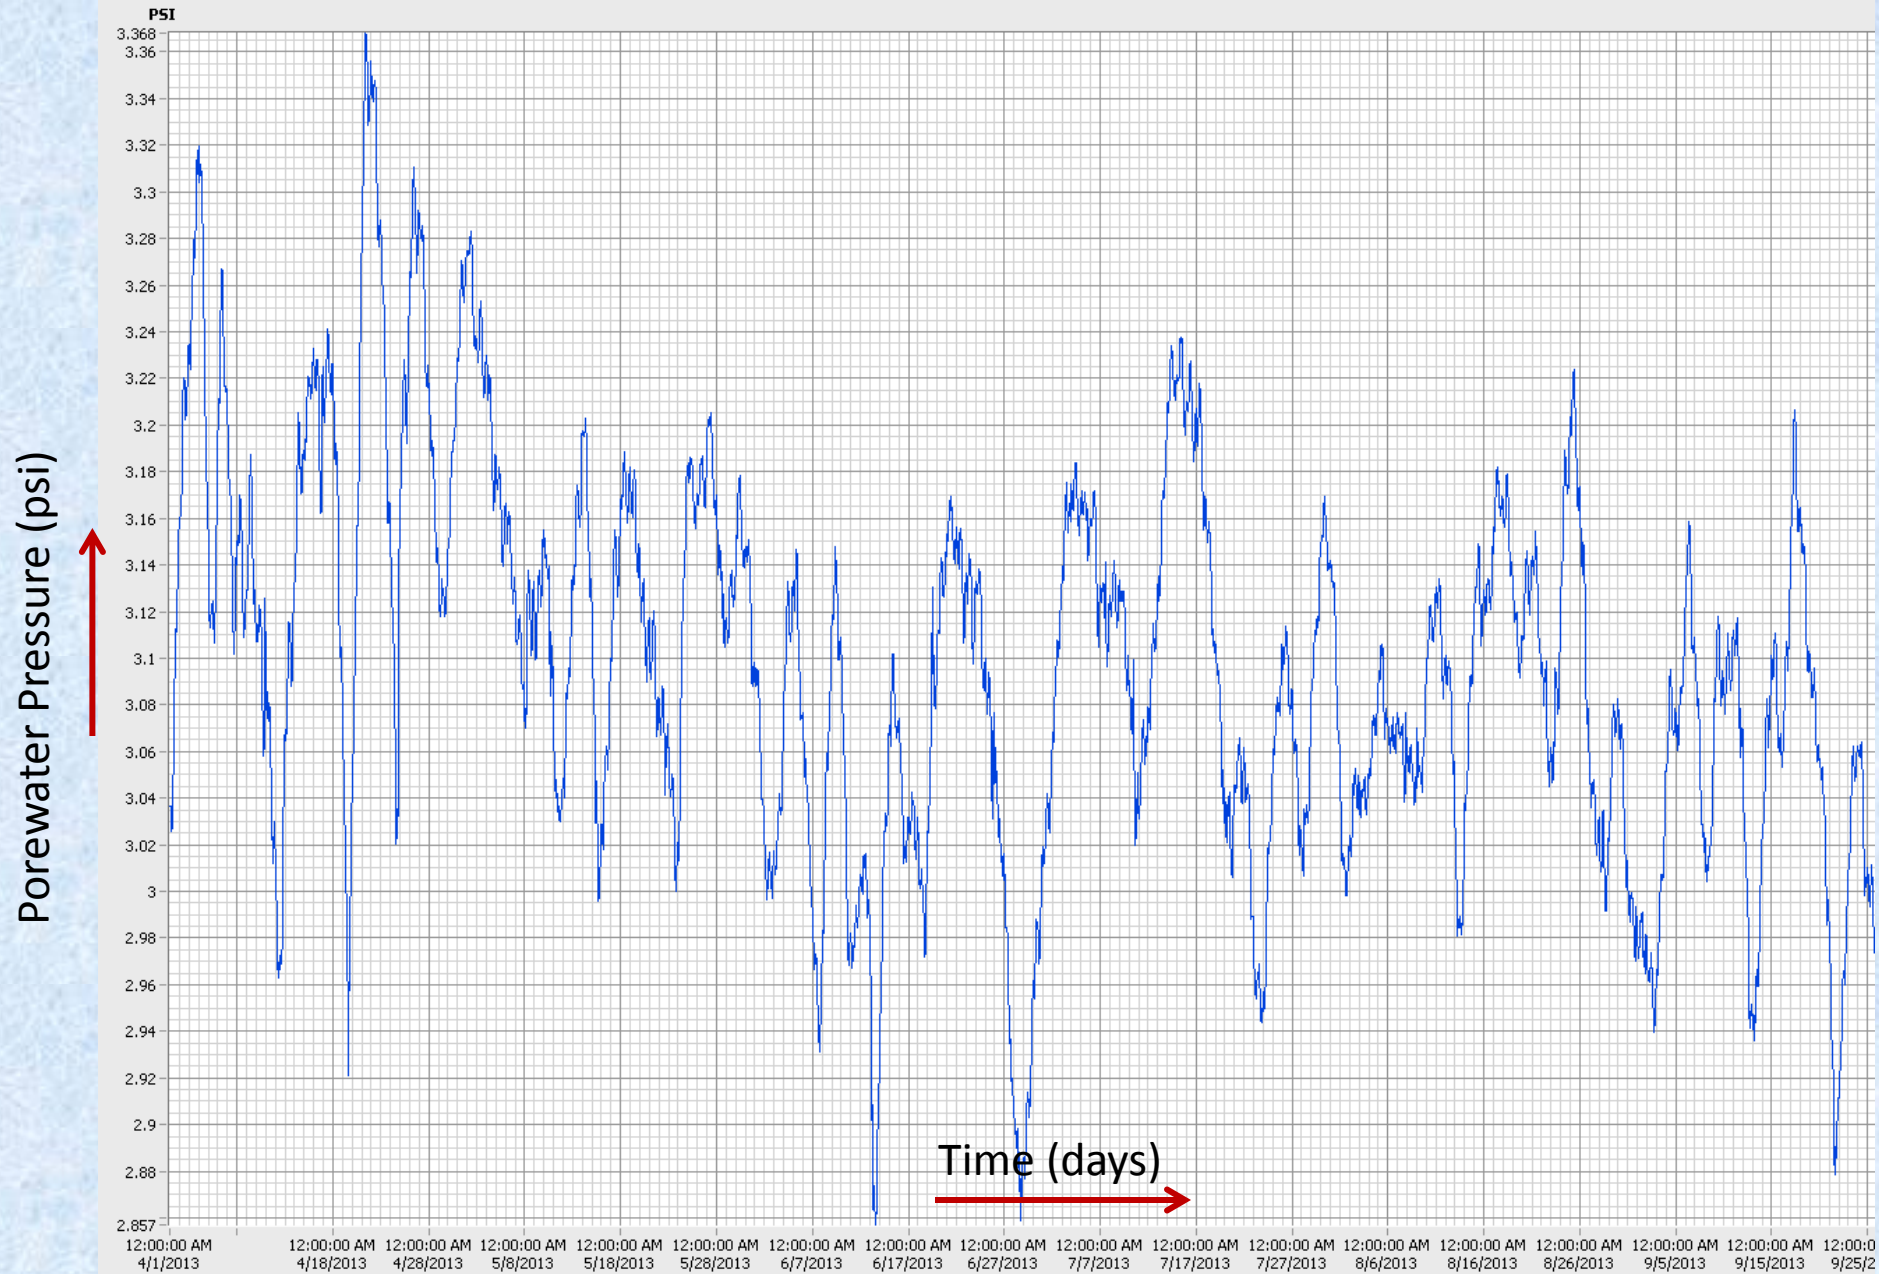
# Vibrating Wire Piezometer - Data

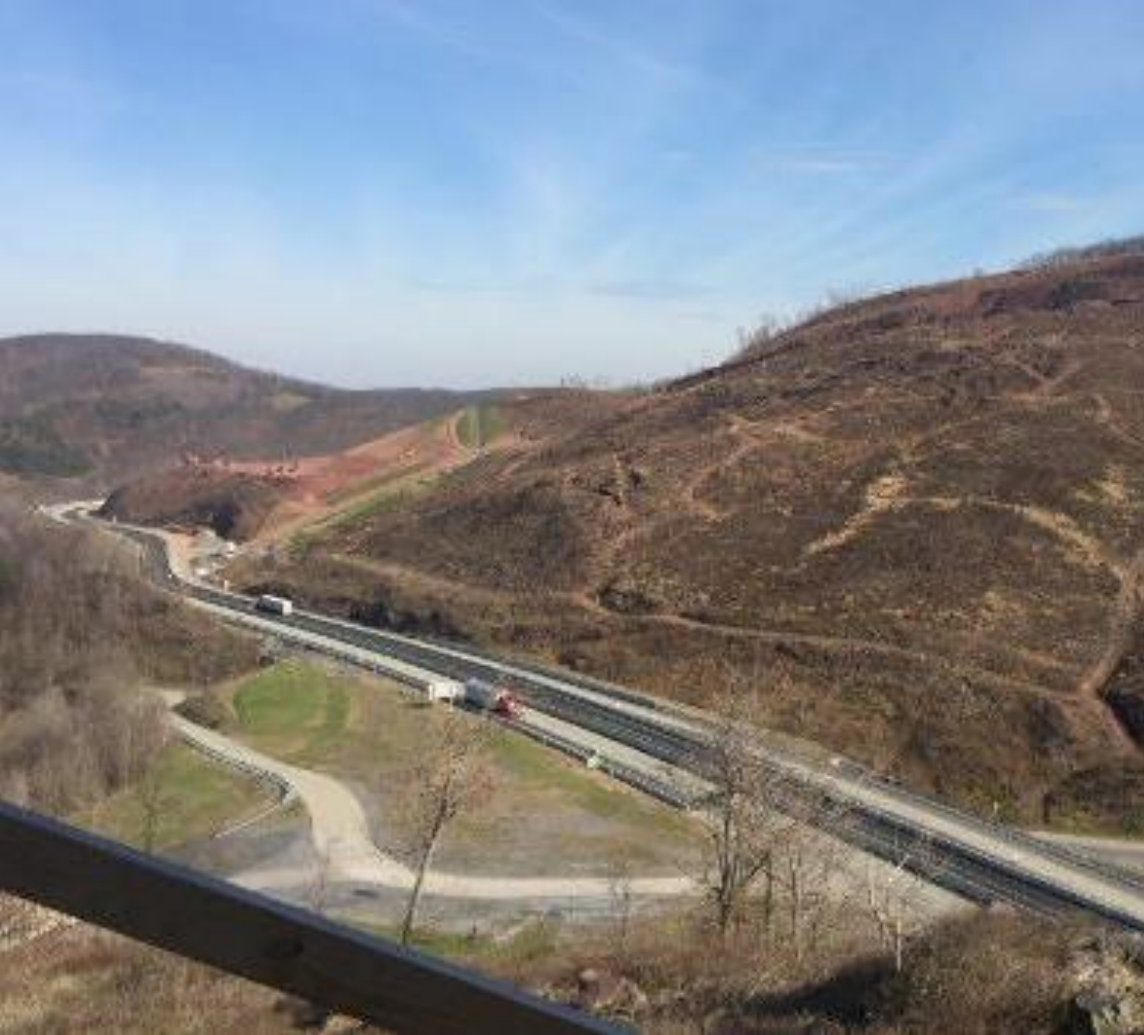
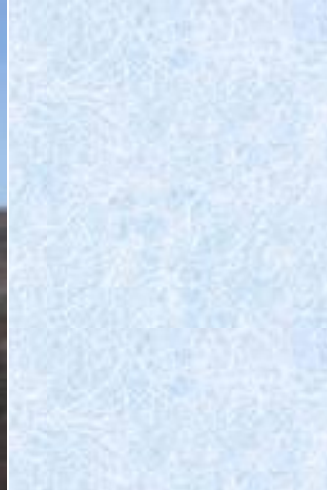
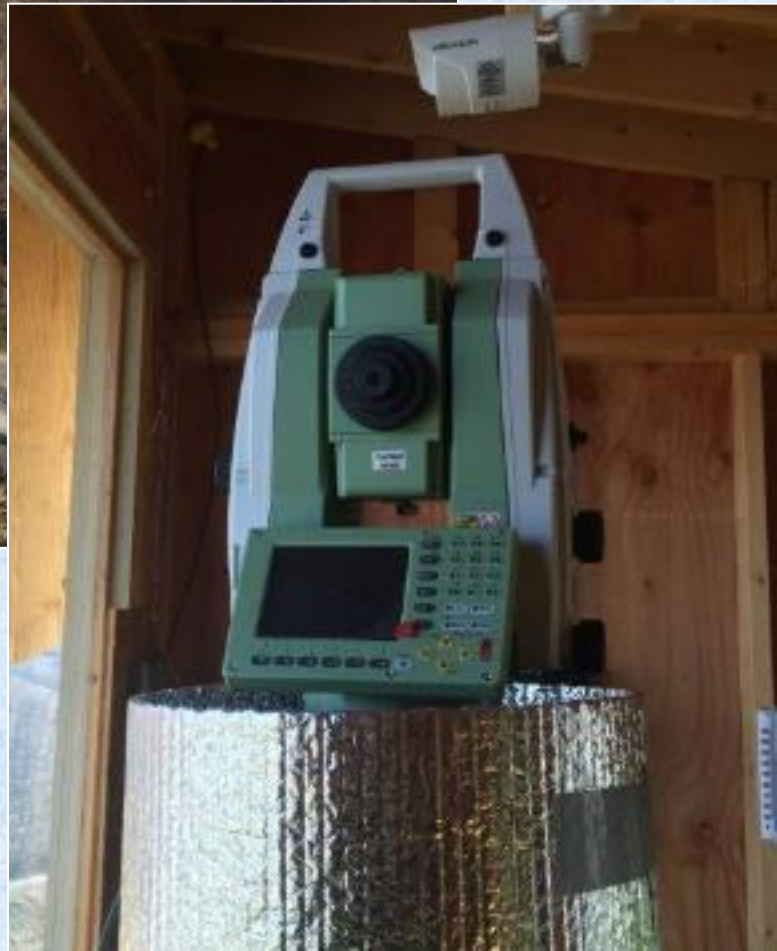
Laser Total Station System
