*Transportation Pooled Fund Project 5(165)*

**DEVELOPMENT OF DESIGN GUIDE FOR THIN AND ULTRA-THIN CONCRETE  
OVERLAYS OF EXISTING ASPHALT PAVEMENTS**

*TASK 1 REPORT:*

**COMPILATION AND REVIEW OF EXISTING  
PERFORMANCE DATA AND INFORMATION**

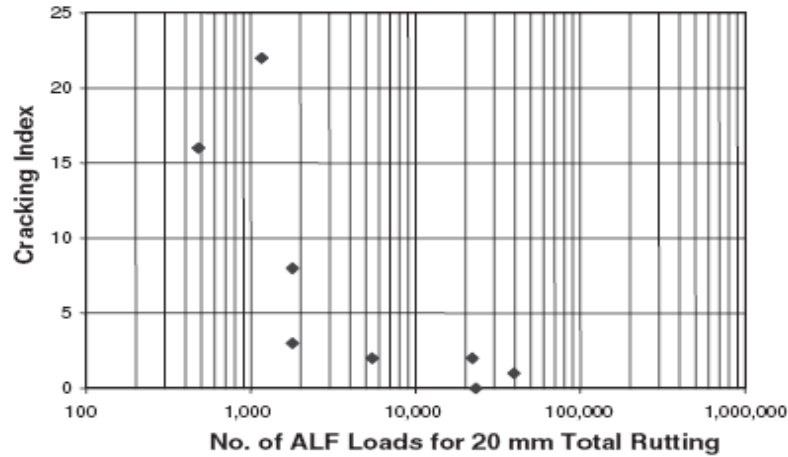
Figure 7: Comparison of HMA rutting to UTW cracking.  
(Rasmussen et al., 2002)

Figure 4 and Figure 5 show typical transverse and corner cracks observed in the ALF experimental study. The most significant faulting was observed along the longitudinal joint probably due to the channelized nature of the loading. Faulting was also observed in a few transverse joints but this was less severe compared to the longitudinal faulting. Figure 6 shows faulting that developed. Most of the observed spalling was of low severity.

To make a rough comparison, the degree of cracking observed in each lane was quantified by using a cracking index. The cracking index is a weighted average of the number of cracks observed in each lane and it is calculated by summing up the cracks for each lane with a full-panel crack weighing 1.0, a partial-panel crack 0.5, and a small chip or break 0.1 (Rasmussen et al., 2002). This cracking index is then compared with rutting that has been quantified as the number of ALF load applications to reach 0.8-in of total rutting (Figure 7). The hypothesis of the cause of various distresses that were observed in the ALF UTW experimental study is presented in the following sections. The mechanism causing each distress was analyzed by Rasmussen et al. (2002) and a summary of their findings is provided below.

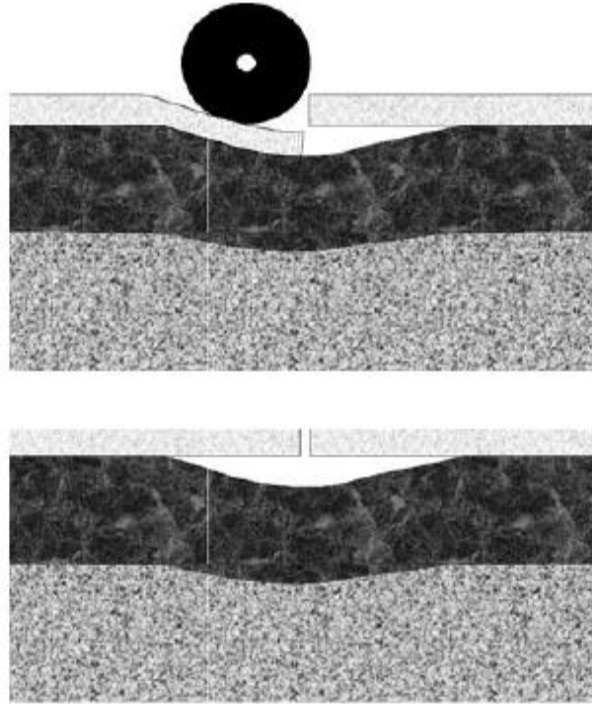
Figure 8: Permanent deformation of HMA base.  
(Rasmussen et al., 2002)

Corner cracking is the most common form of distress typically exhibited by whitetopping pavements, and this was reflected at the ALF UTW project. This is a fatigue-related distress. The stress state within the UTW as a result of the applied loads can change as the support conditions change. The change in support conditions can be due to permanent deformation accumulated with the numbers of load applications or stripping/raveling of the underlying HMA layer. Figure 8 shows formation of a void underneath the UTW due to permanent deformation of HMA layer. The UTW slab then acts as a cantilever under the wheel load and a corner crack develops. Rasmussen et al. (2002) also hypothesized that the corner cracks might have initiated at the loaded (longitudinal) edge of the slab and propagated diagonally toward the closest intersecting joint with each successive wheel load. It will be shown in subsequent sections that other studies have indicated that these corner cracks can also initiate at the intersection of the wheelpath and the transverse joint and propagate until intersecting with the longitudinal joint.

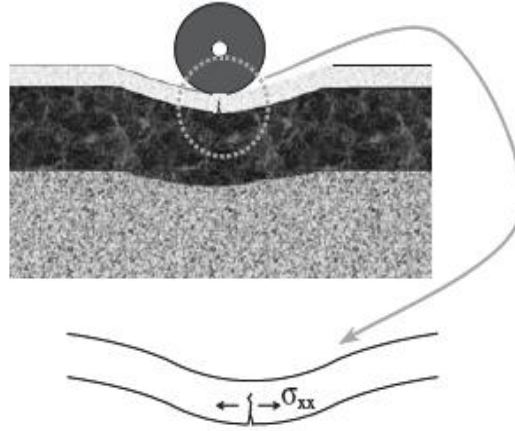
Figure 9: Mid-slab cracking mechanism of an UTW slab.  
(Rasmussen et al., 2002)

Transverse cracking or mid-slab cracking also develops when the concrete loading exceeds the fatigue limit. Rasmussen et al. (2002) hypothesized that the mid-slab cracking initiates at the bottom of the UTW slab. Figure 9 illustrates the initiation of mid slab cracking when wheel load passes directly over the mid-slab at the edge. It is assumed that stress at the edge will be the highest. This tensile stress at the bottom of the slab is compounded by the presence of a void, or soft area beneath the slab. Another hypothesis is that the cracks are initiated at the top of the slab, induced by tensile stresses at the top as the wheel load rolls onto the slab.

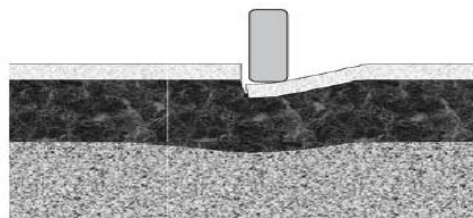
Figure 10: Longitudinal joint faulting mechanism in ALF UTW slabs.  
(Rasmussen et al., 2002)

At the ALF UTW project, both longitudinal as well as transverse faulting was observed. The channelized nature of the wheel loading resulted in more faulting along the longitudinal joint where the wheel load is applied. See Figure 10. Regarding the development of transverse cracking, Rasmussen et al. (2002) hypothesized that under wheel loading, both normal and shearing forces are generated in the support layer materials, which results in deformations that lead to transverse faulting, as shown in Figure 11. But, faulting might also be caused by the erosion of fines as the HMA layer begins to strip due to water infiltration into the transverse joint.

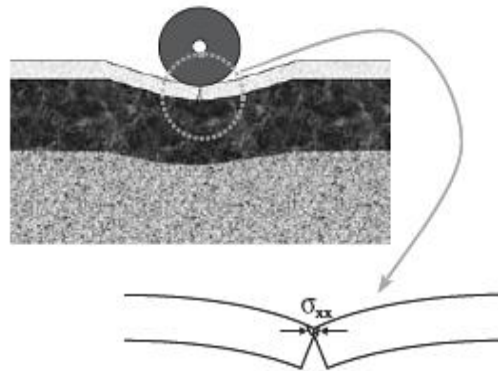
Figure 12: Joint spalling mechanism in ALF UTW slabs. (Rasmussen et al., 2002; Rasmussen and Rozycki, 2004)

Rasmussen et al. (2002) described two common types of joint spalling. The first type, referred to as “delamination spalling,” is caused by the combined effect of horizontal early edge microcracking of concrete and traffic loading that eventually weakens the horizontal crack.

This is a flat-bottom spall. The second type of spalling is termed “deflection spalling.” This is caused when the slab undergoes a substantial amount of deflection under heavy wheel loads. This kind of spalling is observed in airport pavements where the high deflections in the slabs cause a localized crushing of the material at the joints (Figure 12). Since the slabs for UTW are comparatively thin, the deflection spalling might govern the mechanism.

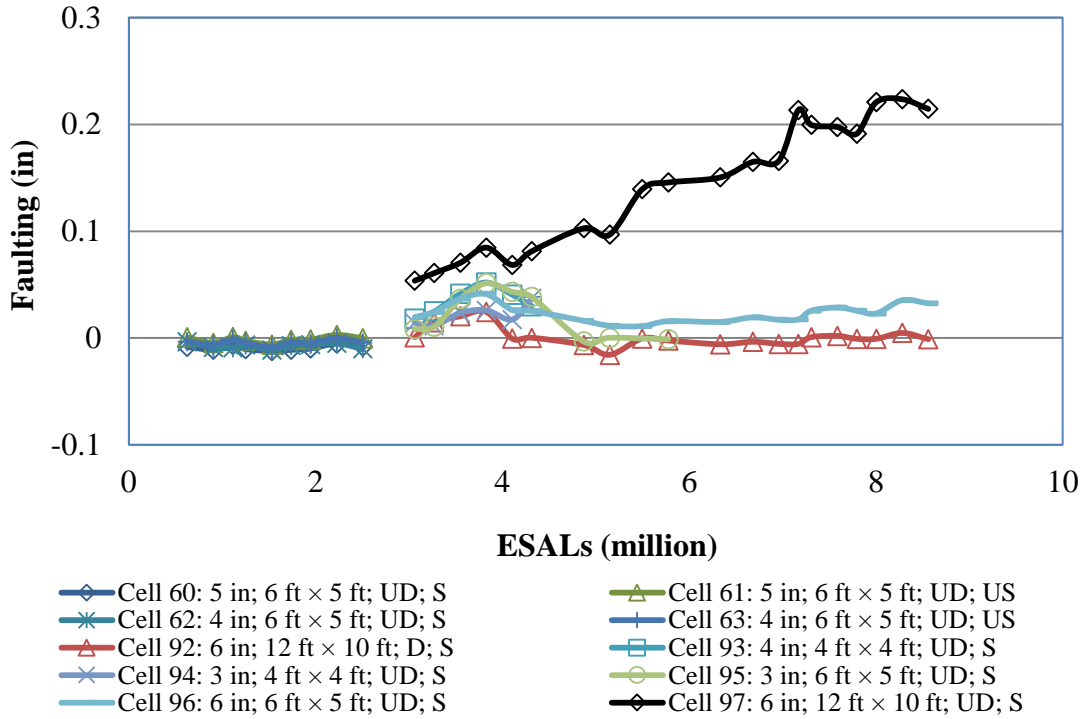
Figure 25: Faulting history for MnROAD cells until October 2007.

The faulting data for the MnROAD cells, as presented in Figure 25, revealed that there is still no faulting in Cells 60 through 63. Among all of the cells still in place, Cell 97 has the most severe faulting. Although Cell 97 has been in service on the interstate for 11.5 years, its magnitude has not yet reached 0.25 in, which is still considered to be low severity.

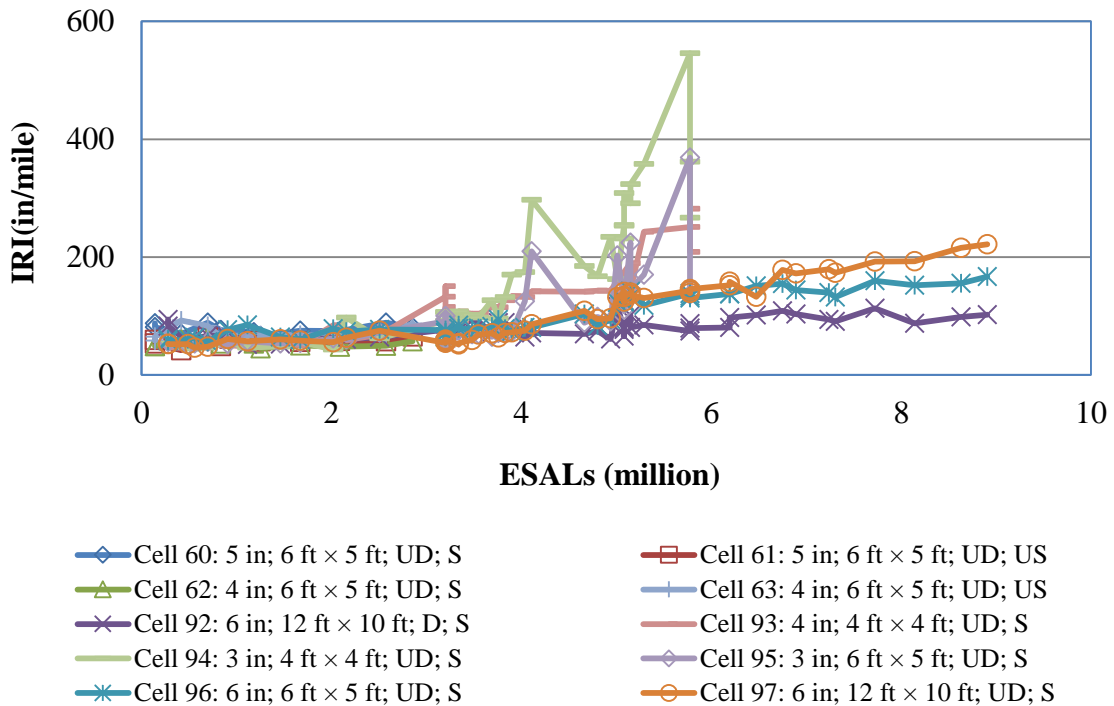
Figure 26: IRI history for MnROAD cells until March 2008.

The IRI history of all the cells is presented in Figure 26. The rideability of Cells 93 through 95 experienced a period of rapid decline in the last two years of their service lives. The IRI for Cells 60 through 63 is still quite low after five years of service on the interstate. Among remaining sections constructed in 1997 (Cells 92, 96 and 97), Cell 92 provides the best rideability. Between Cell 96 and Cell 97, Cell 96 exhibited a lower IRI which is a result of the lower amount of distress observed in this section. Cell 97 has significant joint faulting.

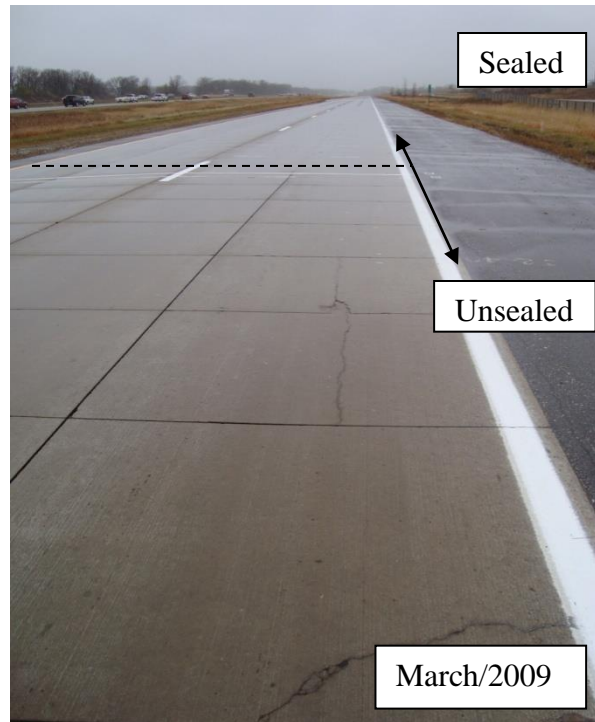
Figure 30: Difference in the amount of water infiltrating the surface for the sealed and unsealed sections.

All of the UTW and TWT cells, except for Cells 61 and 63, were constructed with joints filled with hot pour sealant. The larger amount of longitudinal and transverse cracks (Figure 17 and Figure 18) in Cells 61 and 63 compared to Cells 60 and 62 clearly shows that sealing the joints reduces the amount of cracking. It may also be noted that Cell 63, which is unsealed, developed a corner crack at 2.2 million ESALs. Figure 30 is a photo of the sealed and adjacent unsealed sections while it was raining. It can clearly be seen that the unsealed joints allow the water to enter the pavement structure while the rain puddles on the surface for the sealed joints. The infiltration of the water into the pavement structure facilitates the degradation of the asphalt and hence the bond between the HMA and the overlay. This is not as critical for thicker PCC overlays; but, a good bond is essential for the long-term performance of these thin overlays. The shorter panel spacing also increases the area (due to more joints) for potential rain infiltration within the overlay, which also increases the need to seal the joints to maintain the integrity of the underlying asphalt. The infiltrated water through the unsealed joints may also increase the probability of durability cracks (due to freeze/thaw) near the corners of the panels, although signs of this were not observed at MnROAD.

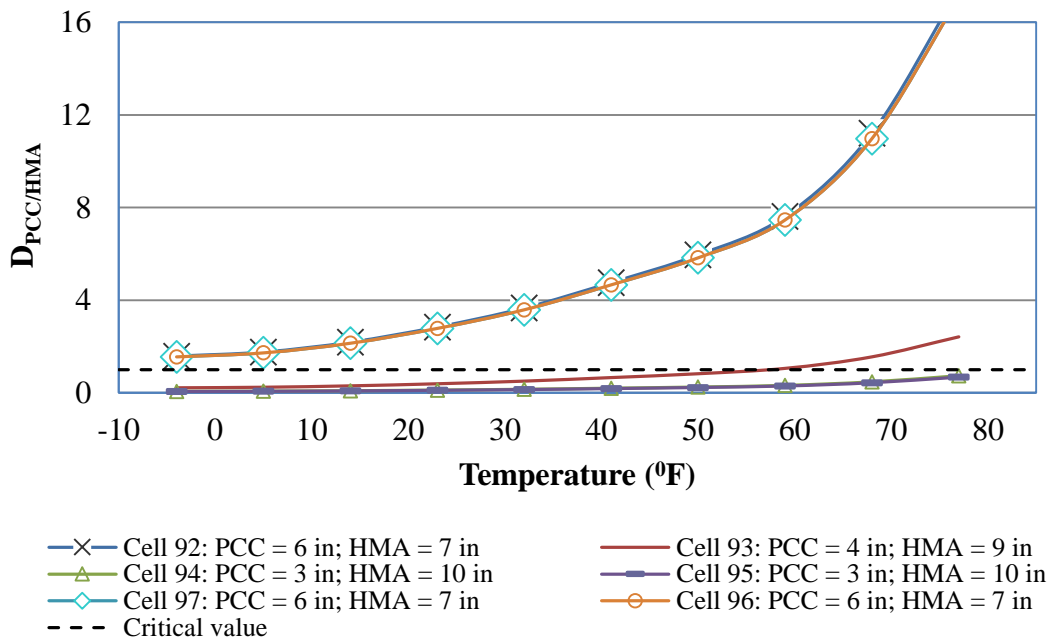
Figure 32: Relative stiffness of PCC and HMA layers for Cells 92 through 97.

If  $D_{PCC/HMA}$  is equal to 1, then the stiffness of PCC layer is equal to that of the HMA layer. The reflection cracks are expected to occur when the value of  $D_{PCC/HMA}$  is below 1. Using the above equation  $D_{PCC/HMA}$  was calculated for the MnROAD UTW and TWT test sections for a range of HMA temperatures and is presented in Figure 32 and Figure 33. It is interesting to

observe that the  $D_{PCC/HMA}$  for Cells 94 (PCC=3 in and HMA = 10 in) and 95 (PCC = 3 in and HMA = 10 in) is below the critical value of 1 for most of the temperature ranges measured in the HMA layer for the MnROAD sections, which indicates that the PCC slabs were vulnerable to reflection cracking for most of the year. Cell 93 (PCC= 4 in and HMA = 9 in) has a  $D_{PCC/HMA}$  value less than 1 at a temperature below 60 °F. The occurrence of a significant amount of transverse reflection cracks in these cells was discussed in Section 4.1.2. Cells 92, 96 and 97, which are 6-in thick, did not suffer any reflection cracks which makes sense because the  $D_{PCC/HMA}$  was always greater than 1. This theory can be validated further by considering the recent performance data for Cell 61; the  $D_{PCC/HMA}$  value for this cell is below 1 at 5 °F. As of March 2009, two reflection transverse cracks developed in Cell 61. Cells 62 and 63, which were constructed with 4-in PCC slabs over 8-in HMA layers, had a  $D_{PCC/HMA}$  that dropped below one at 50 °F. Two and three reflection cracks have developed in Cells 62 and 63, respectively. The performance of the MnROAD sections also revealed that heavy traffic loads in the driving lane accelerate the progression of these kinds of cracks. Further verification of this concept will be provided when discussing the performance of the UTW constructed at Elk River, Minnesota.

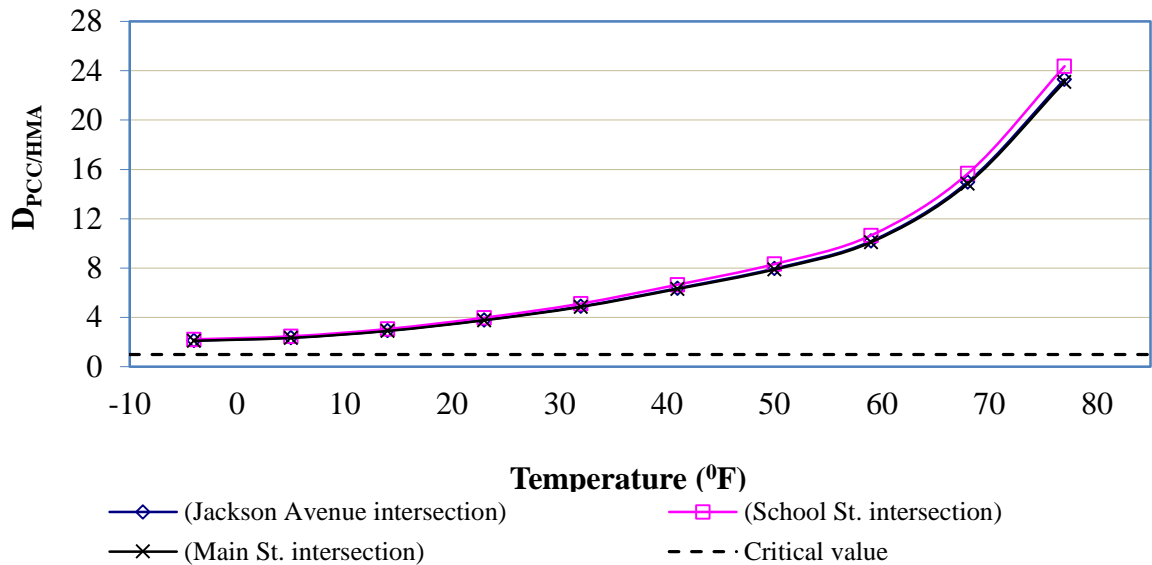
Figure 38: Relative stiffness of PCC and HMA layers for US-169 UTW test sections.

However, comparing the distress surveys prior to and after the overlay was placed revealed that none of the transverse cracks in the HMA layer reflected into the overlay for any of the test sections, while reflection cracks did develop in the 3-in and 4-in overlays constructed at MnROAD. The same joint patterns used on US-169 were also employed on I-94. The difference in the performance can be attributed to the fact that the UTW on US-169 was placed on top of 3-in of HMA exhibiting signs of raveling and the UTW at MnROAD was constructed on 10-in or more of high quality HMA. Therefore, at MnROAD, a higher bond strength and structural rigidity in the HMA layer was experienced. In turn, higher tensile stresses at the bottom of the UTW in the regions of the cracks in the HMA were produced. As previously discussed, reflection cracking is a function of the relative stiffness of the PCC and HMA layers. The relative stiffness of the PCC compared to the HMA layer, represented by  $D_{PCC/HMA}$ , for the US-169 UTW test sections was found to be more than one over the possible range of

temperatures at the project site (Figure 38). As a result, no reflective cracking was observed for any of these test sections.

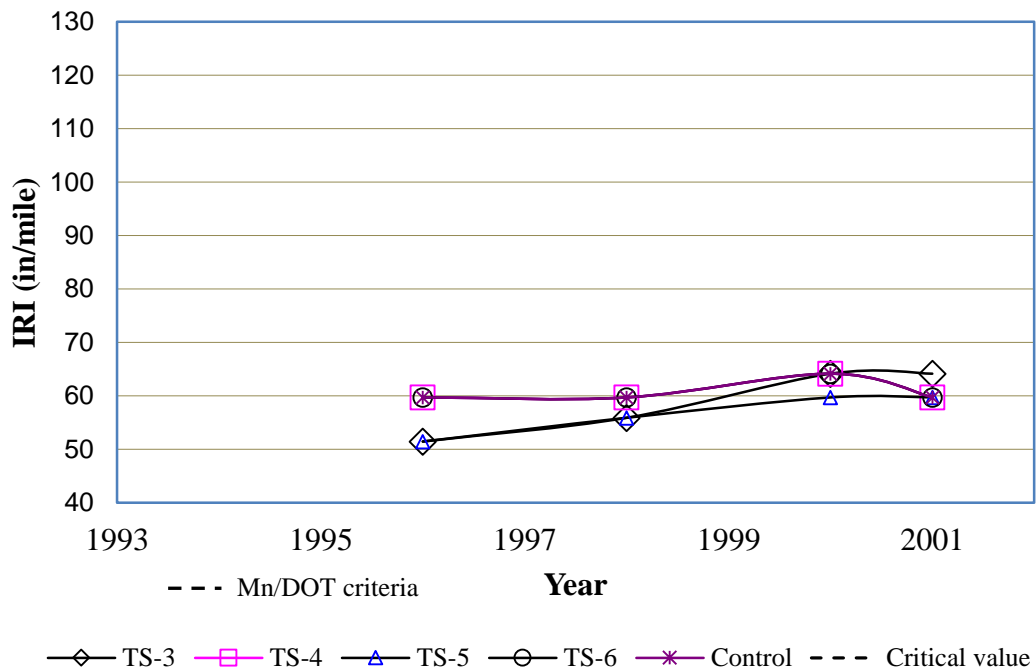
Figure 39: Plot of IRI data for TH-30 from 1994 to 2001.

ft x 12-ft panels. The ride quality of the sections measured from 1994 to 2001 is shown in Figure 39. TS-4 experienced a lot of transverse joint spalling and its measured IRI was greater than the other test sections. However, the measured IRI was still below the Mn/DOT critical value (120 in/mile).

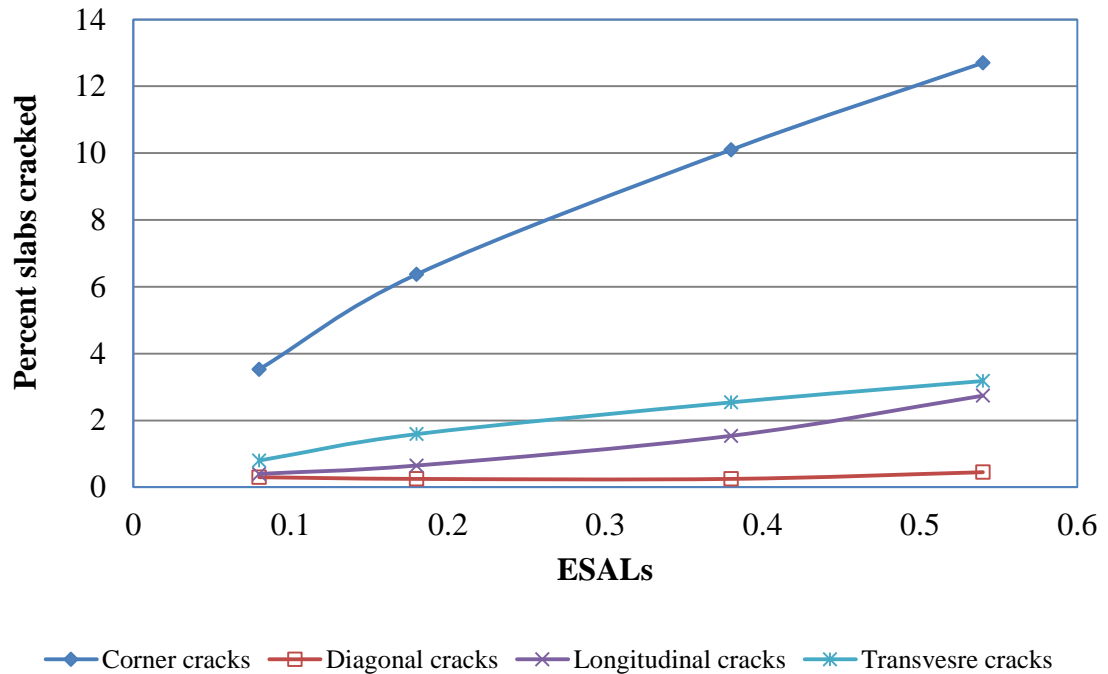
Figure 43: Distresses with respect to ESALs.

**Distress data:** The performance of this intersection indicates a successful application of whitetopping in the distressed areas that exhibit shoving. This intersection did not have any maintenance performed on it until four years after construction, although distresses were observed. Table 33 presents the distress summary of the intersection from 2002 to 2004. Figure 43 presents the trends of the cracks with respect to the ESALs. It may be noted that more than half of the distressed panels appear to be in areas where the concrete inlay was bonded directly to the underlying brick pavers. The debonding rate for this intersection has consistently been five percent for each of the three years surveyed.

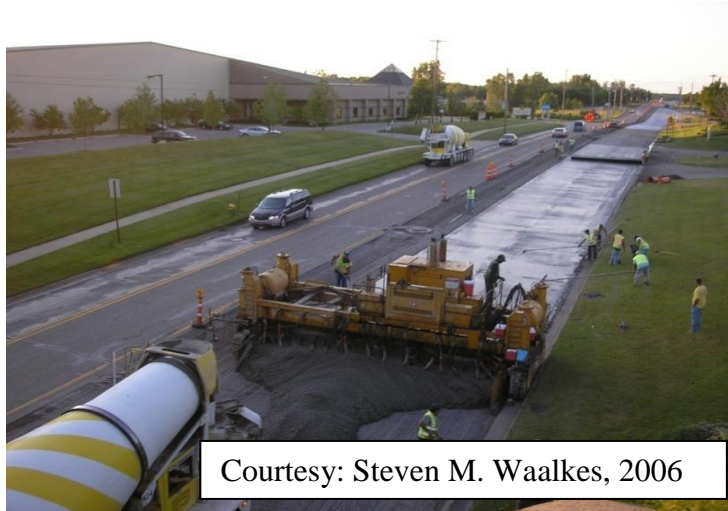
**Background:** This whitetopping project is 33,000 yd<sup>2</sup>. The original pavement was constructed during the 1960's followed by multiple HMA overlays until 2006 when the pavement was suffering rutting at the intersection approaches and some low severity thermal cracks. There may have been some other isolated distresses, but there was no fatigue cracking. The top layer was also worn and oxidized. Figure 47 shows the HMA layer condition before the construction of the Patterson Avenue project.

Figure 47: Condition of the original HMA layer at the time of construction.

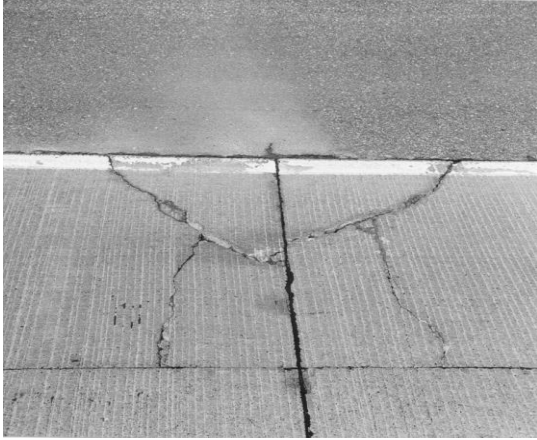
Many of these sections also exhibited transverse cracks but these cracks were typically either reflection cracks or secondary cracks that developed from corner cracks. See Figure 47. Although, there are instances when transverse cracks developed independently of the presents of other cracks, as shown in Figure 49.

a.) Development from corner cracks.    b.) Development independent of other cracking.

Figure 49: Transverse crack development in overlays  $\leq 4$  in.
