The Use of Small Unmanned Aerial Vehicles (sUAVs) to Evaluate Rock Slope Stability and Assess Performance of Rockbolts on Inaccessible Slopes

SR885 – BOULEVARD OF THE ALLIES – DUQUESNE BLUFF... ROCKBOLT INVENTORY AND ASSESSMENT

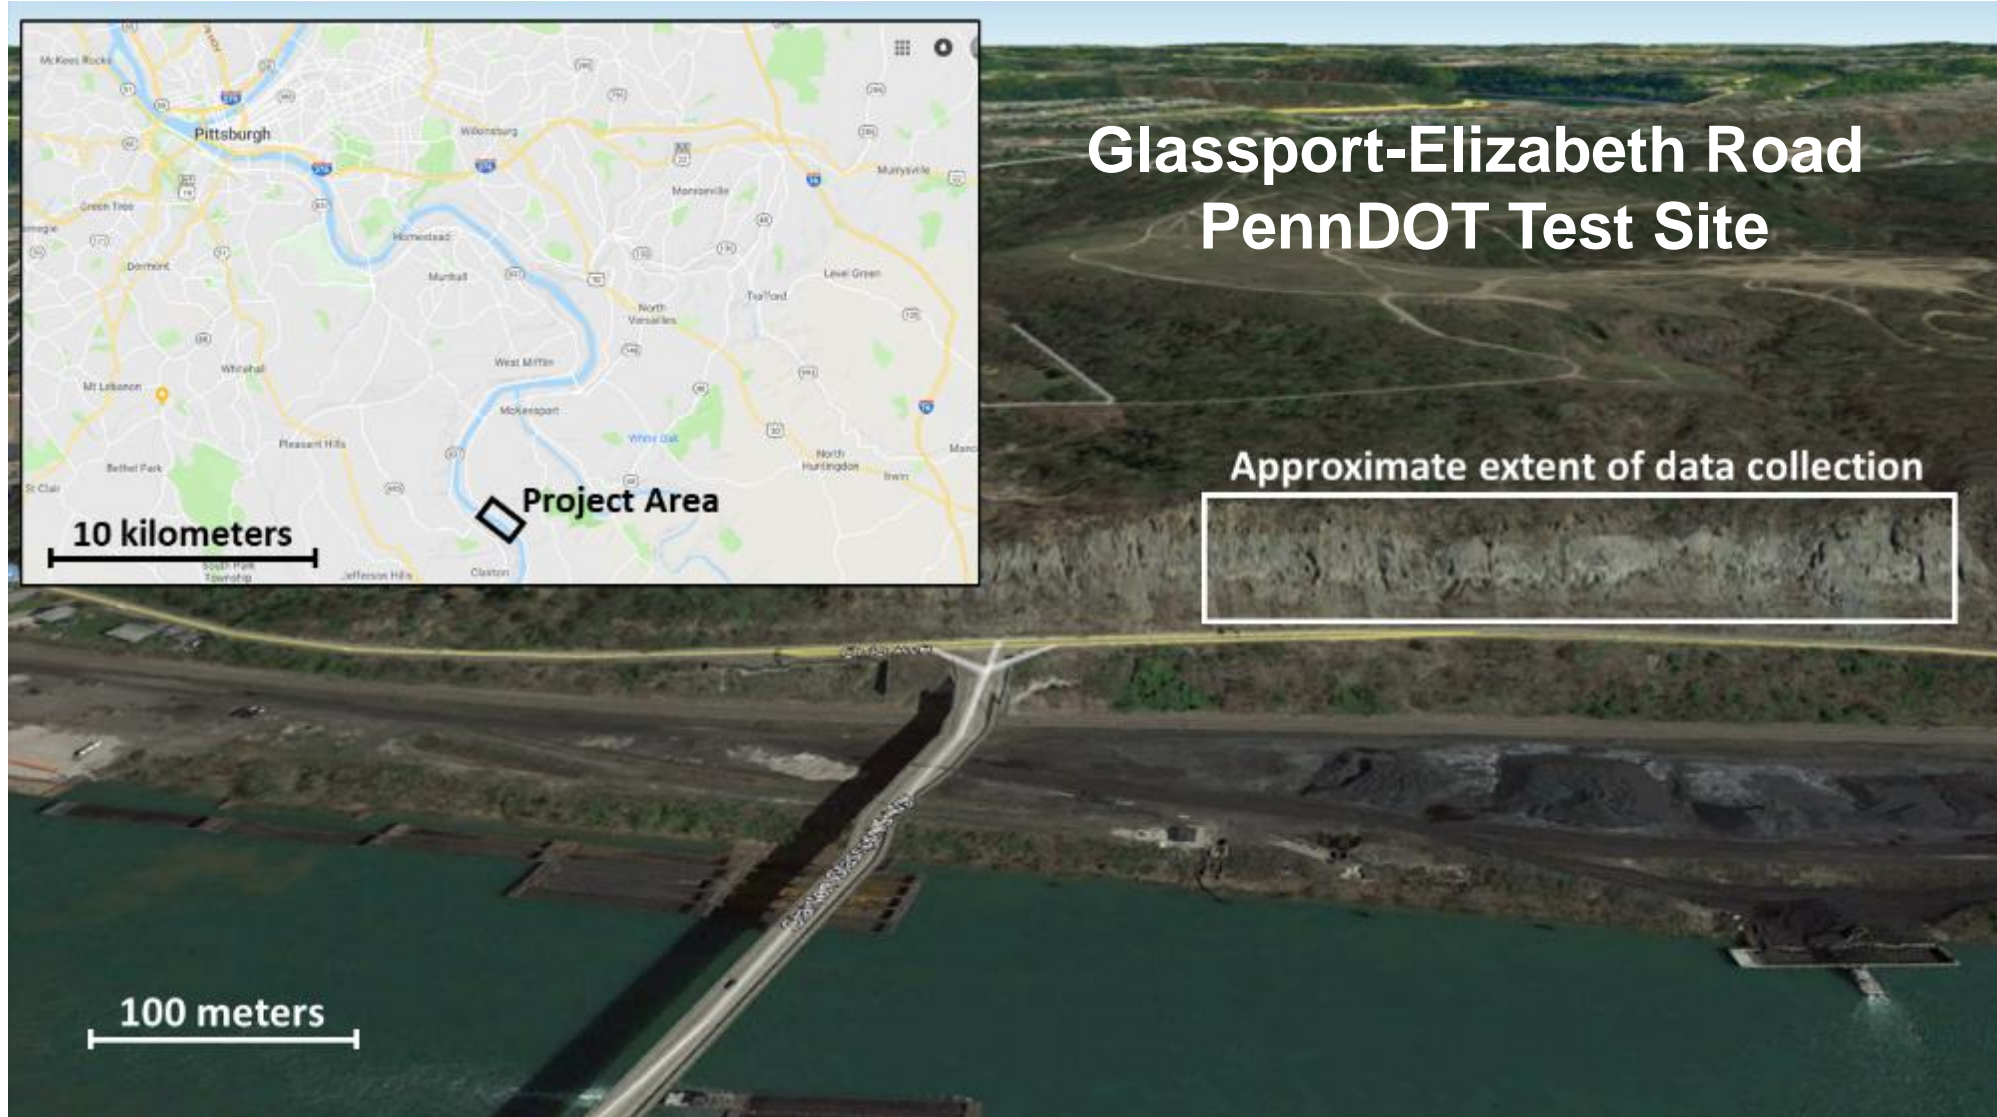
- Thick, resistant, massive layer is the Morgantown Sandstone.
- Overlain and underlain by weak, coal-bearing clay rocks (Clarksburg Clay and Wellersburg Clay).
- Three Problems:
 1. Undercutting of Morgantown Sandstone removes vertical support.
 2. Sub-vertical / slope-face-parallel valley stress relief joints result from ancient and modern removal of lateral support...form sliding wedges, sliding blocks, and toppling blocks.
 3. Erosion of weak rocks above allows water into joints behind the slope face...freeze/thaw separates slabs from intact slope...failure. In this case, a large sliding block / slab.

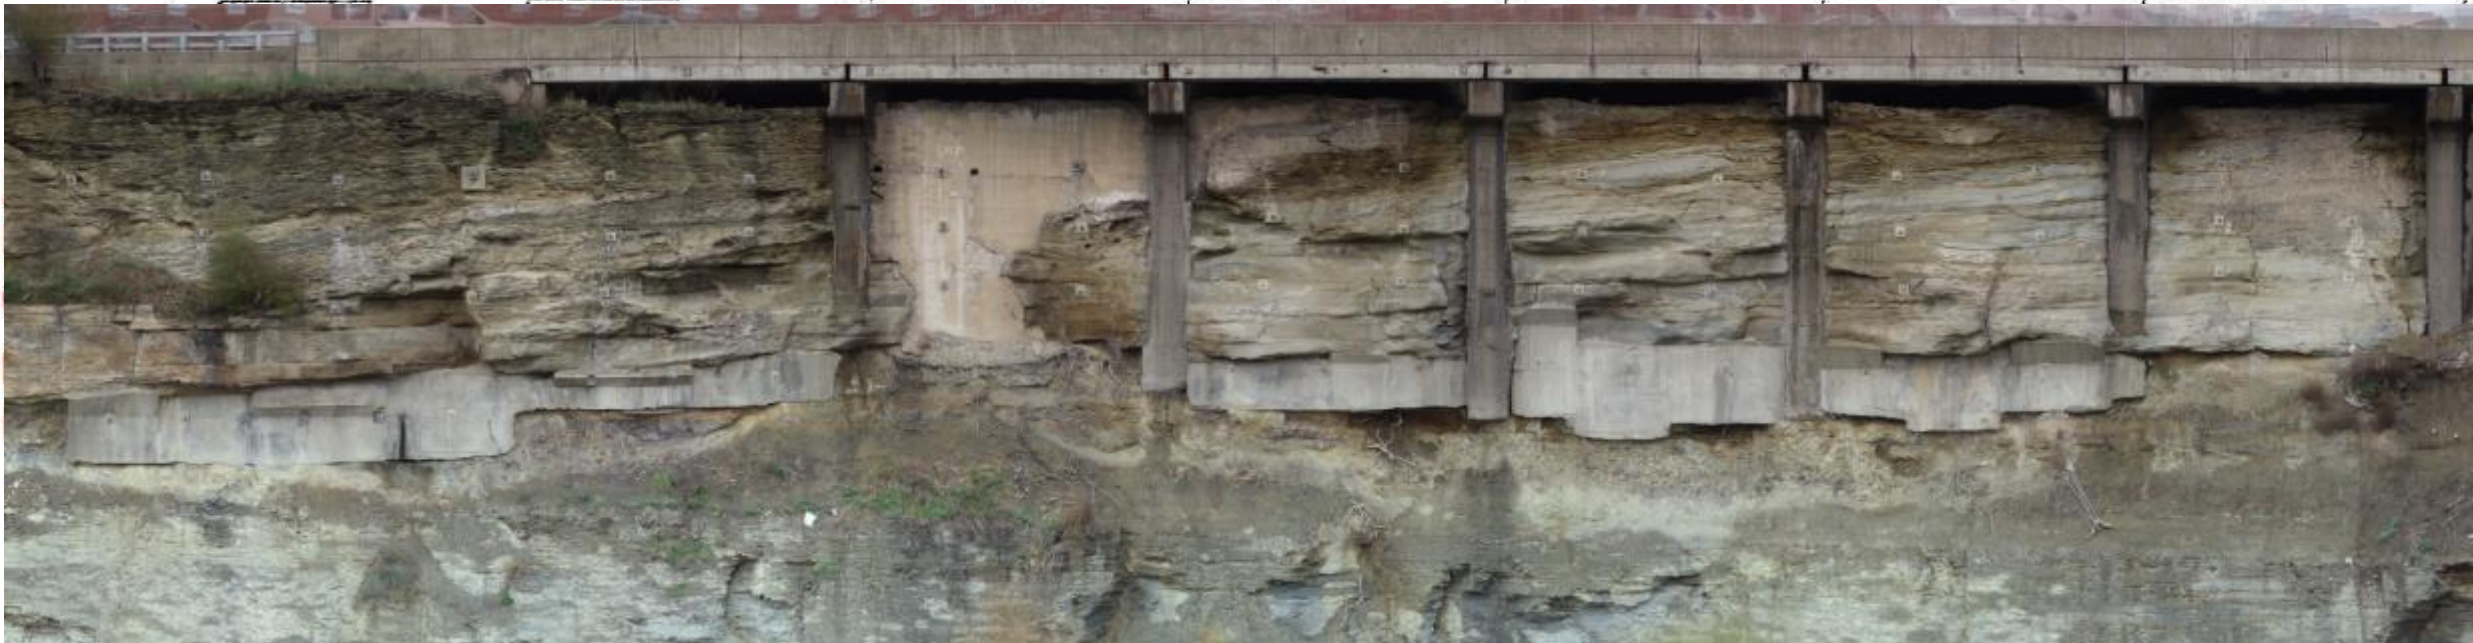
- ROCK BOLTS EXHIBITING DEFECTS

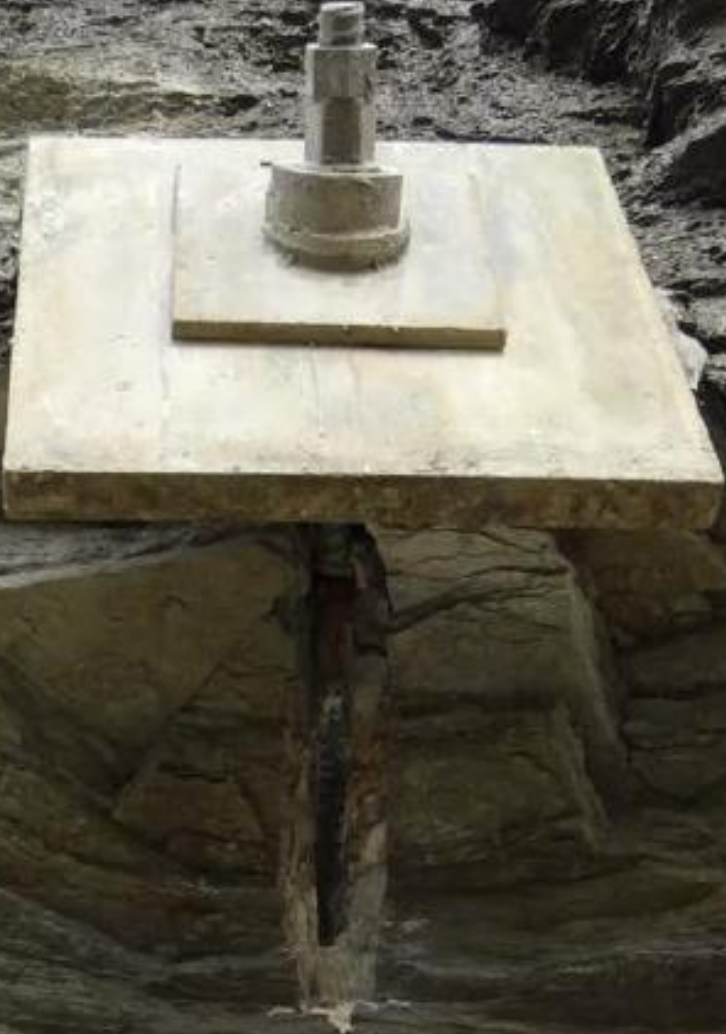
90B EXPOSED ROCK BOLT

47B	Corrosion at Top of Plate
	53C	Corrosion on Plate
	57C	Plate is Undercut
	58C	Plate is Undercut
	61A	Corrosion Around Plate
	65A	Plate is Undercut
	66B	Drillhole Adjacent to Bolt
	67B	Drillhole Adjacent to Bolt
	68B	Drillhole Adjacent to Bolt
	74B	Plate is Undercut
	77B	Plate is Undercut
	78B	Significant Corrosion on Plate & Bolt
	82B	Corrosion at Top of Plate
	83B	Corrosion at Top of Plate
85B	Corrosion at Top of Plate	
86B	Dental Concrete is in Poor Condition; Void Adjacent to Bolt	
90B	Large Void Below Bolt; Bolt is Exposed Behind Plate
